Auburn Lake Trails Community Disposal System

FEASIBILITY STUDY REPORT

November 16, 2020

Bennett Engineering Services
1082 Sunrise Ave, Suite 100
Roseville, CA 95661

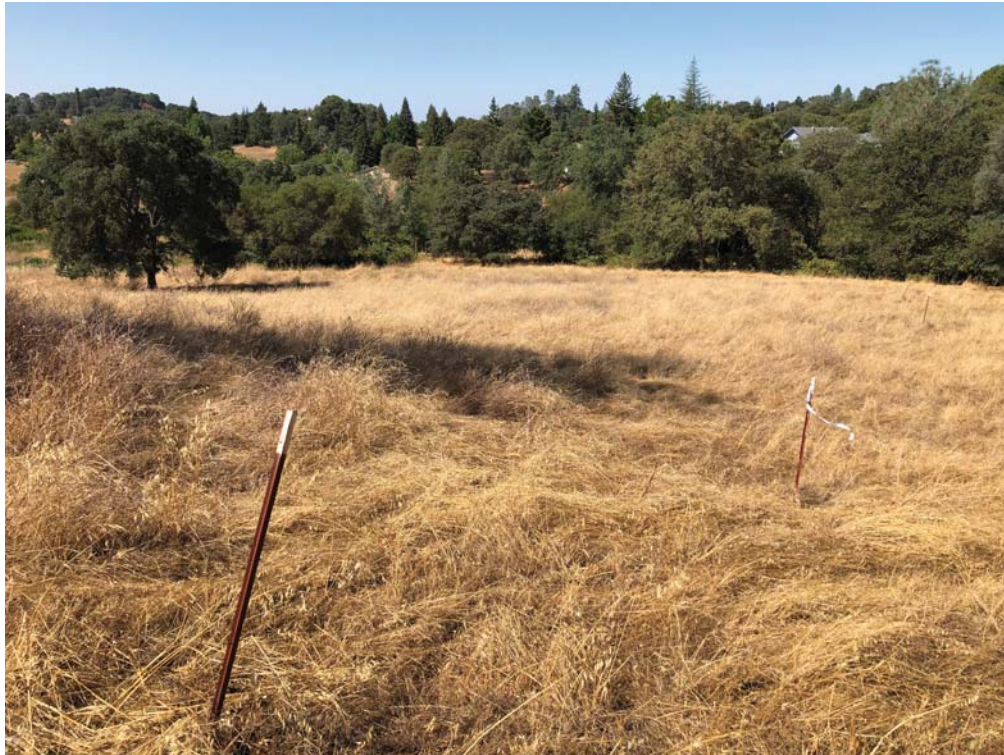
Photo No. 1 Northern portion/margin of Field O. View is looking downslope to the southwest. Excavation LF1 was located at the post with white flagging (photo date 8/3/2020).

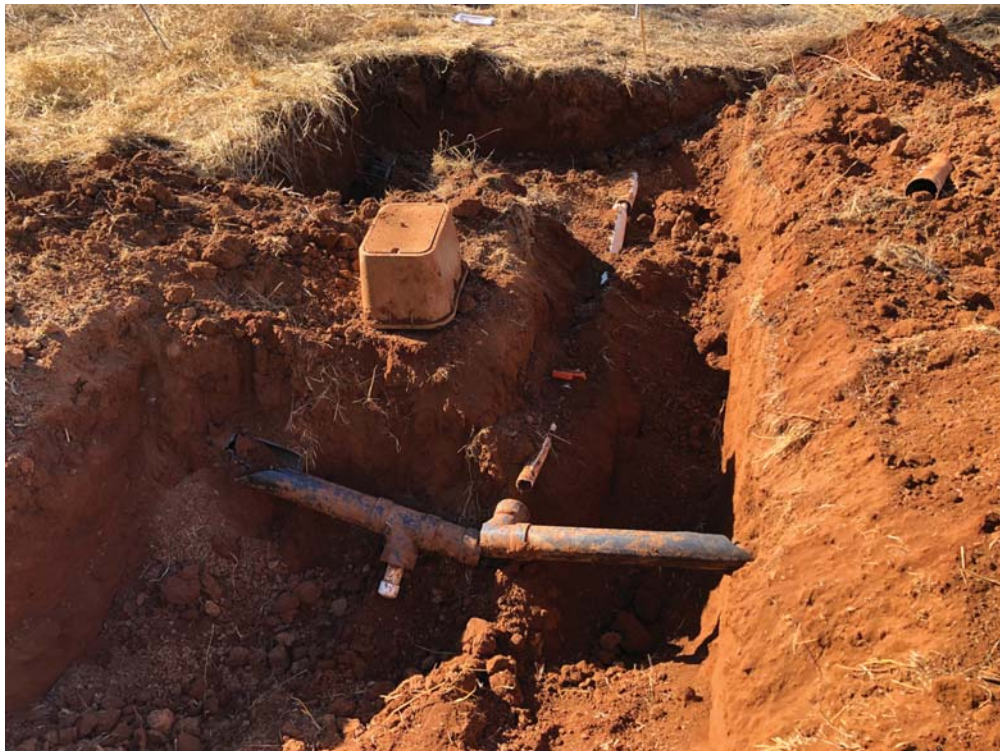
District staff excavated and exposed the northern end of one leach field lateral at location LF1 (see Figure 1). Geocon observed and recorded findings. The lateral was exposed along with its distribution line and a ball valve. The exposed lines were dry and valves at both ends of the lateral were in the off position. Based on the number and location of valves in the central part of Field O, LF1 appeared to be the fourth lateral down from the top of the field. It is assumed that the other laterals in Field O connect to the junction with a ball valve.

Photo No. 2 Distribution piping exposed in LF1 at the northern margin of Field O. View is looking approximately along contour to the southwest (photo date 8/6/20).

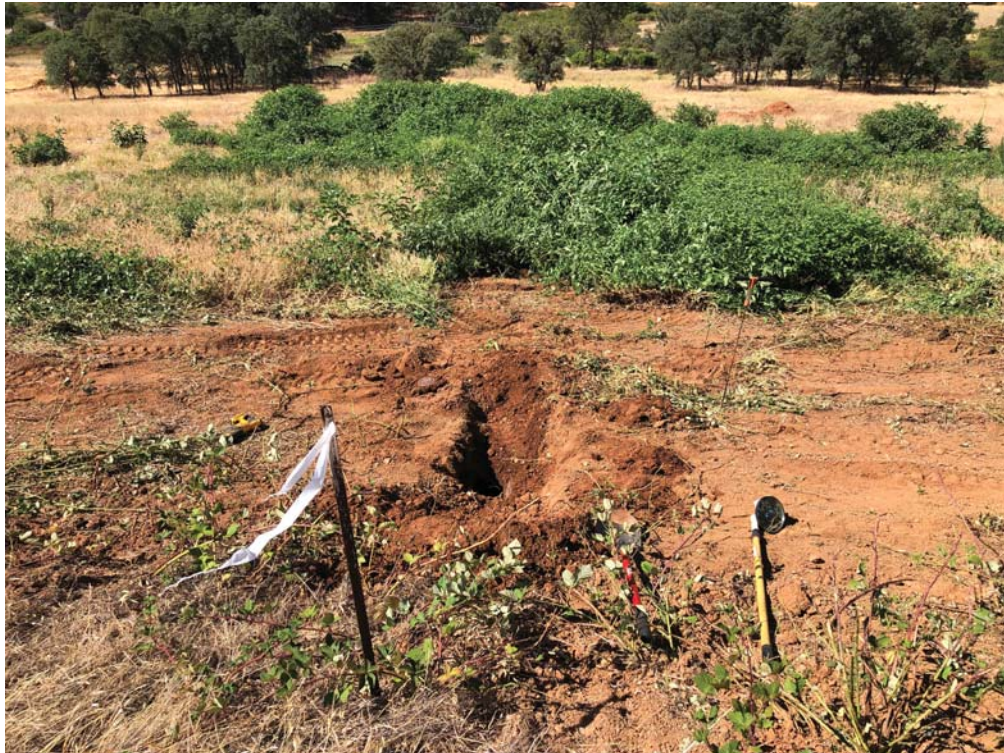
In the central portion of Field A, there is an area of dense, lush vegetation that extends downslope approximately 130 feet from near the top of the field (Photos 3 and 4, 13 and 14, 17 and 18). GDPUD staff used shovels/hand tools to excavate and expose the mid-portion of the uppermost infiltrator in Field A (LF4) and open an observation hole in the top of the infiltrator. The top of the infiltrator was approximately 12 inches below the surface. Fluid was present in the infiltrator approximately 21 inches below ground surface. The presence and level of fluid in the infiltrator was an anticipated condition, as effluent flow to Field A was occurring until approximately 3 days before our field investigation.

Our limited investigation of Field A did not reveal obvious signs of damage to or plugging of infiltrators that might be the cause of high soil moisture/lush vegetation in that field. We speculate that gopher/rodent burrows are a possible cause.

Photo No. 3 View looking directly downslope (southwest) from the top of Field A. Excavation LF4 is in the foreground (photo date 8/7/2020).

3. Increase vegetation maintenance to reduce the future establishment of invasive plant species.
4. Increase rodent deterrent measures to reduce gopher damage to leach fields.

5. Test section and recompact soil to repair damage caused by gopher holes creating conduits for water to reach the surface.
6. Add additional cleanouts and blowoff valves in laterals not currently equipped.

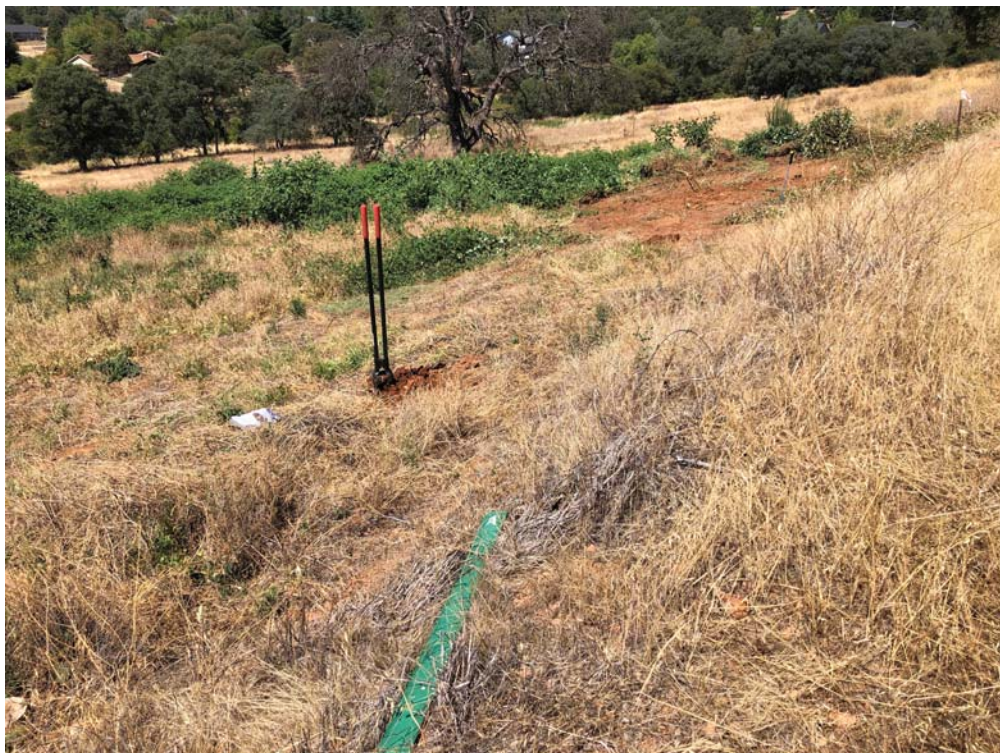
Photo No. 4 View looking to the west from near the top, eastern corner of Field A. (photo date 8/7/2020).

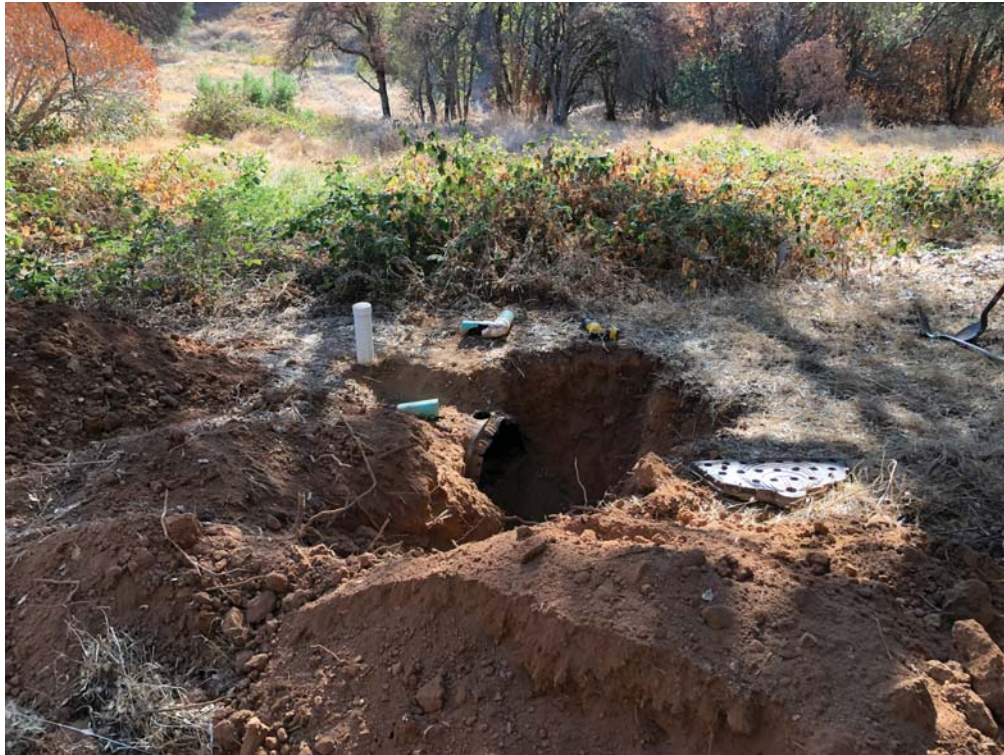
Photo No. 5 View looking east (downslope) at the southwestern portion of Field B and excavation LF2, exposing the end of an infiltrator (photo date 8/7/2020).

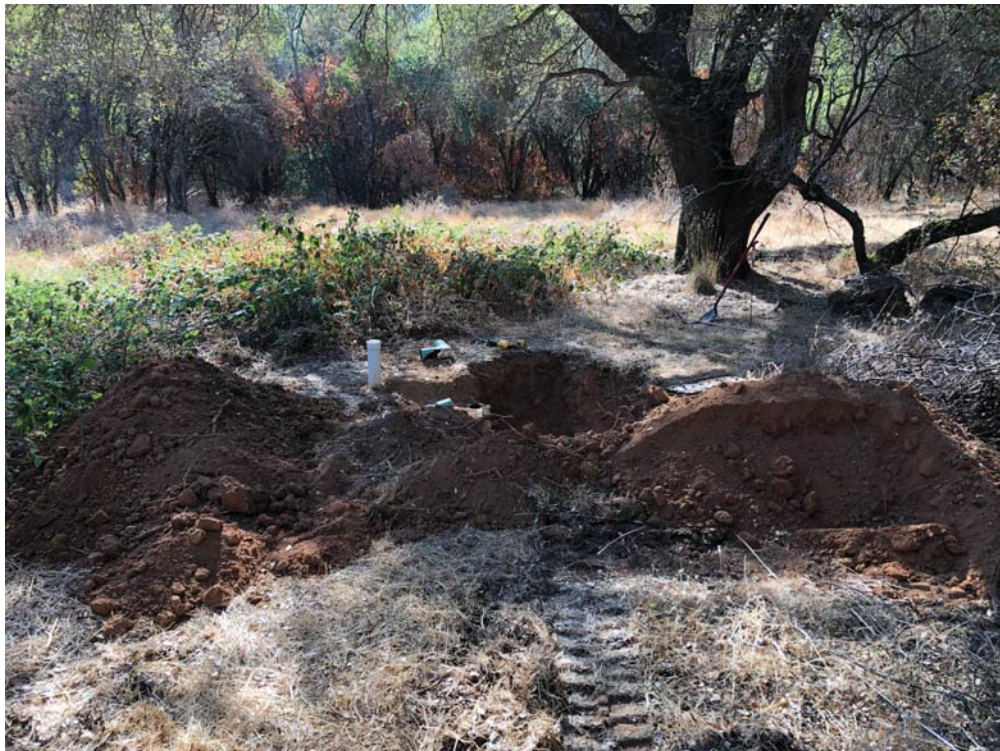
Photo No. 6 View looking southeast at the southwestern end of Field B and excavation LF2 (photo date 8/7/2020).

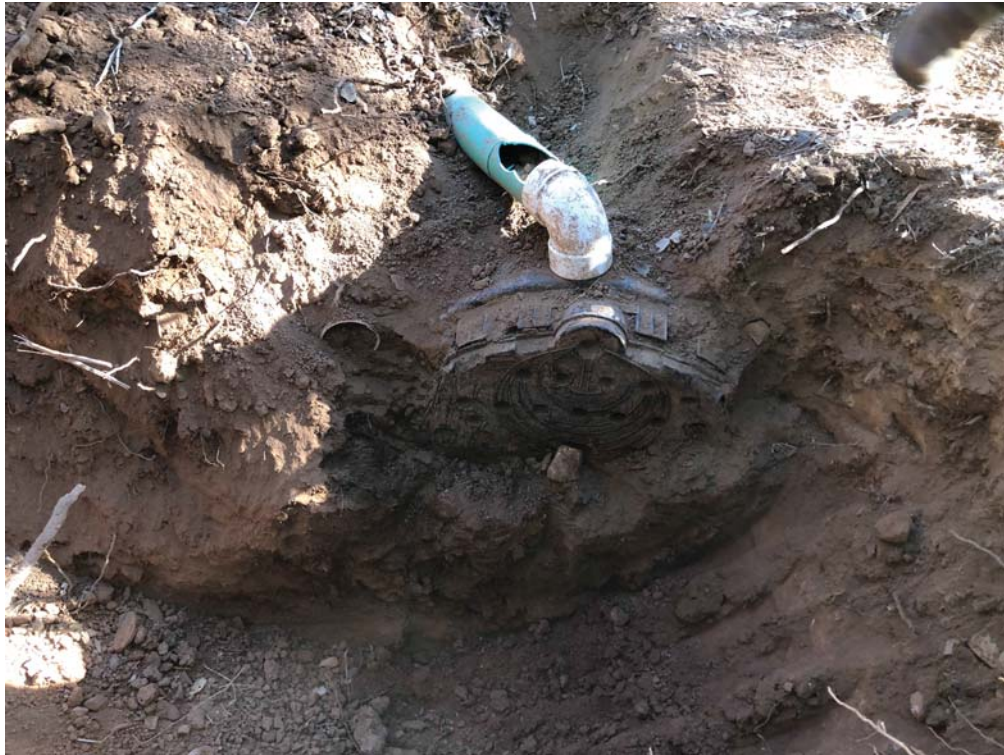
The two infiltrators we opened did not exhibit plugging or other obvious damages and appeared to be in generally good condition (Photos 7 through 10). We observed approximately 2 to 4 inches of biosolids on the interior bottom of the infiltrators, with somewhat greater accumulations (up to approximately 6 inches) near the ends where overflow distribution piping penetrates the infiltrators (Photos 8 and 10). We did not observe any plugging or significant accumulations of roots. We noted that the distribution piping inside the infiltrators was no longer hanging from top of infiltrator in many places, rather it was laying on top of the biosolids due to deteriorated/broken zip-ties. The distribution piping appeared intact with no breaks observed. We did not note any significant differences between condition of the infiltrators at the two locations (LF2 and LF3).

Photo No. 7 Southwest end of Field B, Row 4 infiltrator exposed in excavation LF2. (photo date 8/7/2020).

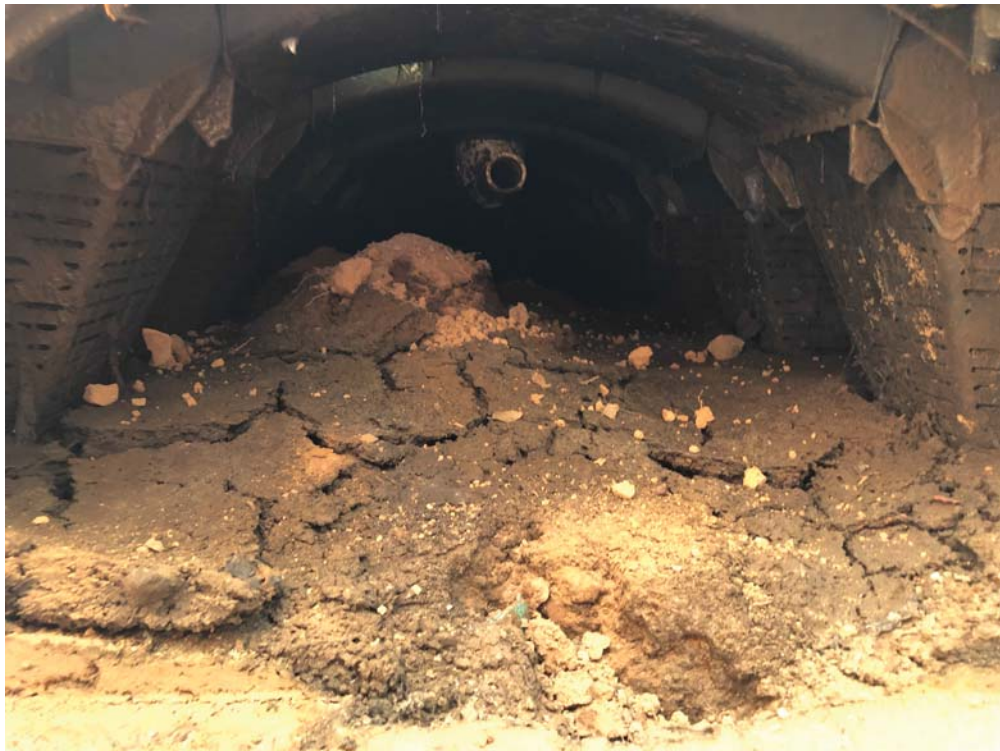
Photo No. 8 Looking into the southwest end of Field B, Row 4 infiltrator (looking to the northeast) (photo date 8/7/2020).

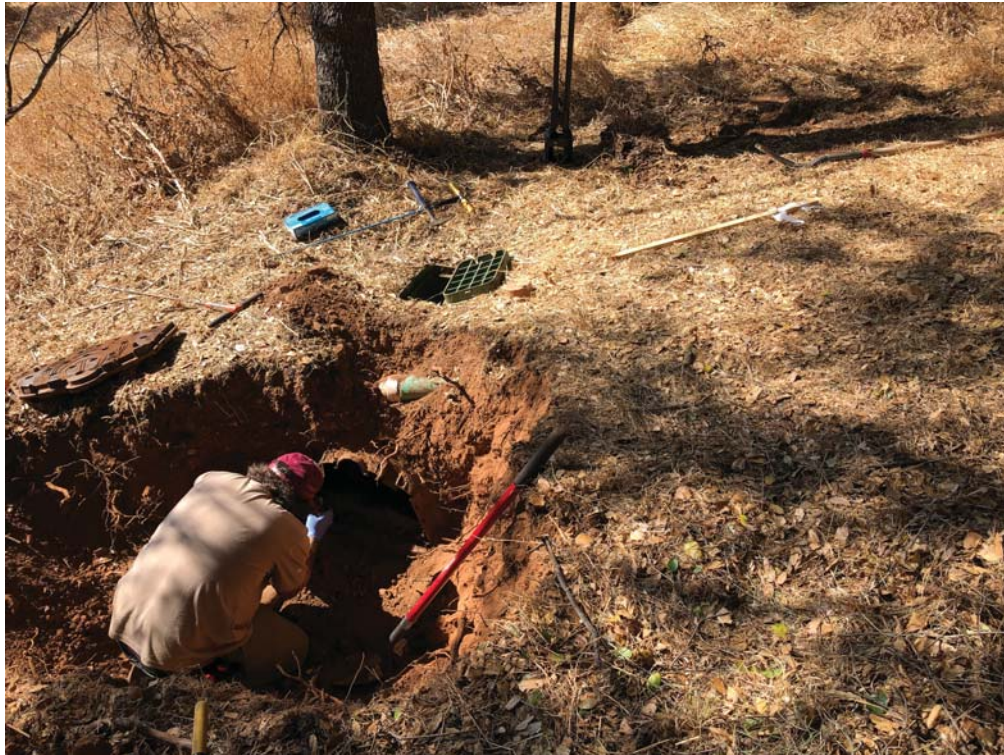
Photo No. 9 Northeast end of Field B, Row 2 infiltrator exposed in excavation LF3. View is looking to the southwest (photo date 8/7/2020).

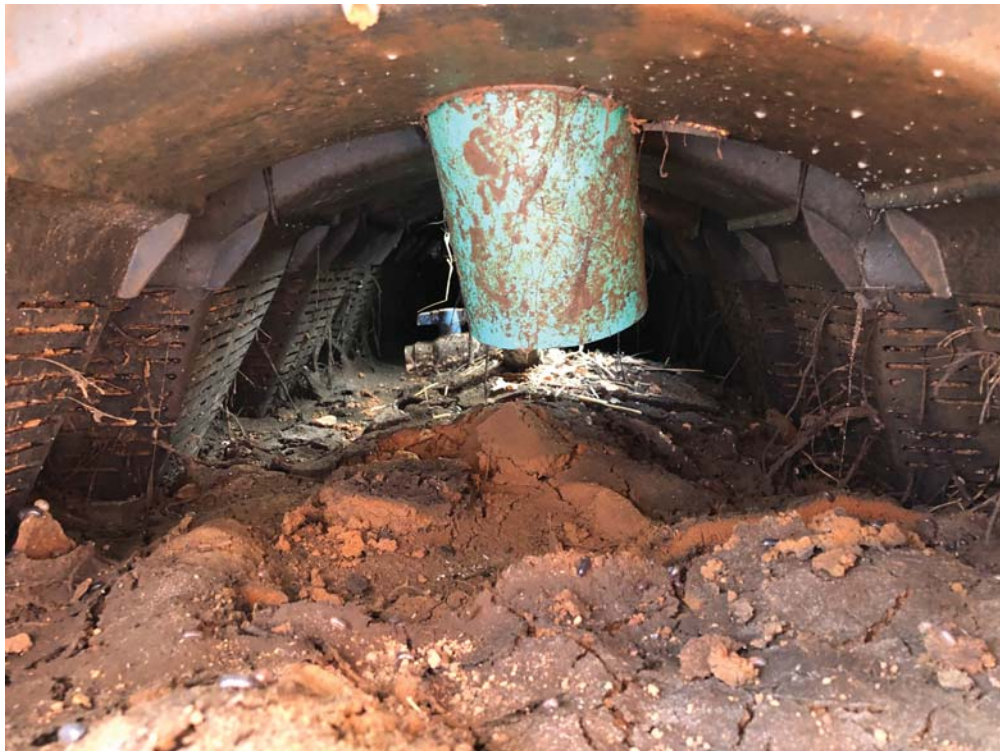
The Field B infiltrators we opened did not exhibit plugging or other obvious damage and appeared to be in generally good condition. There was approximately 2 to 4 inches of biosolids on the interior bottom of the infiltrators, with somewhat greater accumulations (up to approximately 6 inches) near the ends where overflow distribution piping penetrates the infiltrators. We did not observe any plugging or significant accumulations of roots. The distribution piping inside the infiltrators was no longer hanging from top of infiltrator in many places; rather it was laying on top of the biosolids due to deteriorated/broken zip-ties. The distribution piping appeared intact with no breaks observed.

Photo No. 10 Looking into the northeast end of Field B, Row 2 infiltrator (looking to the southwest) (photo date 8/7/2020).

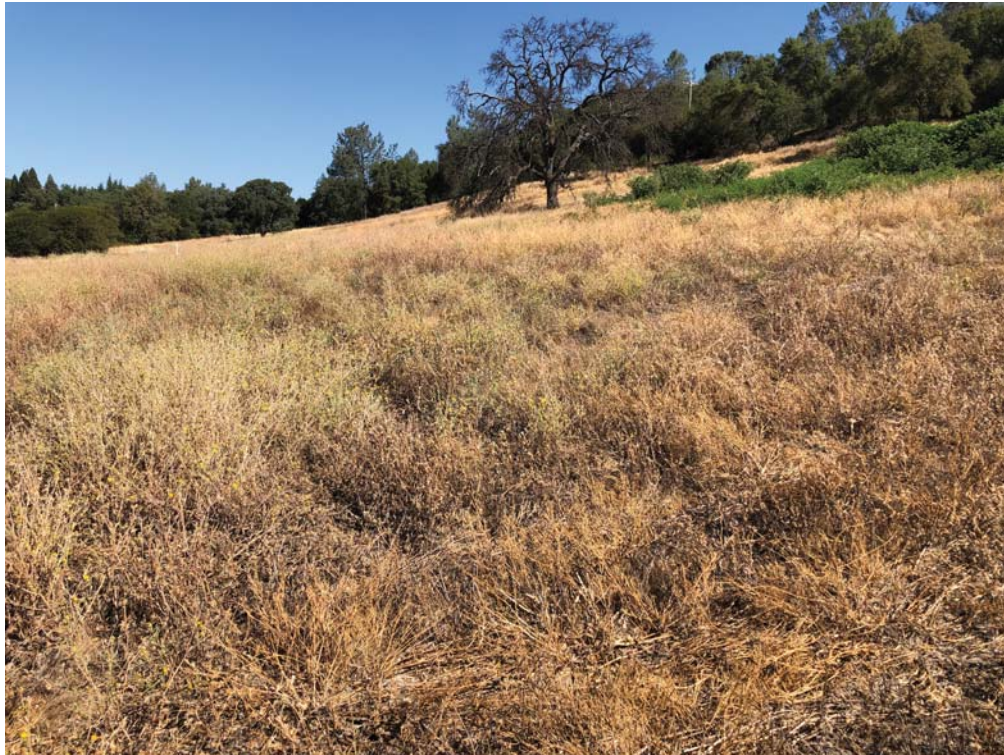
Photo No. 11 View looking to the north-northwest at possible expansion area downslope of Fields A and O. Downslope limit of lush vegetation in Field A is in upper right (photo date 8/3/2020).

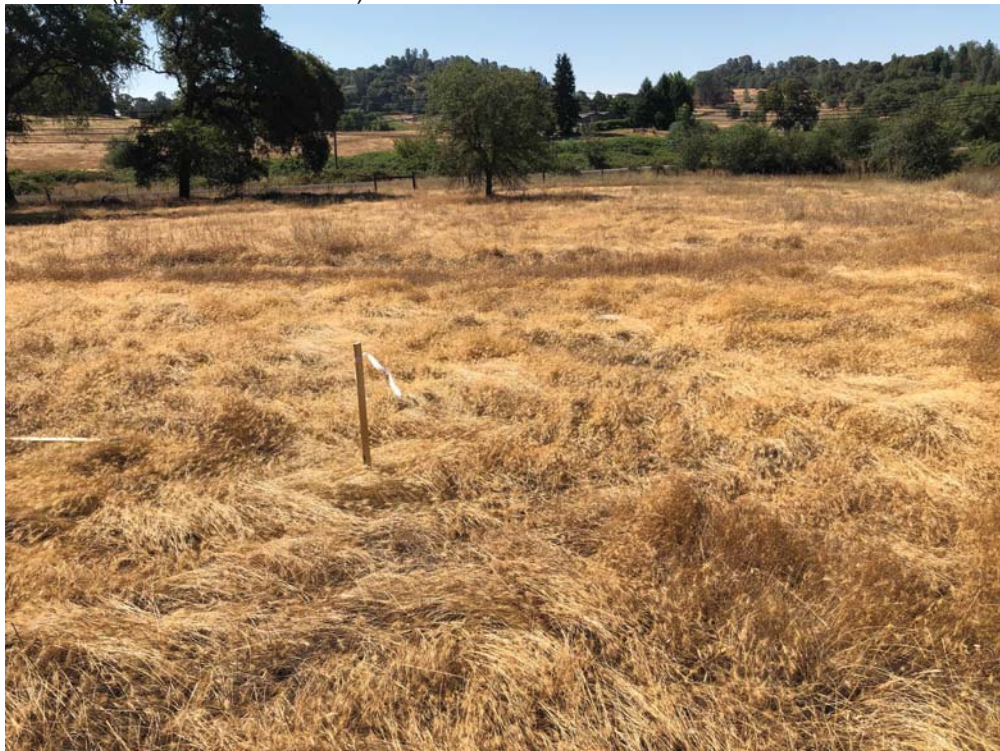
Photo No. 12 View looking to the south at possible expansion area downslope of Field A. Foreground stake marks the location of Soil Profile Test Pit TP8 (photo date 8/3/2020).

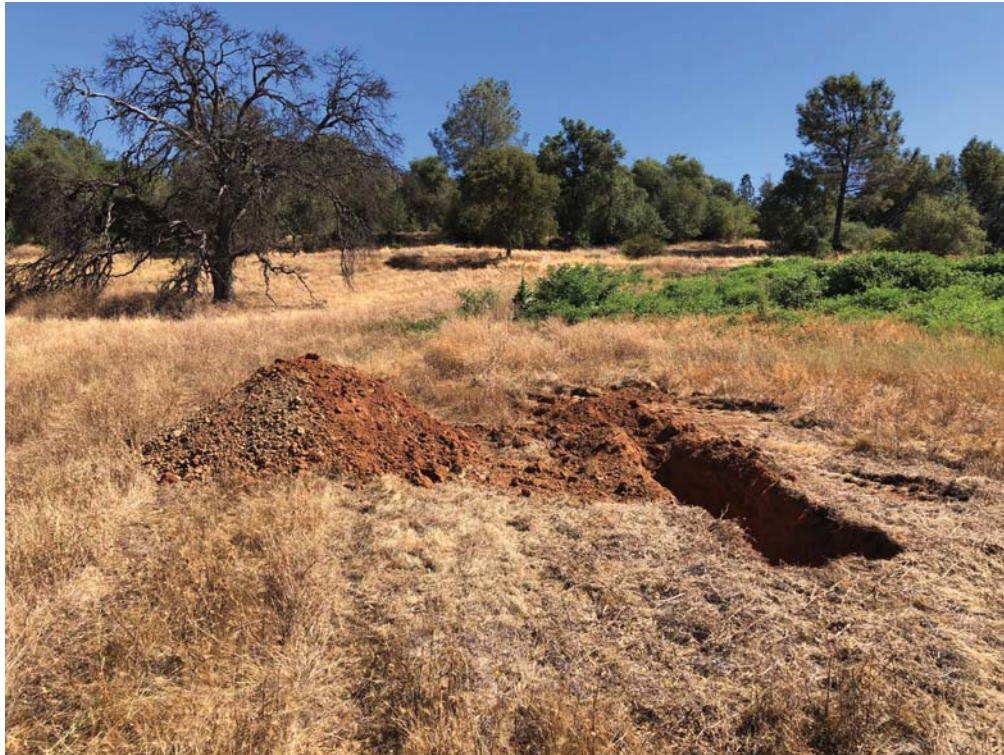
Soils directly downslope of the Field A/O area (TP6 and TP7) are predominantly loamy/silty with varied (laterally and vertically) sand, clay, and gravel content. These soils transition into completely weathered metamorphic rock at a depth of approximately 30 inches. The completely weathered rock extends to varied depths on the order of 4½ to 5 feet, where it transitions to highly weathered, intensely fractured bedrock. Excavation refusal was encountered in/at moderately weathered, intensely fractured rock at depths of approximately 5 to 6 feet in TP6 and TP7. Neither groundwater nor associated evidence (e.g., mottled soils) were observed in TP6 or TP7 soils.

Photo No. 13 View looking northeast at Soil Profile Test Pit TP6. Downslope limit of lush vegetation in Field A is in upper right (photo date 8/6/2020).

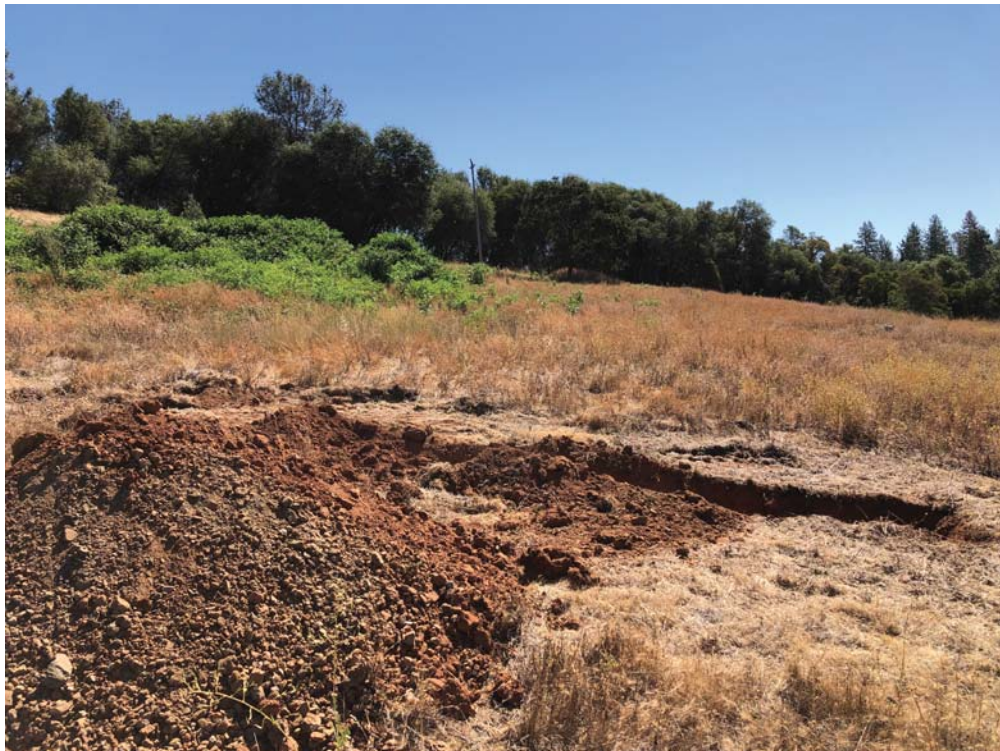
Photo No. 14 View looking southeast at Soil Profile Test Pit TP6. Downslope limit of lush vegetation in Field A is in upper left (photo date 8/6/2020).

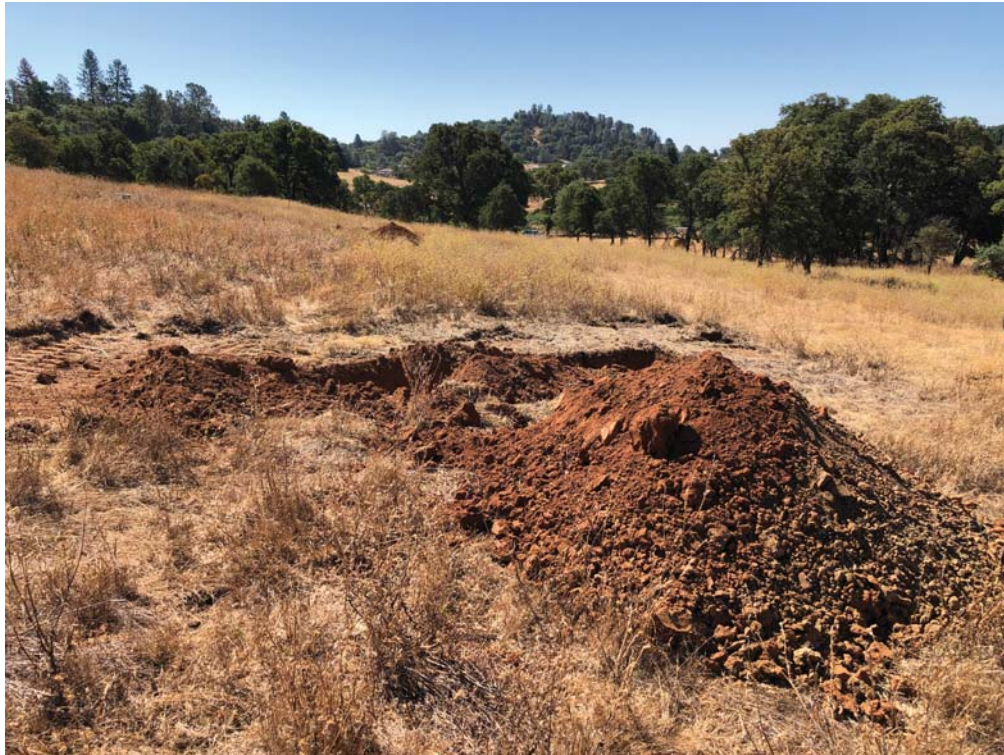
Photo No. 15 View looking to the southeast at Soil Profile Test Pit TP6, with TP7 excavation visible beyond (photo date 8/6/2020).

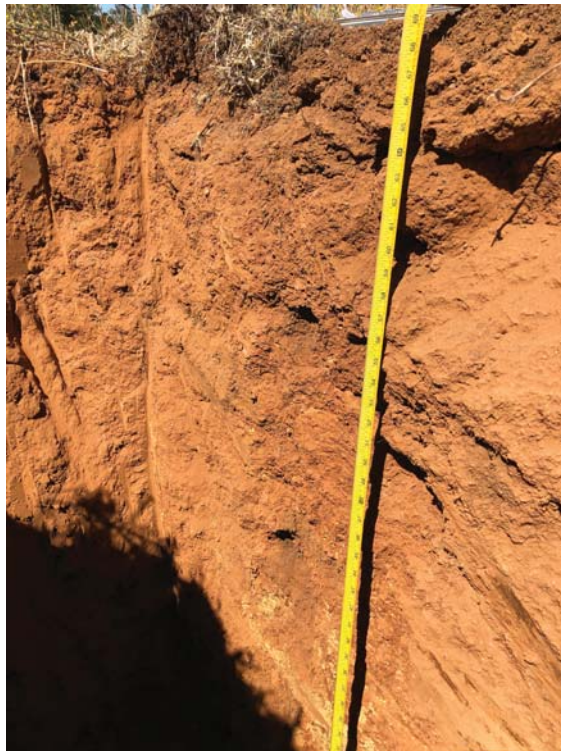
Photo No. 16 Soil profile in Test Pit 6 (photo date 8/6/2020).

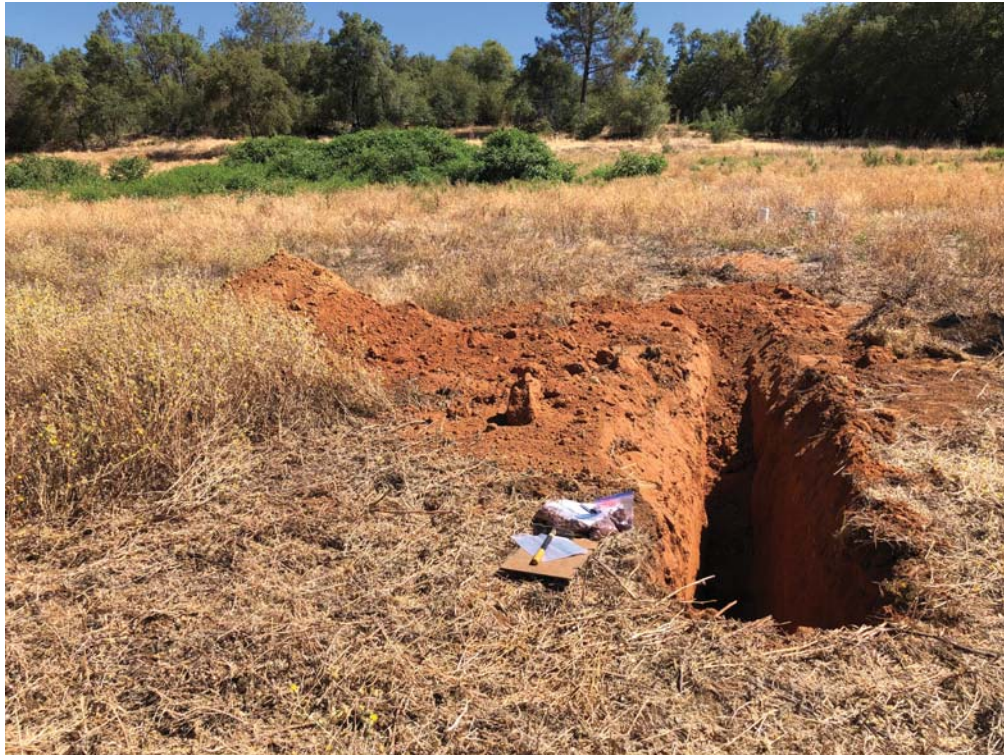
Photo No. 17 View looking to the north (upslope) at Soil Profile Test Pit TP7, with Field A in the background. White riser beyond the test pit is bottom (south corner) of Field A (photo date 8/6/2020).

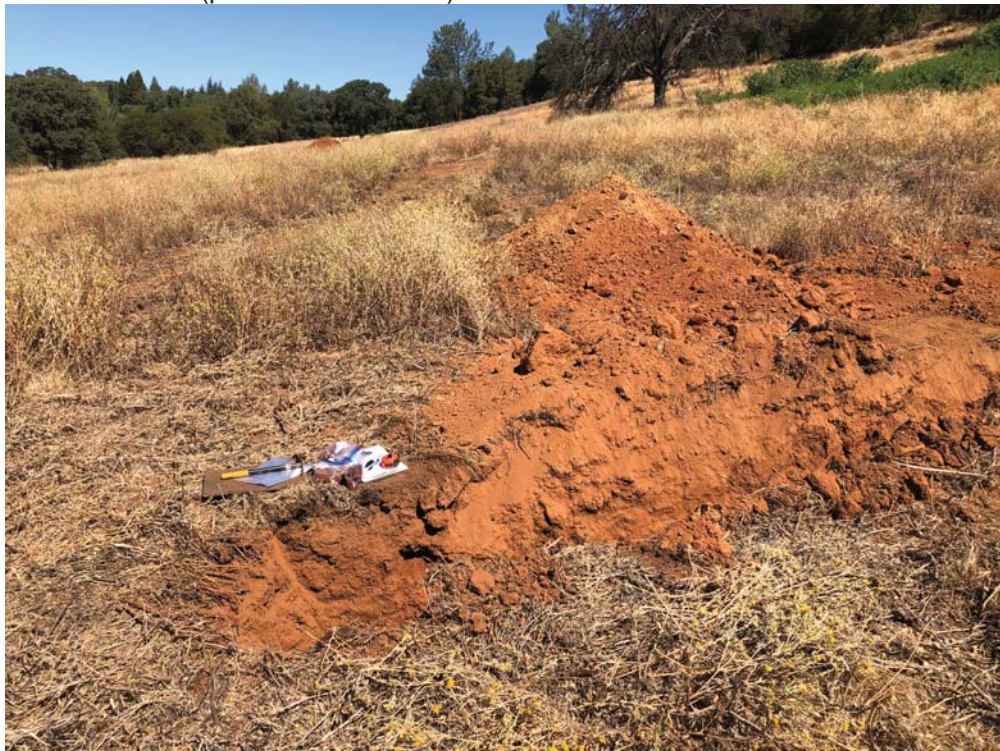
Photo No. 18 View looking to the northwest at Soil Profile Test Pit TP7, with lush vegetation of Field A in the upper right and TP6 excavation near upper left (photo date 8/6/2020).

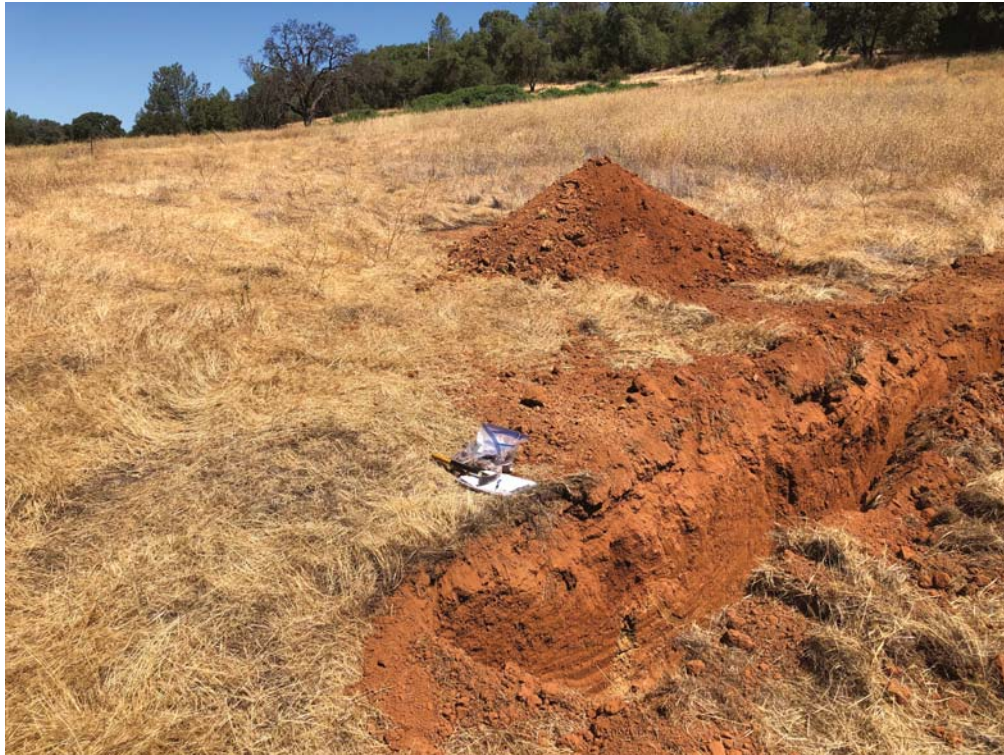
The soil profiles in TP8 and TP9, located further downslope, were somewhat similar to TP6 and TP7 at/near the surface (silty/loamy) and at depth (weathered metamorphic rock), but contained a significant clay horizon first encountered at depths of 18 to 30 inches. Neither groundwater nor associated evidence (e.g., mottled soils) were observed in TP8, but gray and strong brown mottling were observed in TP9 soils at and below the 6-foot depth.

Photo No. 19 View looking to the north at Soil Profile Test Pit TP8 (photo date 8/6/2020).

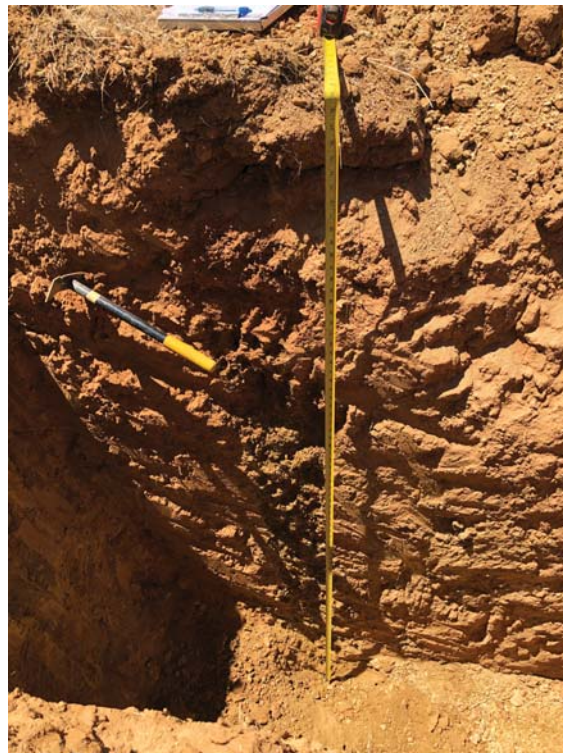
Photo No. 20 Soil profile in Test Pit TP9 (photo date 8/6/2020).
