**EL DORADO CONDUIT RAW WATER CONVEYANCE
TUNNEL INSPECTION
GEORGETOWN, CALIFORNIA**

BRIERLEY ASSOCIATES CORPORATION

January 2025

Subject: Tunnel Inspection Report
Raw Water Conveyance Tunnel Inspection
Georgetown, California

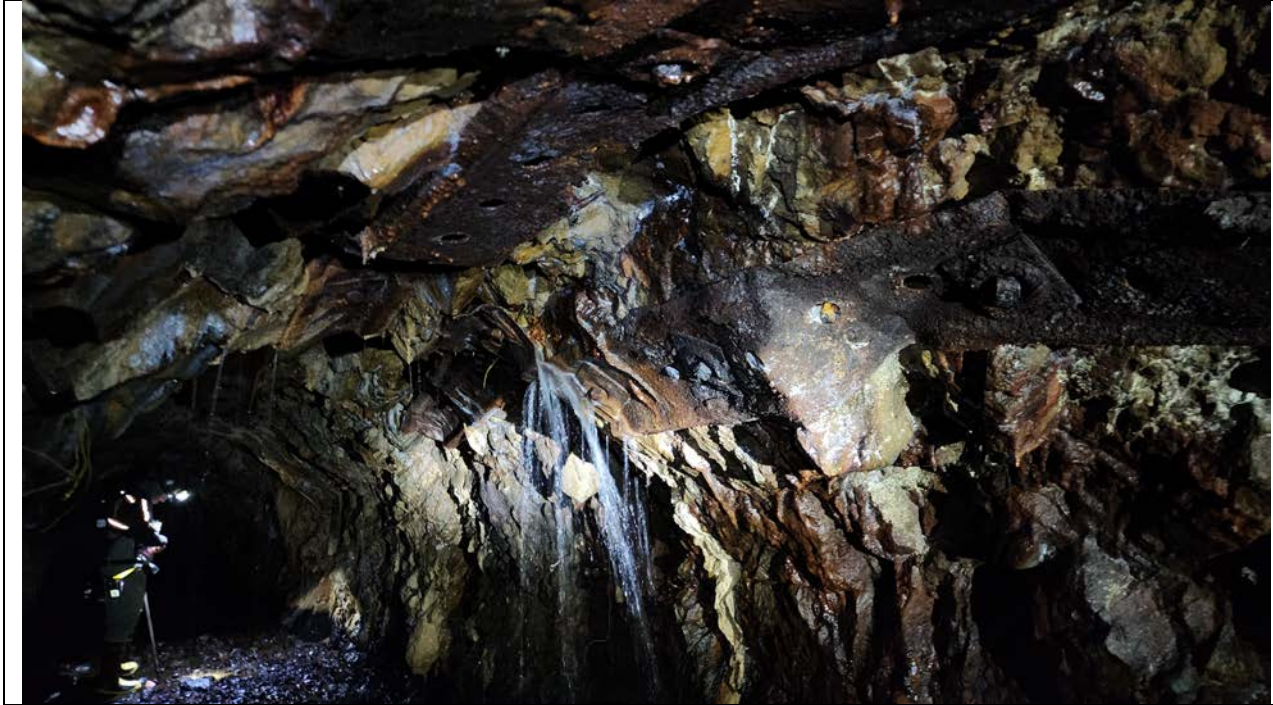
STATION: 452+65 – 452+75

Defect No.	2024 Start Station	2024 End Station	Photo Number	Defect/Observation Description
3	452+50.00	452+75.00	IMG_5062.HEIC _163252	Mine straps in crown corrodged and held with 0.75 inch pins of unknown length. Significant water inflow, 10-20gpm.
4	454+00.00	451+53.00	_162854	Tunnel height reduced to approximately 6.5 feet
5	454+50.00	454+70.00	IMG_5059.HEIC _162846	Mine straps in crown corrodged and held with 0.75 inch pins of unknown length
6	454+95.00	455+05.00		Geologic Map - see tunnel Geologic Map 01 in Appendix E

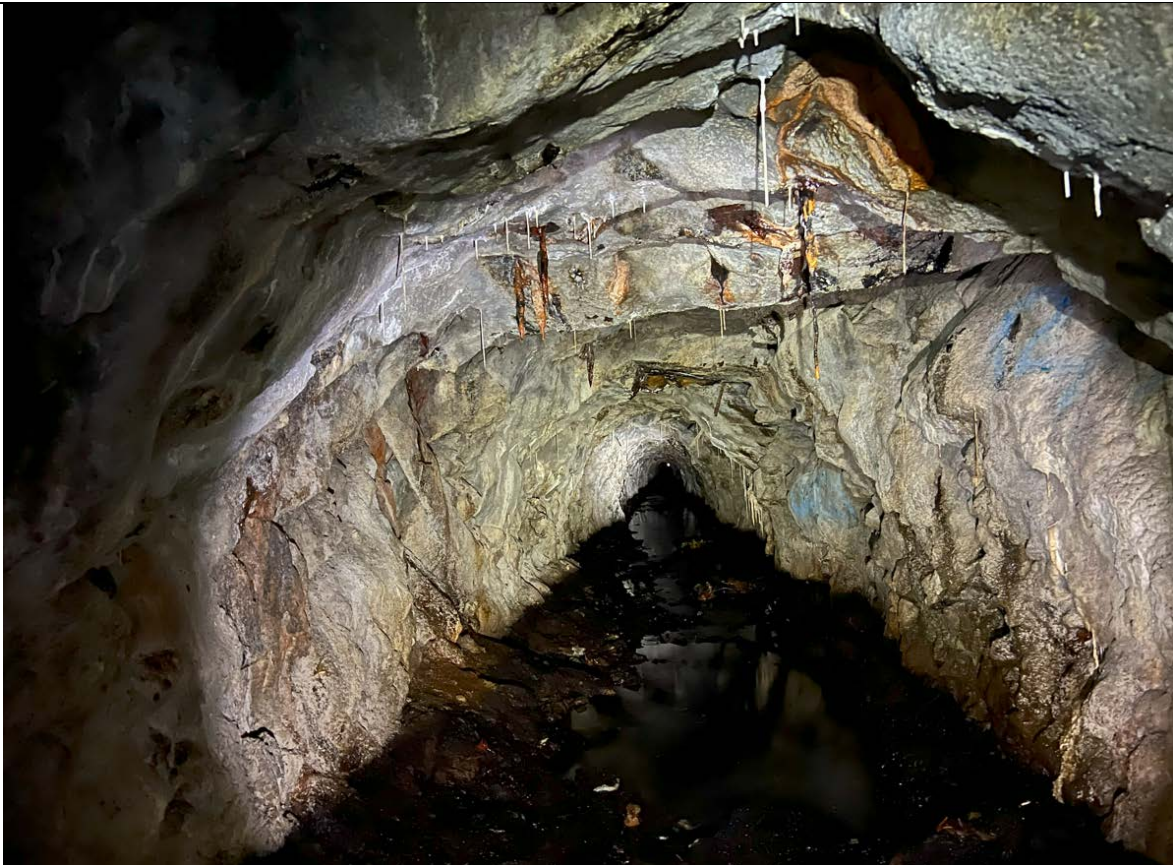
STATION: 461+20

- Inlet Portal (between about Sta.451+60 and 451+95): Shotcrete with no observation of welded wire mesh. Shotcrete appears in good condition.
- Sta. 461+20: Shotcrete observed together with mine straps, thin and white stalactites. Some delamination in places. Shotcrete thickness is less than approximately 1 in.

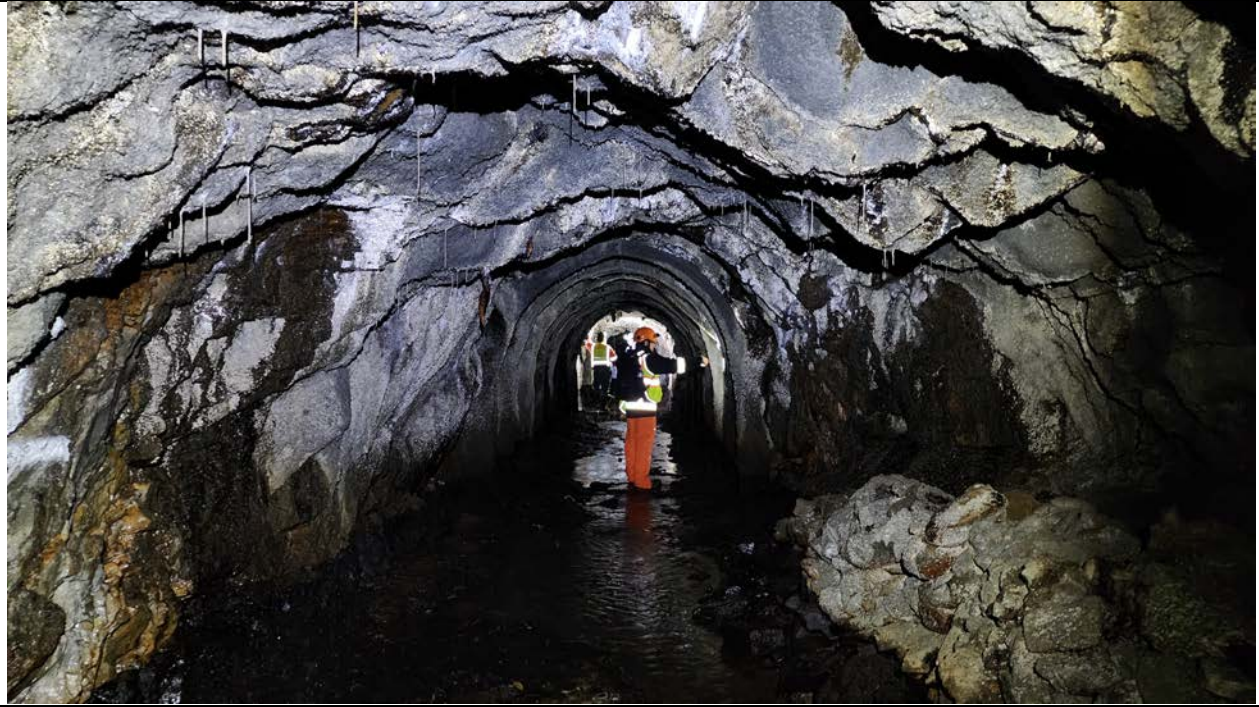
STATION: 493+00 – 493+55

- Between Sta.493+00 and 493+55: Shotcrete and welded wire mesh observed together with thin, white stalactites
- Outlet: Occasional and incomplete shotcrete (i.e., to secure some of the steel sets it was applied closer to the tunnel invert) with no observation of welded wire mesh

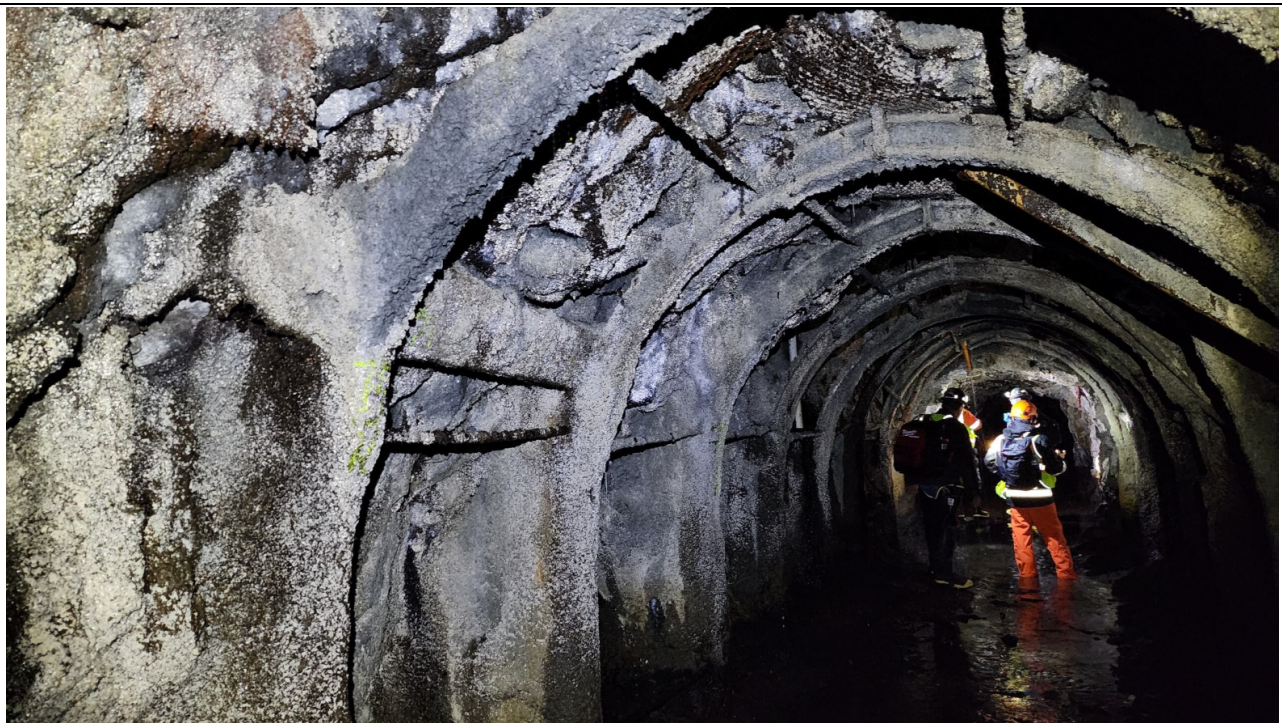
STATION: 493+05 – 493+35

- Between about Sta. 493+10 and 493+40, a total of 8 steel sets (between No. 74 and No. 82) spaced at 4.0-ft were observed. This area is the previous fallout zone. There were about six drainpipes to collect or divert groundwater discharge at several locations within this interval. The wood blocking and timbers between the steel sets and rock surface were missing at the crown. Steel sets and tie-rods were covered with shotcrete. It was not possible to inspect the steel set surfaces under shotcrete. Tie-rods between the steel sets were missing at the following locations:

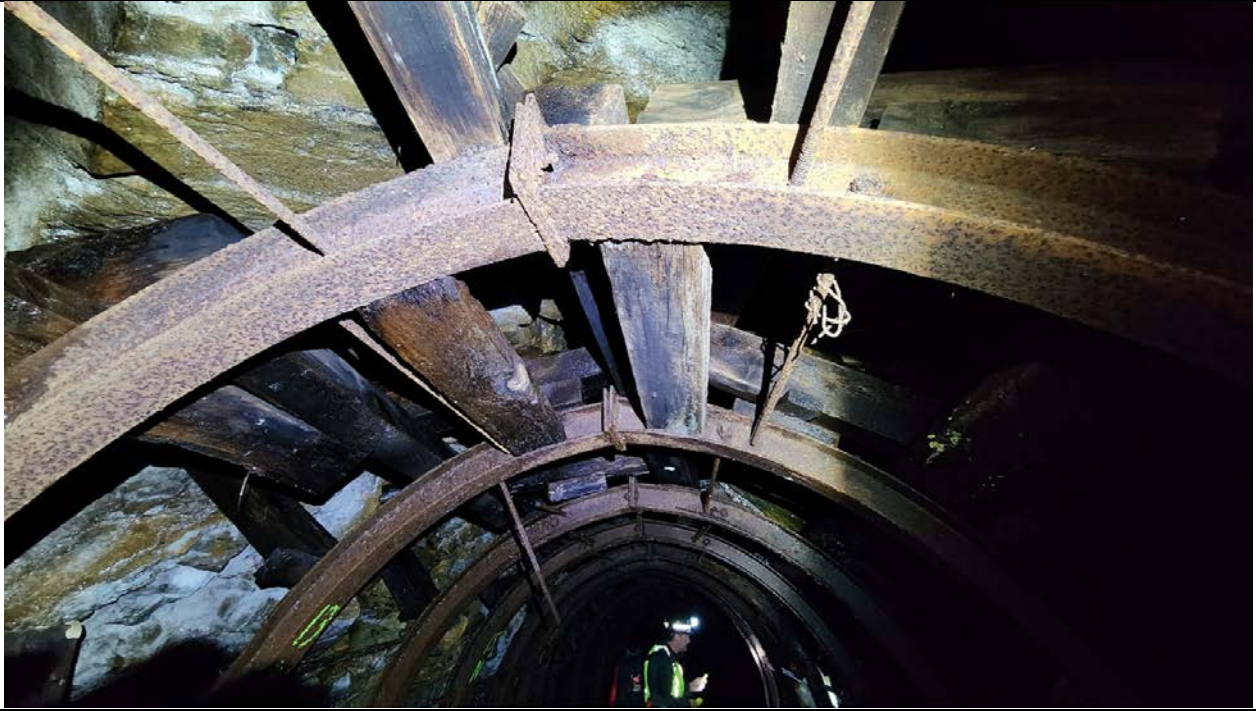
STATION: 496+00 - 497+50

- The steel sets and tie-rods connecting them were not covered with shotcrete, and they appeared to be affected by significant corrosion. Some occasional shotcrete applications were observed on steel sets closer to the tunnel invert. The wood blocking between the steel sets and rock surface were missing at the shoulders, walls and crown for the first ten steel sets. Tie-rods between the steel sets were missing at the following locations:

55	496+00.00	497+53.11	_123124	Significant water inflow throughout entire section. Estimated 10 to 20gpm

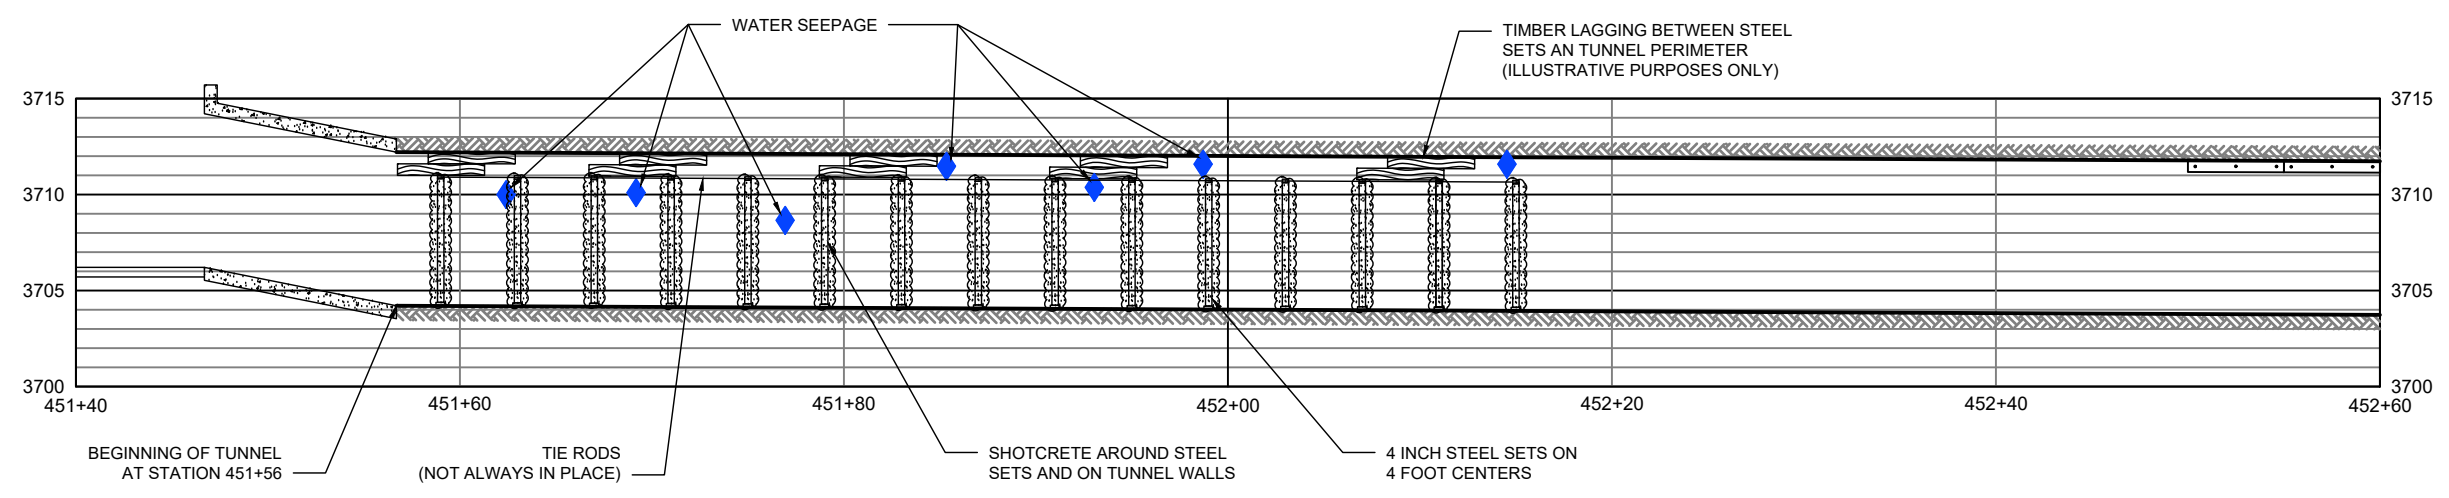
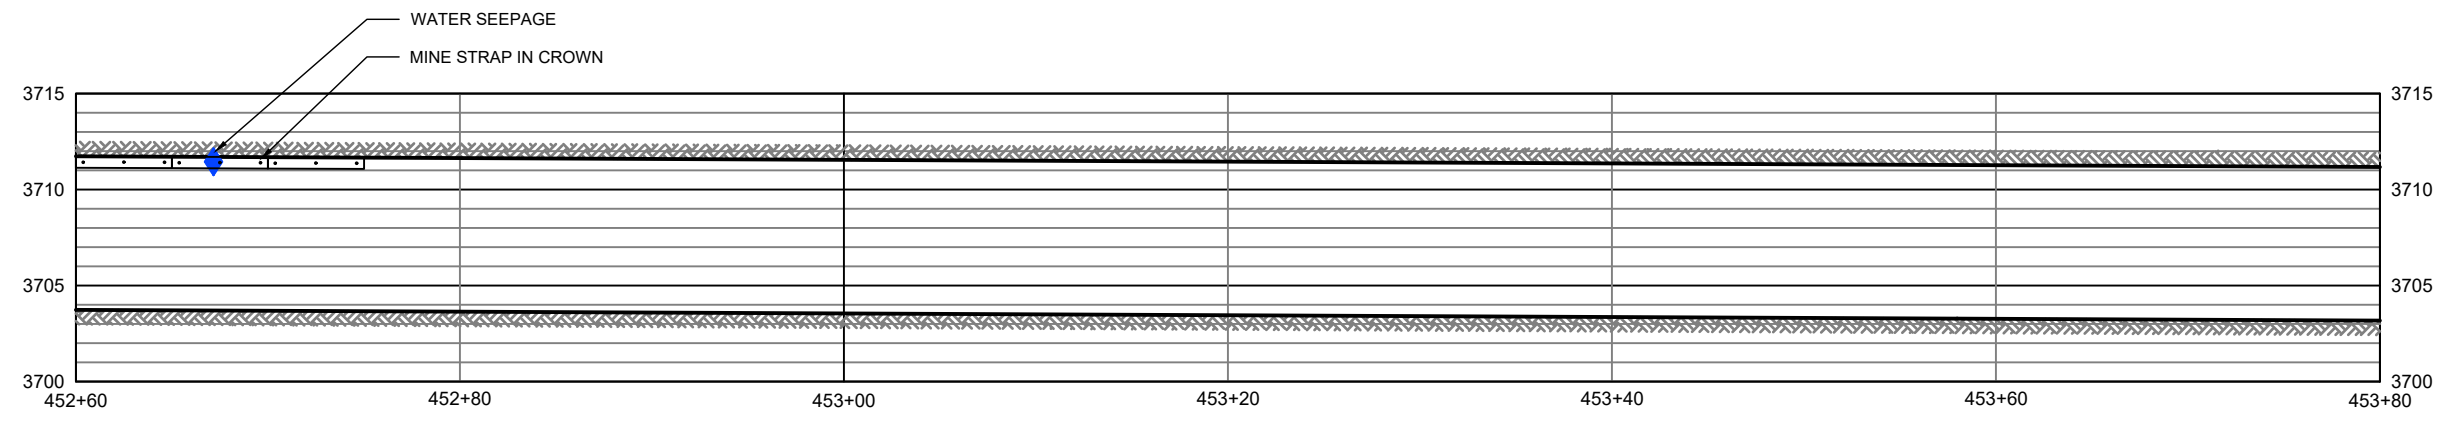
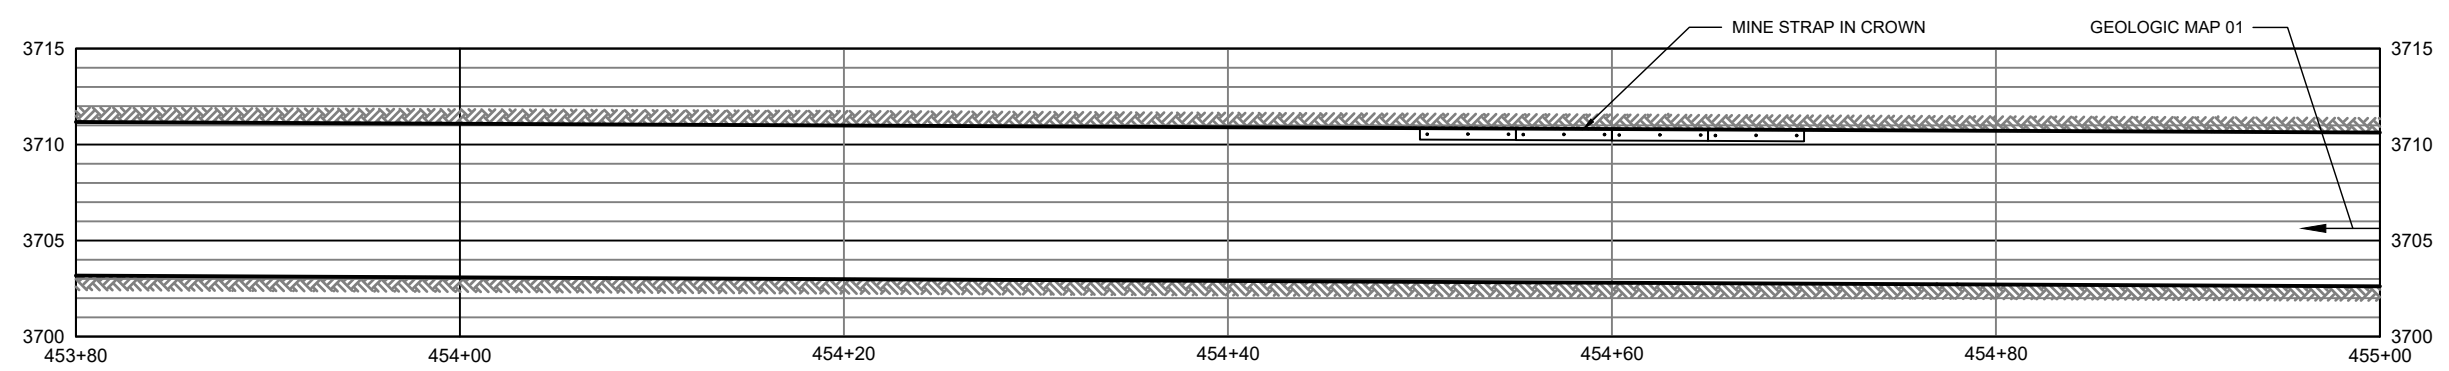
FIG-01
 1 OF 13

Defect No.	2024 Start Station	2024 End Station	Photo Number	Defect/Observation Description
1	451+47.00	451+57.00	_164249 _164300	The concrete surface of transition structure has some rust and efflorescence especially along a crack. There was no delamination, scaling, spalling, exposed bar, honeycombing or active leakage. While brown staining was mainly present where the concrete is close to the trash rack and first steel ribs in the tunnel, light-colored and greenish staining was in the middle section. Condition State: CS2
2	451+57.00	452+15.00		A total of 16 steel ribs (between #83 and #98) were observed at spacing of approximately 4-ft. The steel ribs and tie-bars were usually covered with shotcrete and it was not possible to inspect the steel rib surfaces under shotcrete. Shotcrete appears in reasonable condition and no spalling noted. Where tie-bars were not covered with shotcrete, they appeared to be affected by significant corrosion. The wood blocking between the steel ribs and rock surface appeared to be inadequate. Some minor water inflow through shotcrete at certain locations, mainly on south wall, totalling 5-10gpm

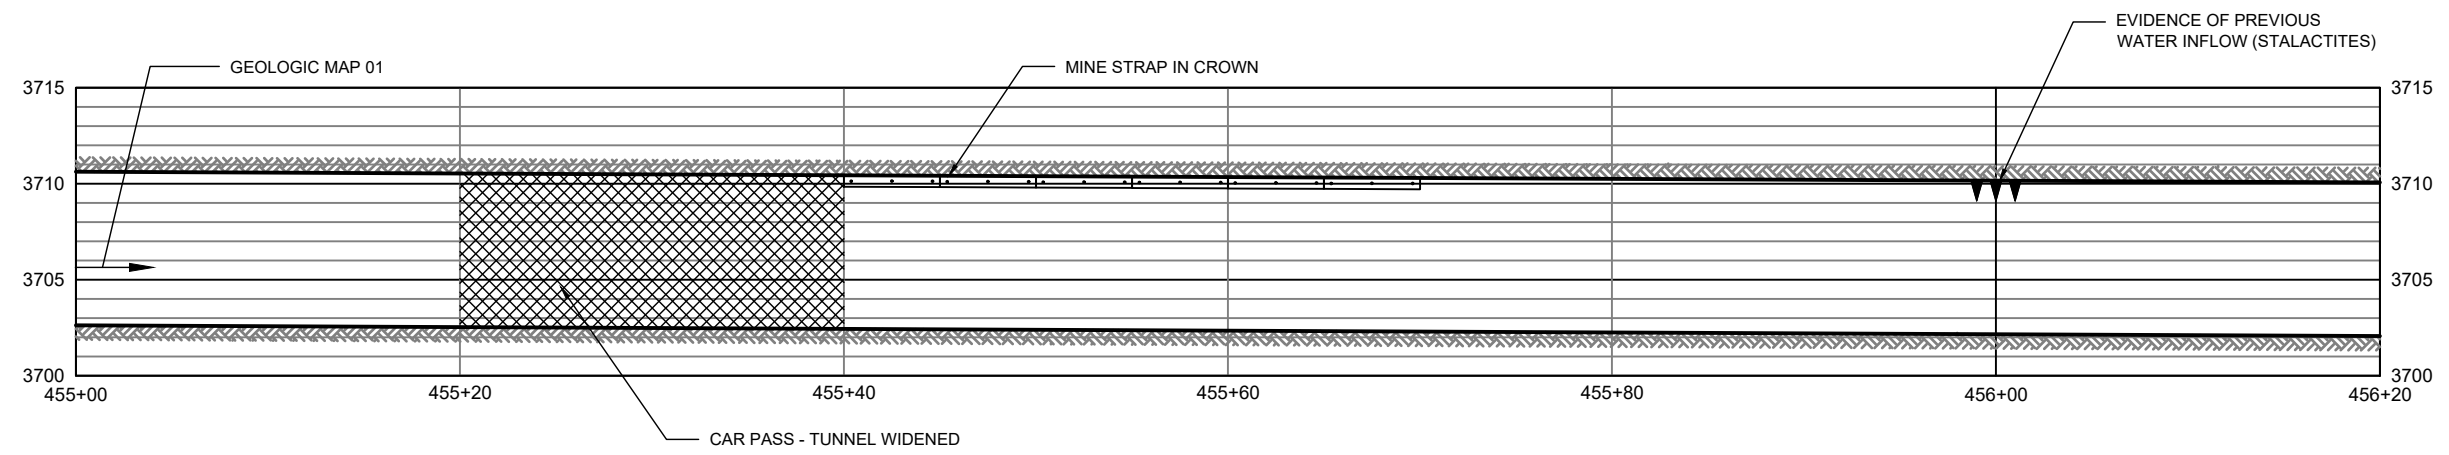
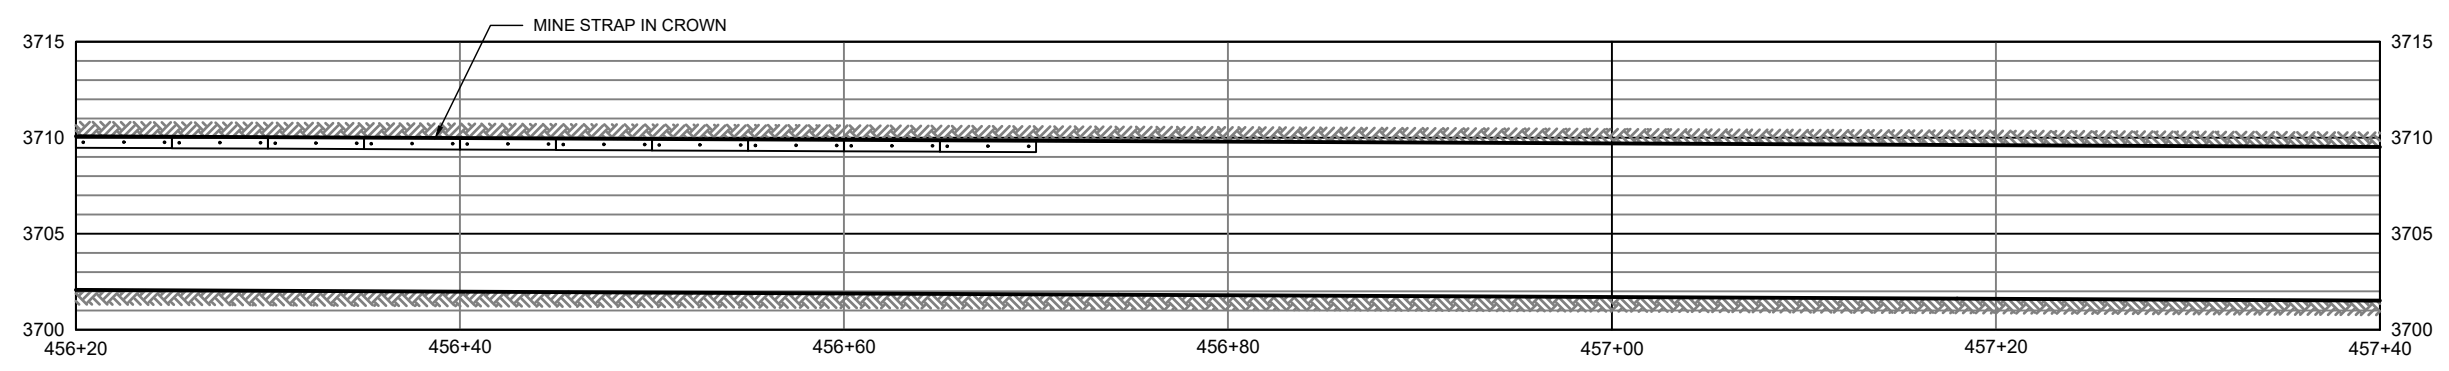
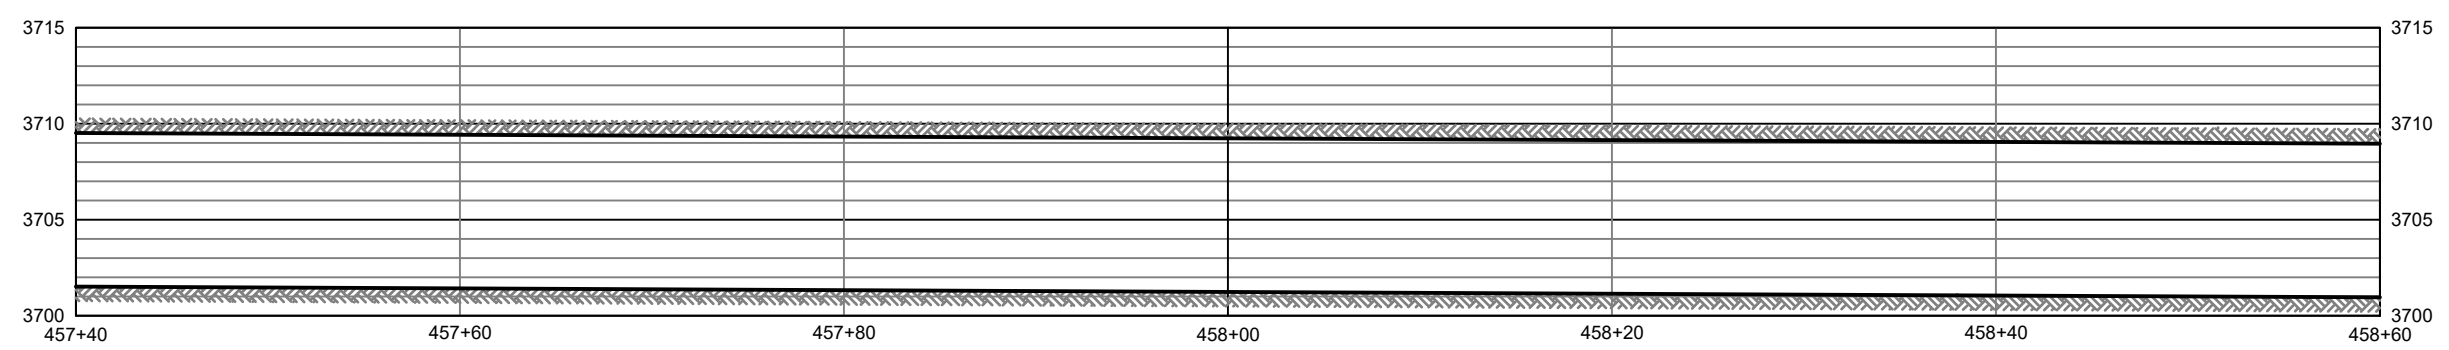
FIG-02
 2 OF 13

Defect No.	2024 Start Station	2024 End Station	Photo Number	Defect/Observation Description
7	455+20.00	455+40.00	IMG_5054.HEIC _161829	Car pass - tunnel widened on north wall up to approximately 12 feet. Minor water inflow (<1 gpm). Observed sediment (clay/sand) deposition at the tunnel floor at N
8	455+40.00	455+70.00	IMG_5056.HEIC _161058	Mine straps in crown corrodod and held with 0.75 inch pins of unknown length
9	456+00.00	-	_160405	Evidence of previous water inflow with 6 to 12 inch long stalactites
10	456+20.00	456+70.00	IMG_5052.HEIC _161000	Mine straps in crown corrodod and held with 0.75 inch pins of unknown length

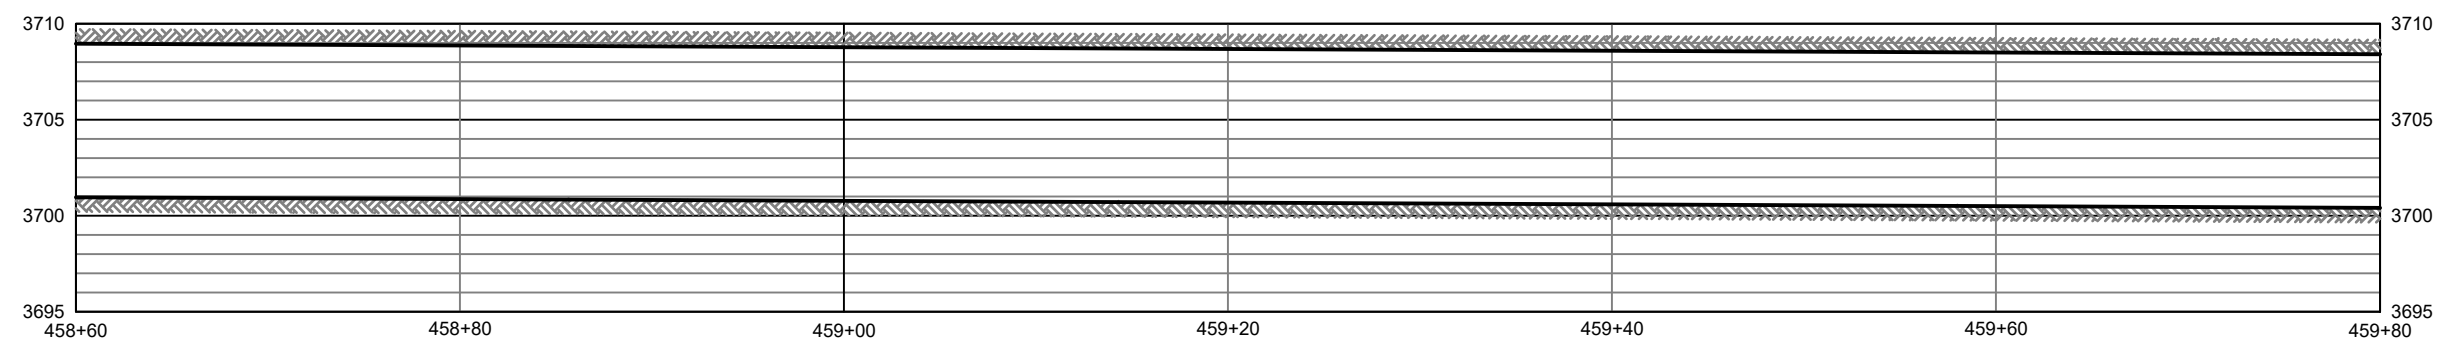
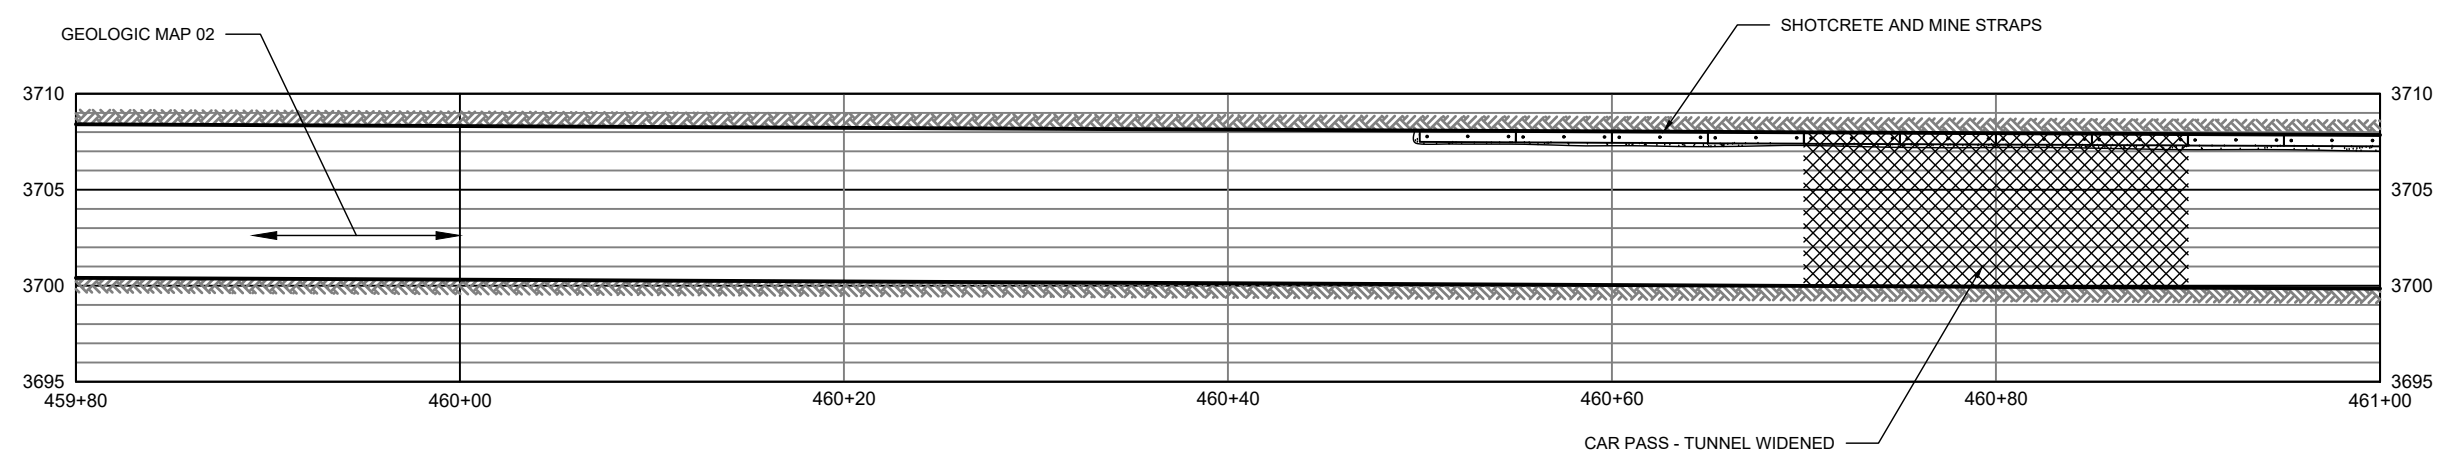
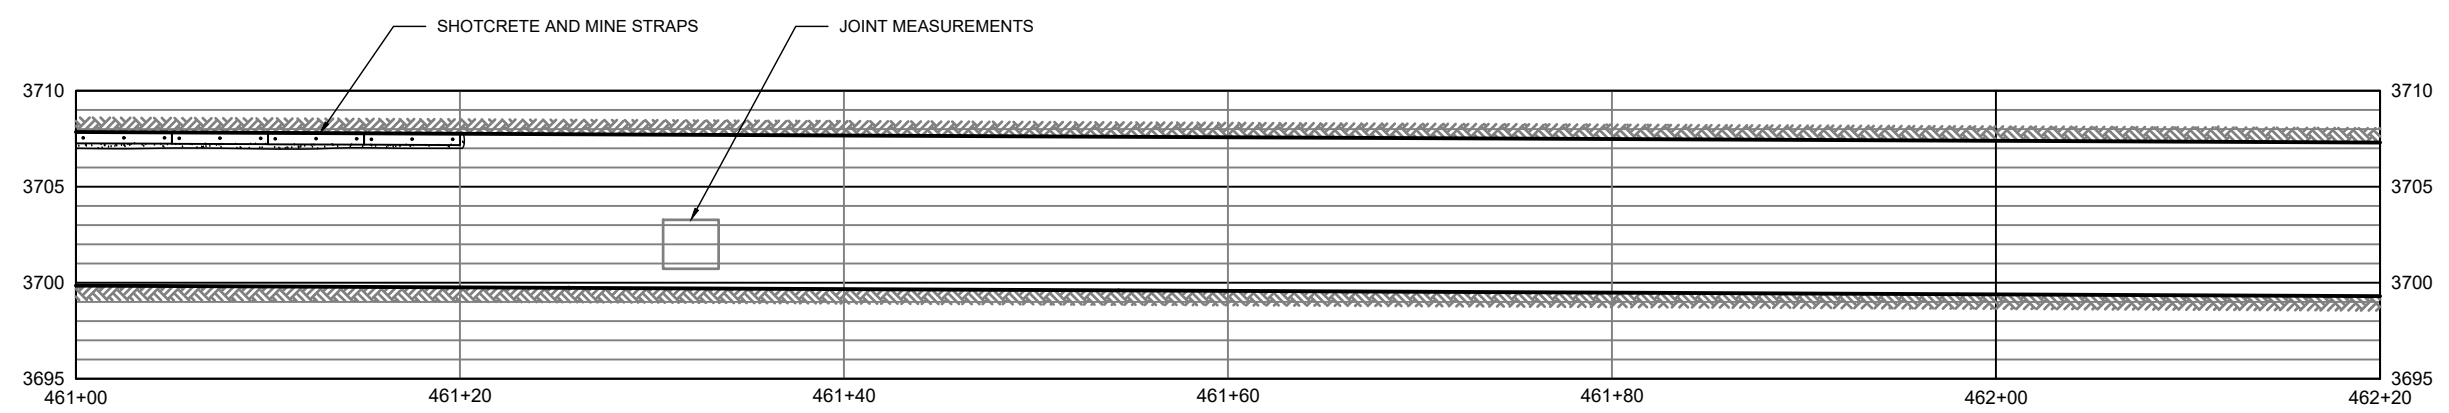
FIG-03
 3 OF 13

Defect No.	2024 Start Station	2024 End Station	Photo Number	Defect/Observation Description
11	459+90.00	460+00.00	_160405	Geologic Map - see tunnel Geologic Map 02 in Appendix E
12	460+70.00	460+90.00	IMG_5036.HEIC _155006	Car pass - tunnel widened on north wall up to approximately 12 feet. Observed sediment (clay/sand) deposition at the tunnel floor at N
13	460+50.00	461+20.00	IMG_5035.HEIC _154821	Shotcrete and mine straps with some delamination in places. Shotcrete up to 1 inch thickness with few cracks. Thin light colored stalacties, likely from leaching of shotcrete
14	461+50.00	-	IMG_5033.HEIC _154235	Geologic measurements - refer to Appendix E

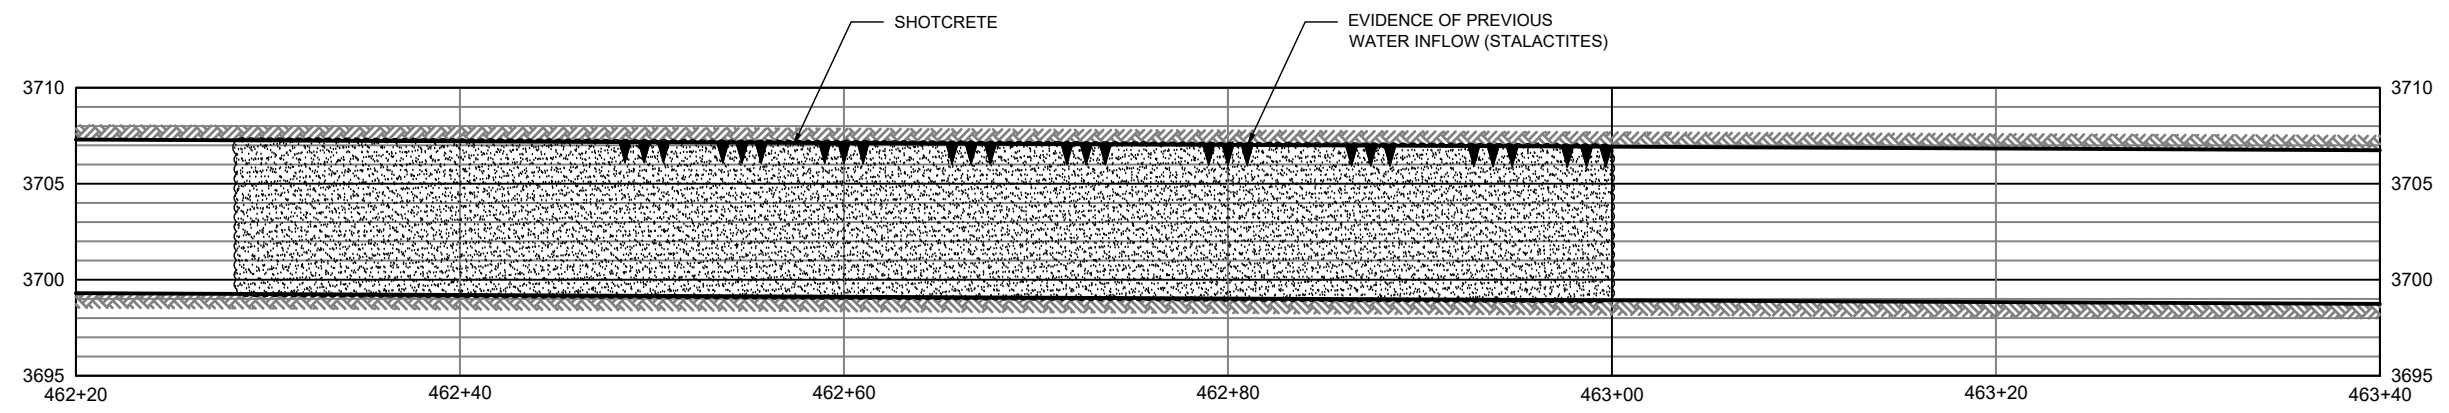
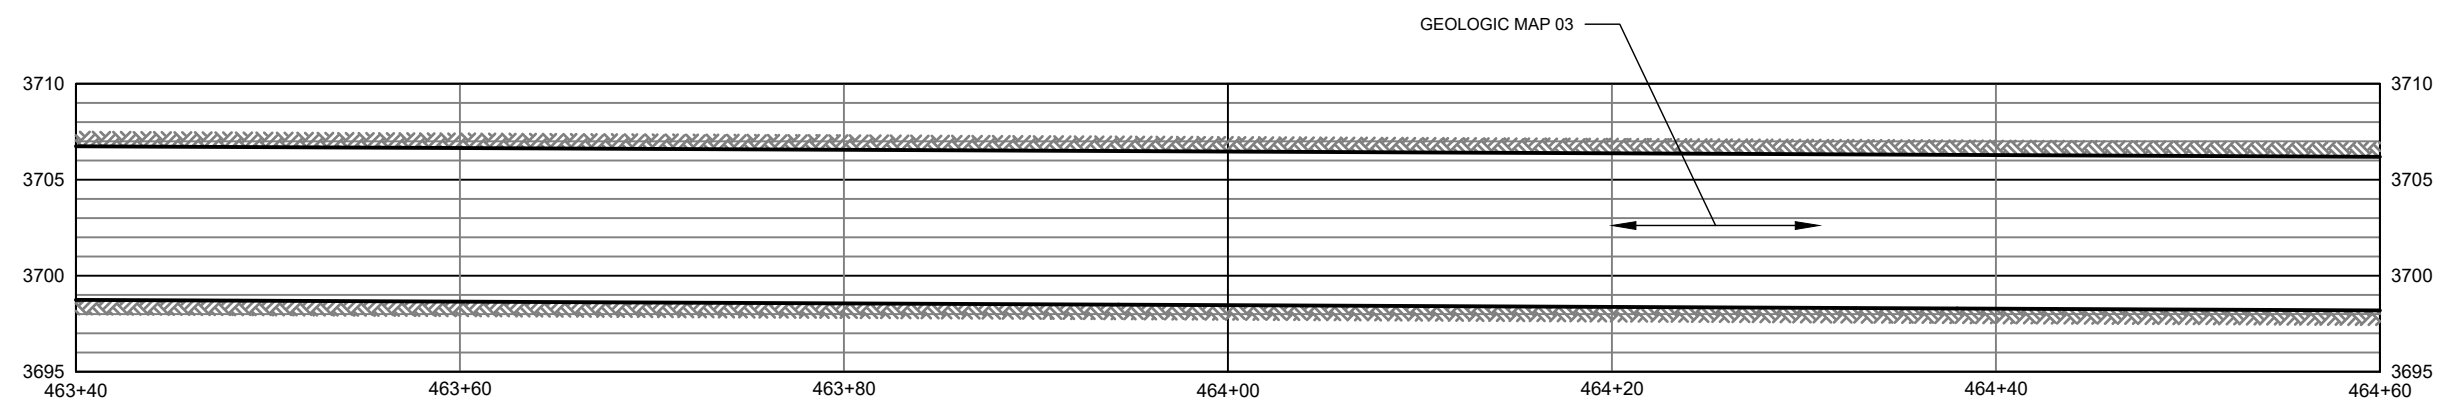
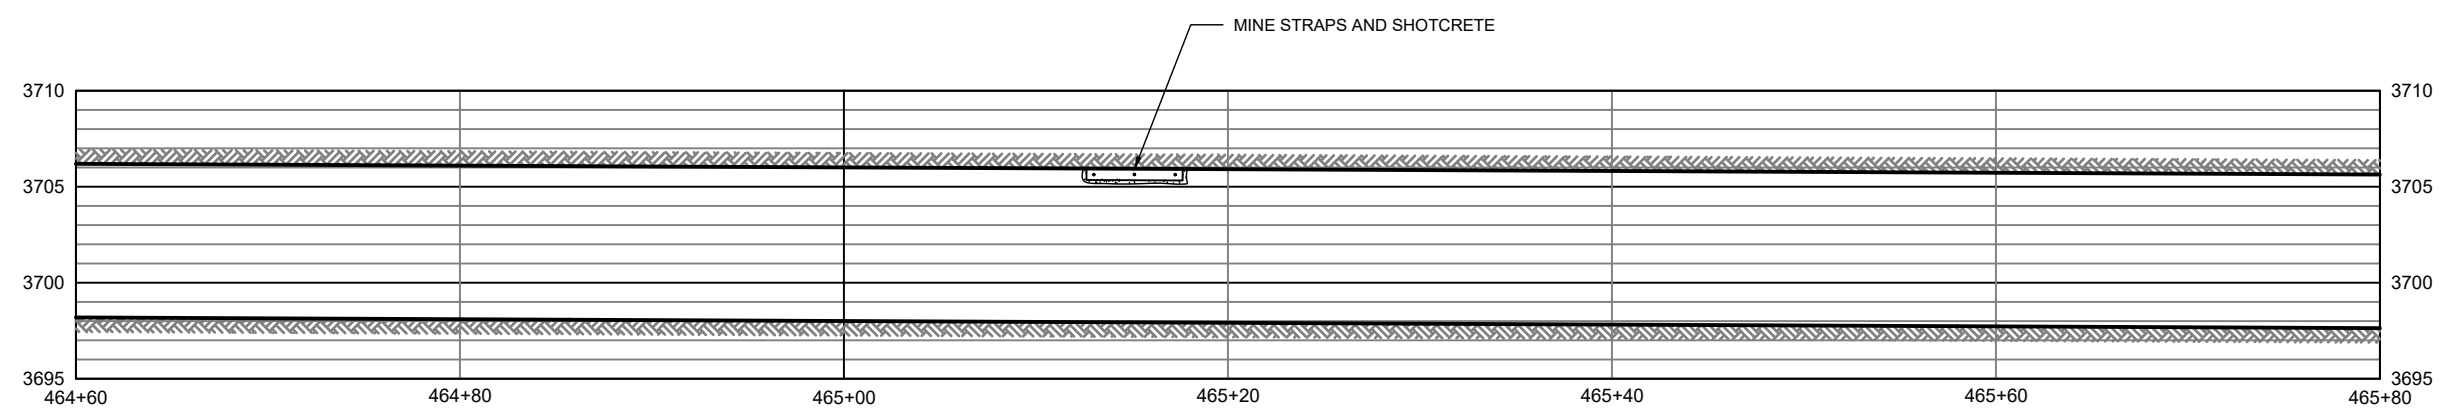
FIG-04
 4 OF 13

Defect No.	2024 Start Station	2024 End Station	Photo Number	Defect/Observation Description
15	462+30.00	463+00.00	IMG_5030.HEIC _153249	Shotcrete in crown and tunnel walls, including invert. Shotcrete up to 1 inch thickness with few cracks. No spalling observed. Thin light colored stalacties, like from leaching of shotcrete.
16	462+50.00	463+00.00	_152936	Evidence of previous water inflow with 6 to 12 inch long stalactites
17	464+20.00	464+30.00		Geologic Map - see tunnel Geologic Map 03 in Appendix E
18	465+10.00	465+18.00	IMG_5023.HEIC	Shotcrete and 4 inch WWM. Shotcrete up to 1 inch thickness with few cracks, with possible demalination or non-contact with tunnel walls. No spalling observed. Thin light colored stalacties, like from leaching of shotcrete.

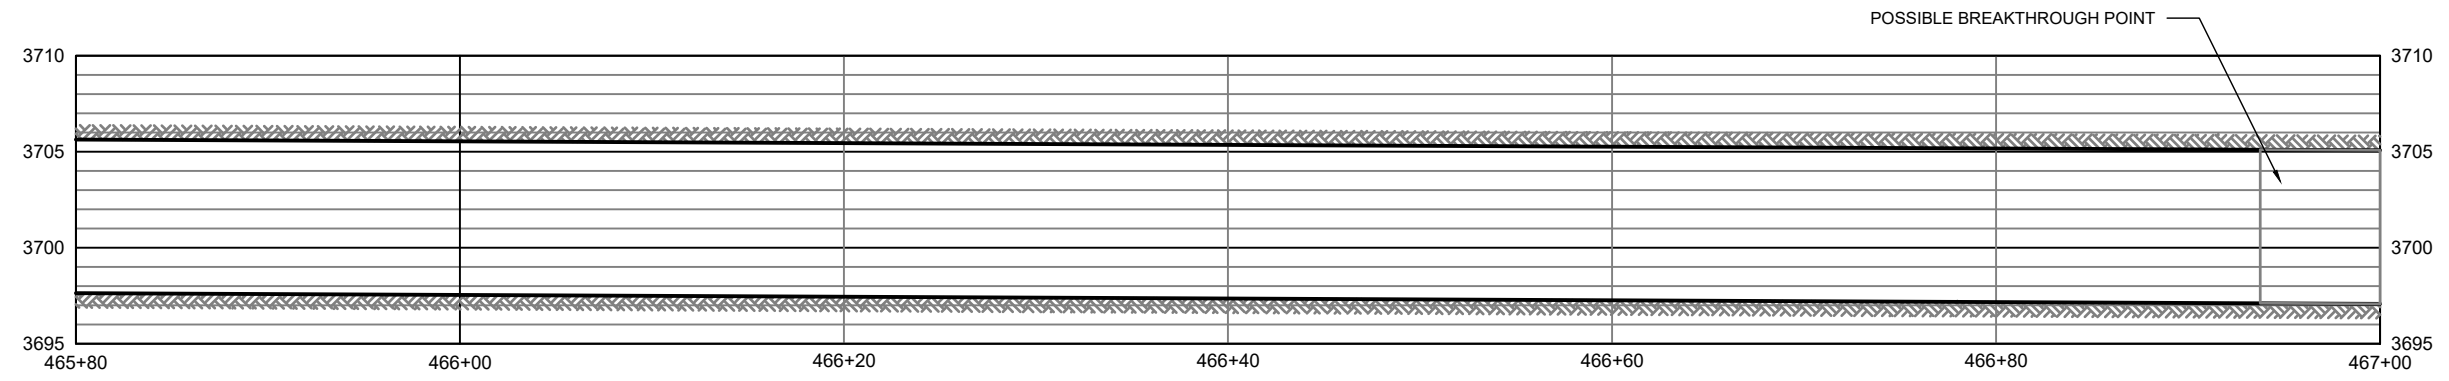
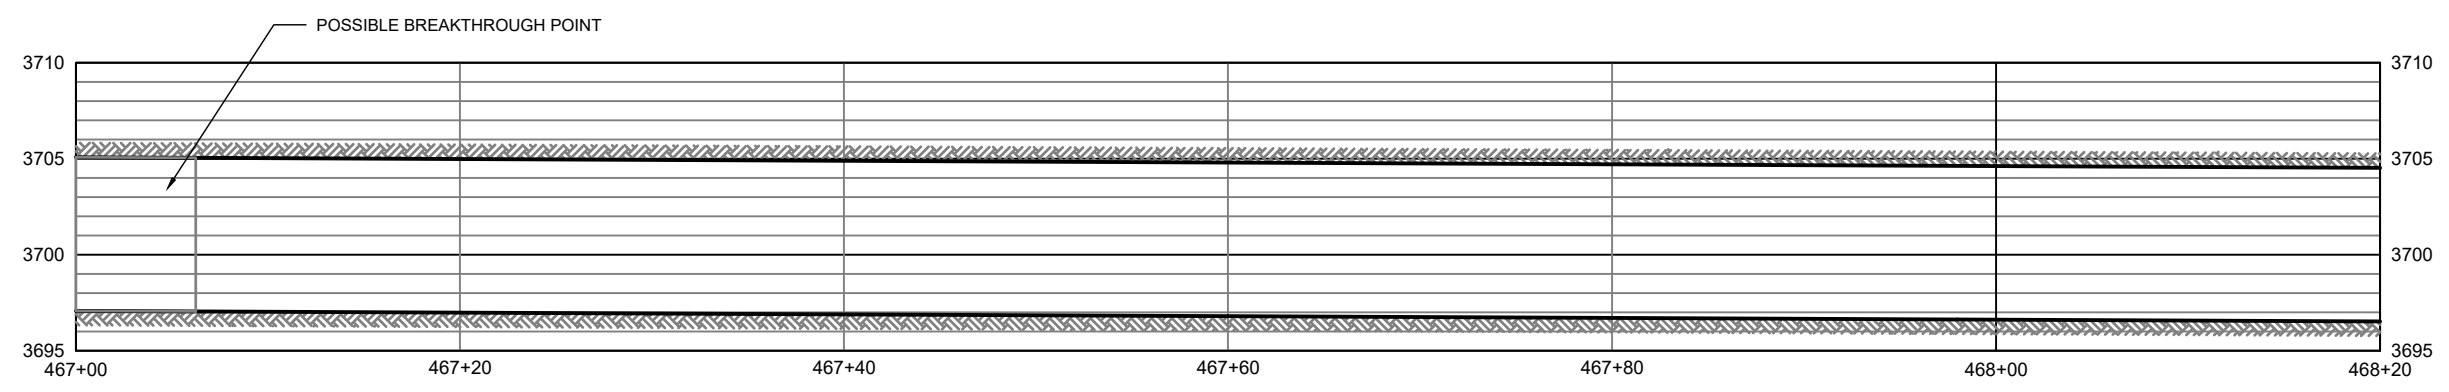
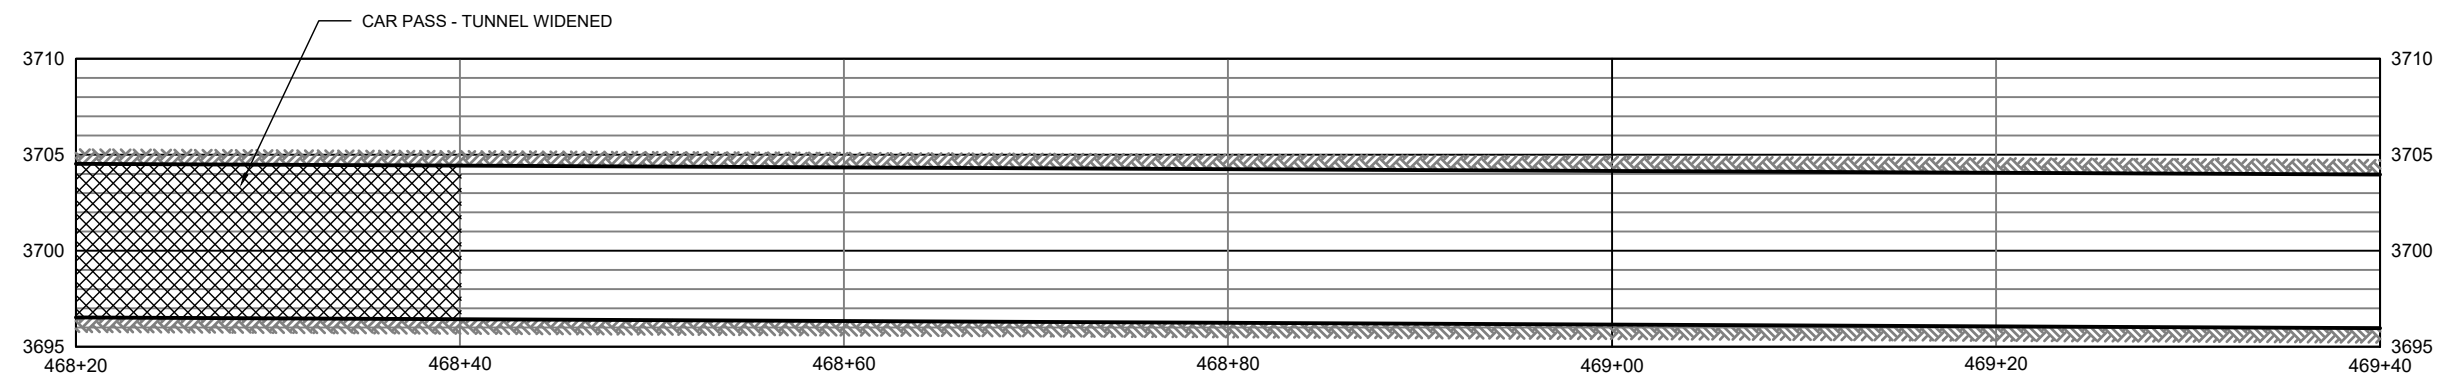
FIG-05
 5 OF 13

Defect No.	2024 Start Station	2024 End Station	Photo Number	Defect/Observation Description
19	467+00.00	-	_151657	Possible breakthrough as tunnel walls become kinked
20	468+20.00	468+40.00	IMG_5016.HEIC _151448	Car pass - tunnel widened on south wall up to approximately 12 feet wide. Observed sediment (clay/sand) deposition at the tunnel floor at S
