**EL DORADO CONDUIT RAW WATER CONVEYANCE
TUNNEL INSPECTION
GEORGETOWN, CALIFORNIA**

BRIERLEY ASSOCIATES CORPORATION

January 2025

Subject: Tunnel Inspection Report
Raw Water Conveyance Tunnel Inspection
Georgetown, California

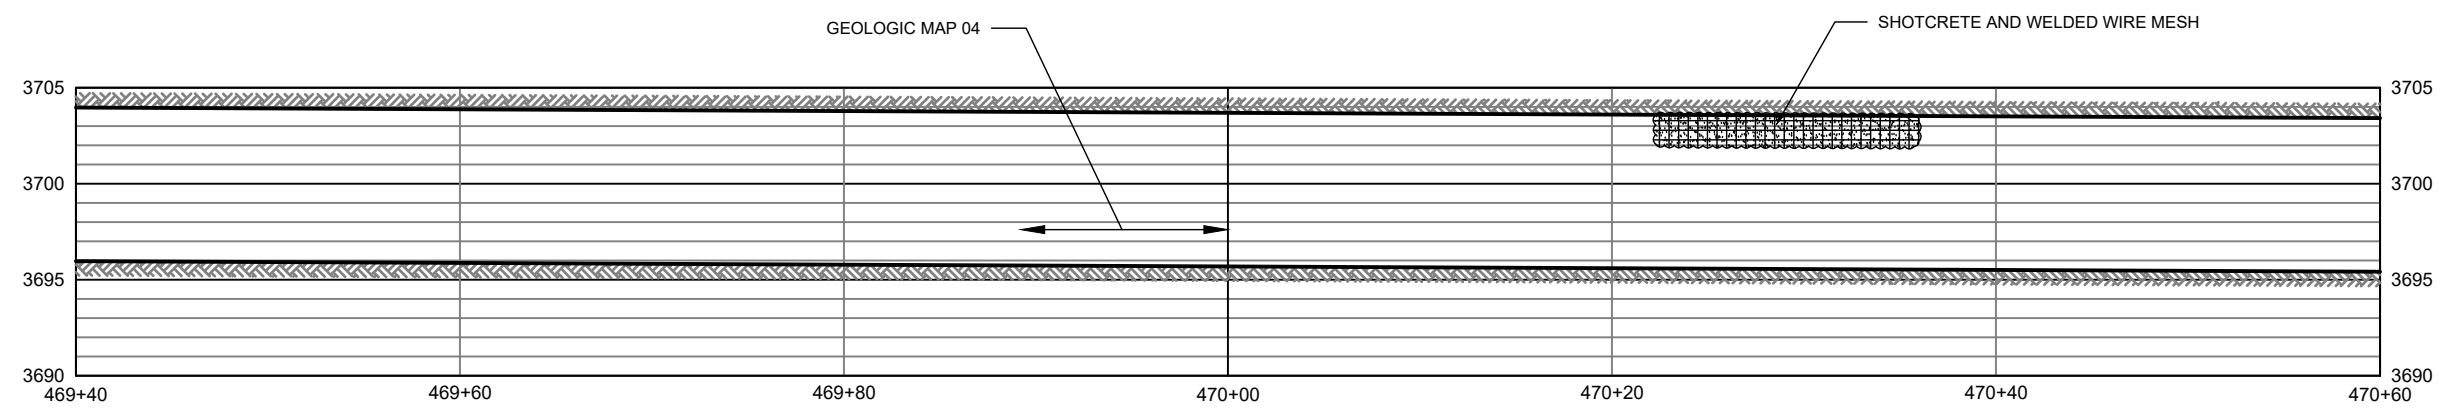
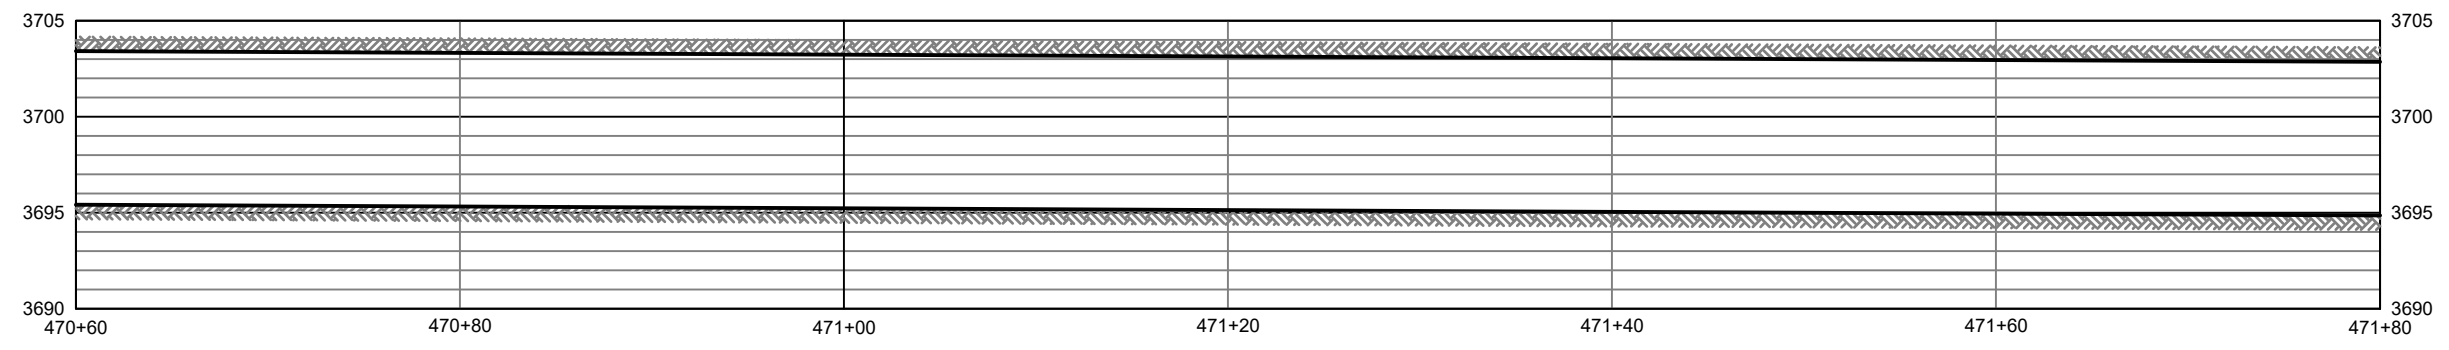
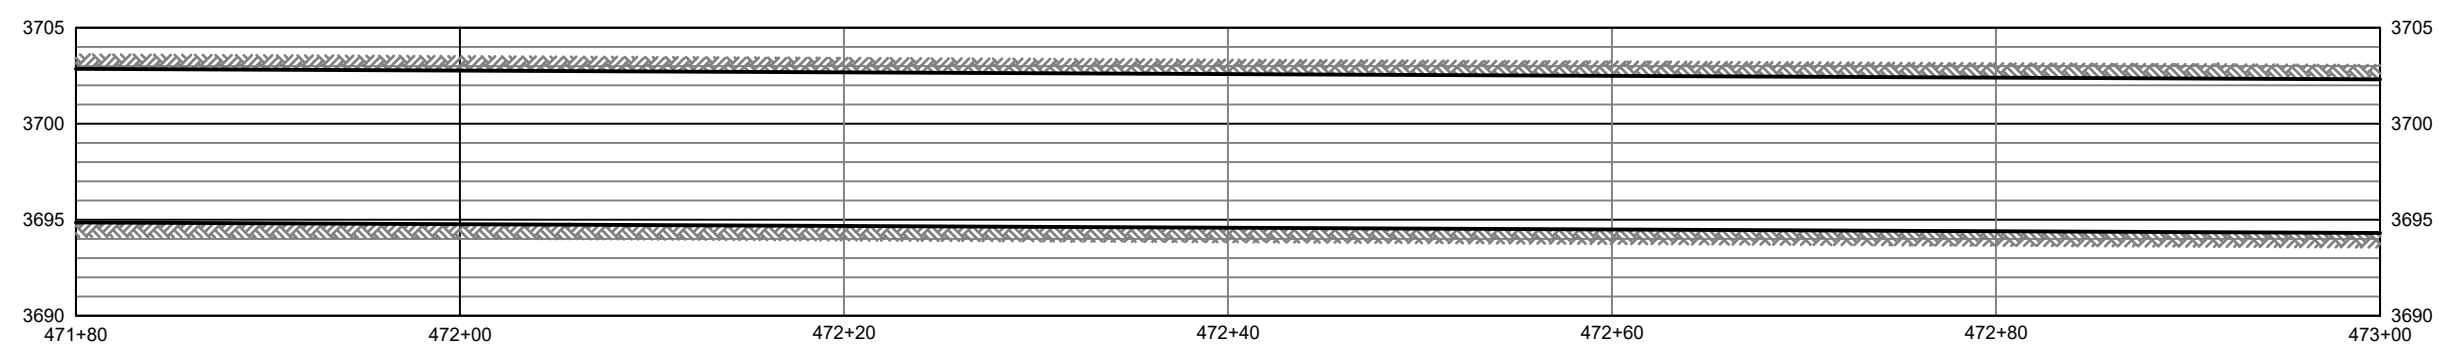
FIGURE NUMBER
FIG-06
 6 OF 13

Defect No.	2024 Start Station	2024 End Station	Photo Number	Defect/Observation Description
21	469+90.00	470+00.00	_151224	Geologic Map - see tunnel Geologic Map 04 in Appendix E
22	470+25.00	470+35.00	IMG_5012.HEIC _145739	Shotcrete and 4 inch WWM. Shotcrete up to 1 inch thickness with few cracks, with possible delamination or non-contact with tunnel walls. No spalling observed. Some thin light colored stalacties, like from leaching of shotcrete.

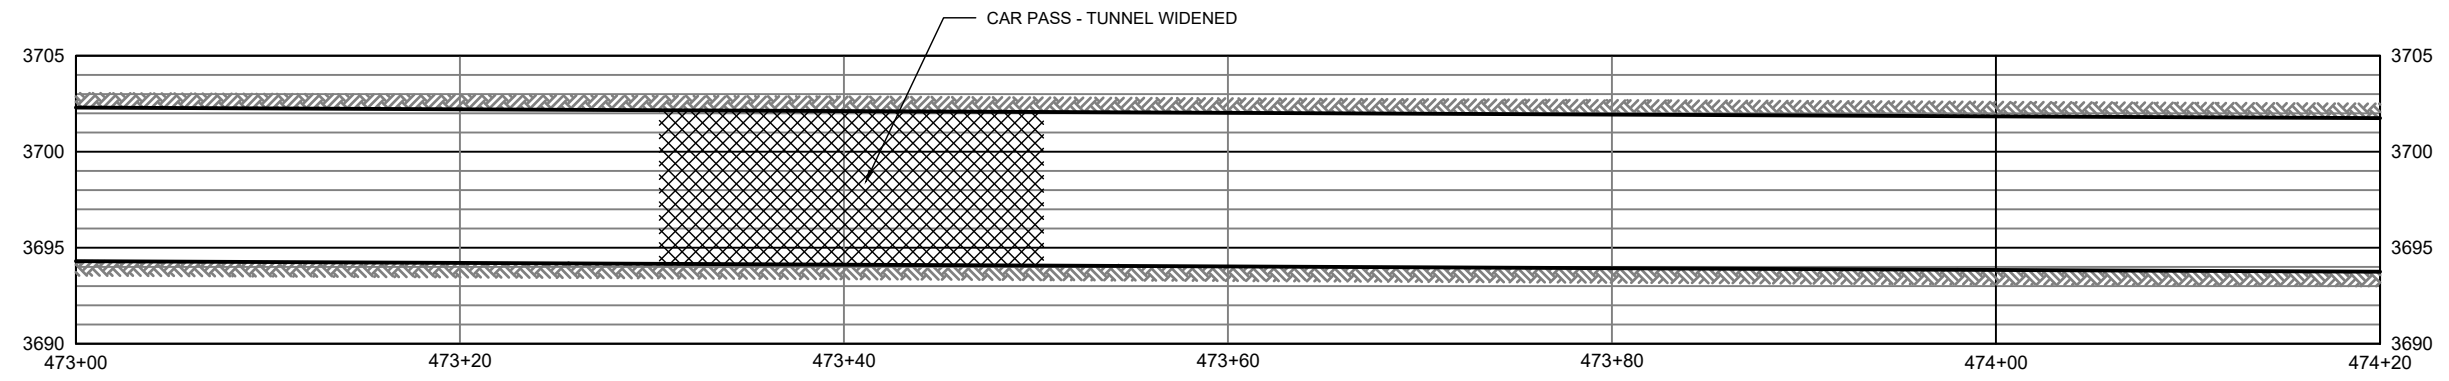
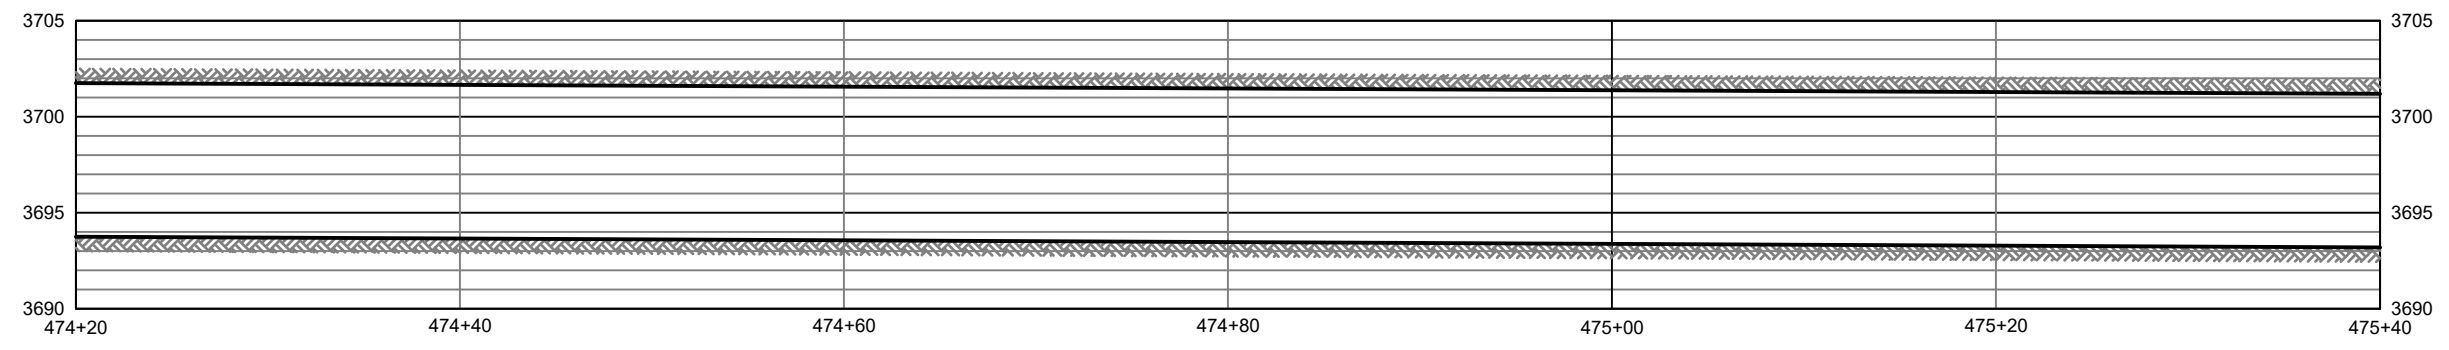
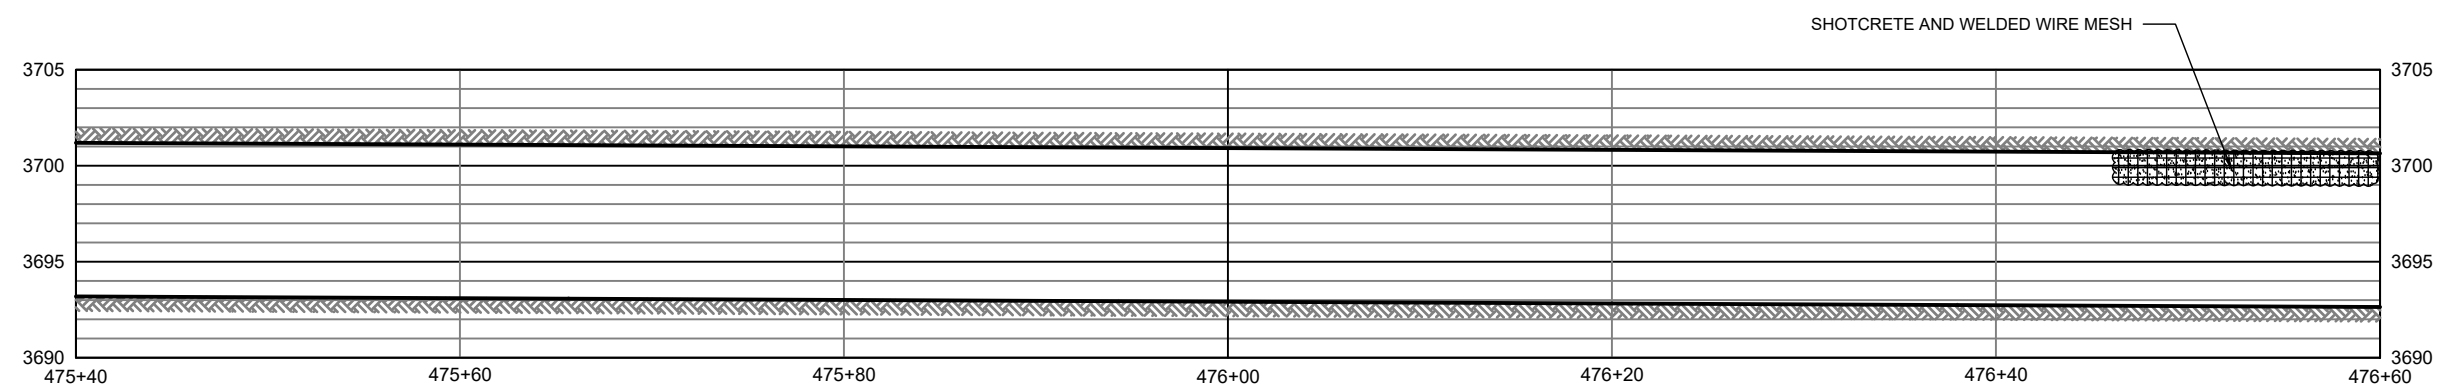
FIG-07
 7 OF 13

Defect No.	2024 Start Station	2024 End Station	Photo Number	Defect/Observation Description
23	473+30.00	473+50.00	IMG_5005.HEIC _145236	Car pass - tunnel widened on south wall up to approximately 12 feet. Observed sediment (clay/sand) deposition at the tunnel floor
24	476+45.00	476+60.00	IMG_4997.HEIC _143713	Incomplete shotcrete with 4 inch WWM. WWM exposed in many areas. Shotcrete up to 1 inch thickness with few cracks, with possible delamination or non-contact with tunnel walls. No spalling observed. Some efflorescence and thin light colored stalactites, likely from leaching of shotcrete. Mine straps in crown.

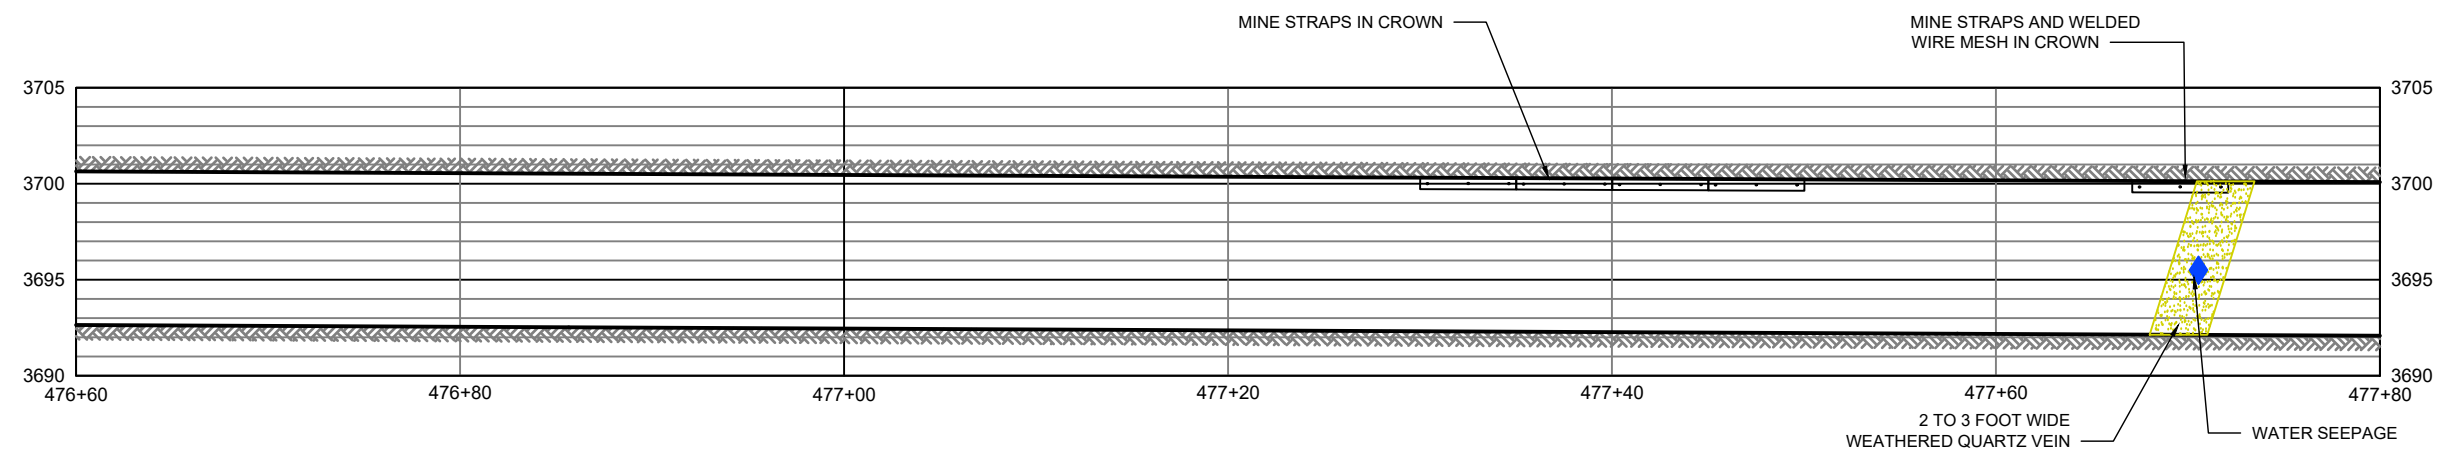
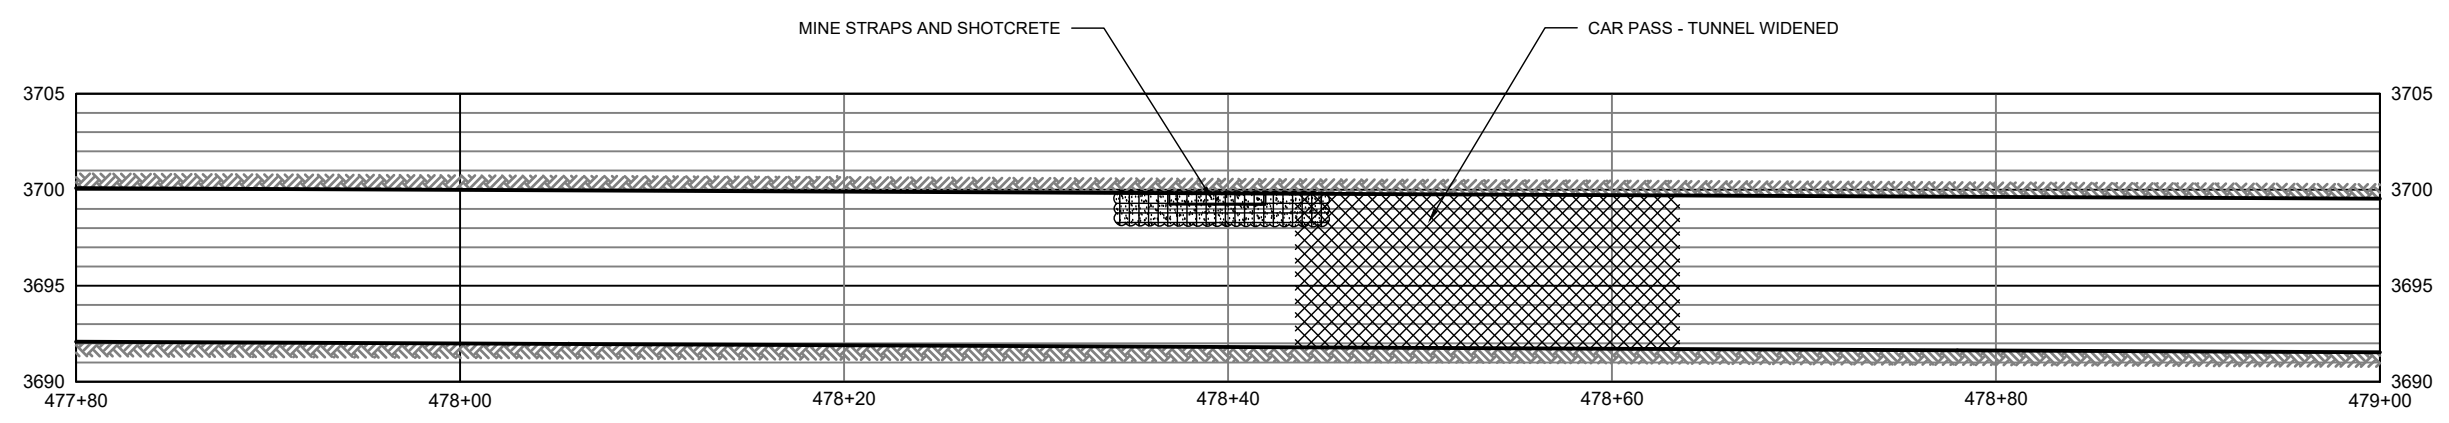
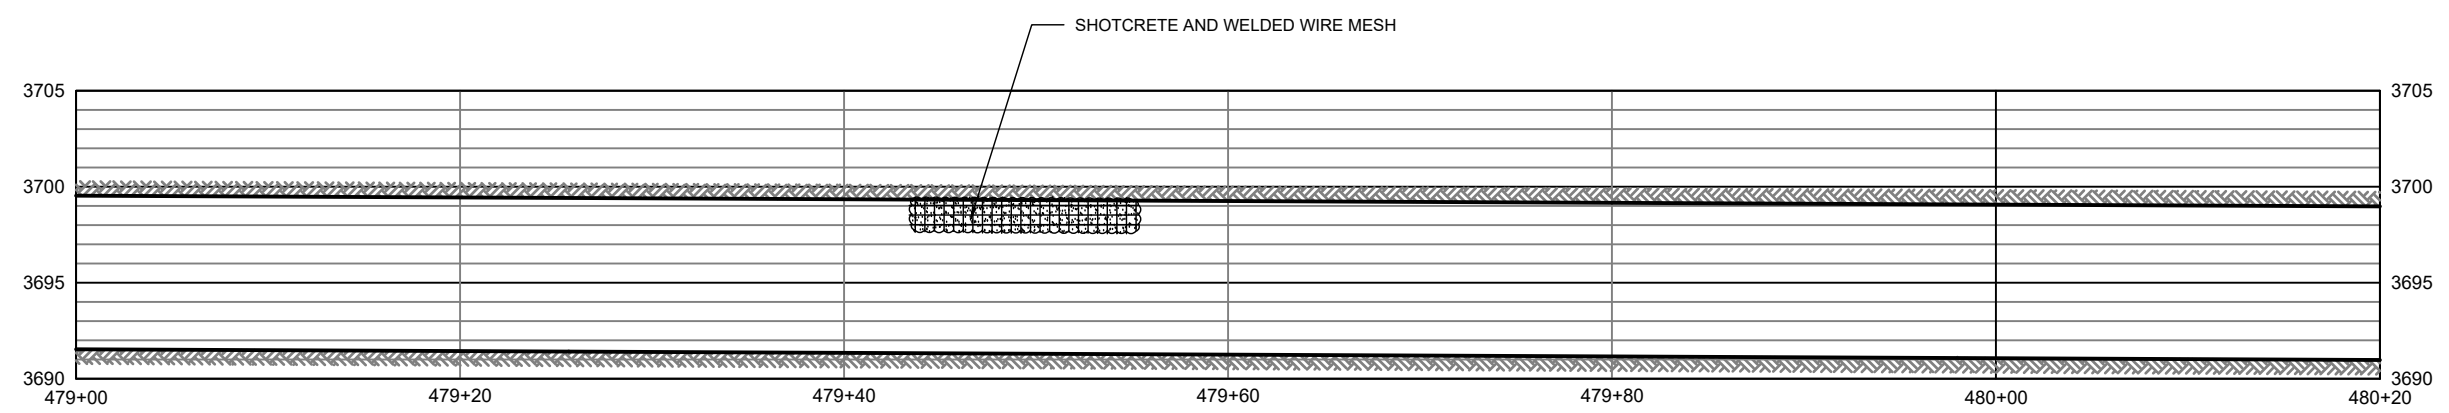
Defect No.	2024 Start Station	2024 End Station	Photo Number	Defect/Observation Description
25	477+35.00	477+50.00	_143433	Single mine strap installed in crown
26	477+70.00	-	IMG_4988.HEIC _143353	0.5 inch WWM and mine straps in crown. Water seep with iron oxide discoloration; tunnel walls wet 2 to 3 foot wide quartz vein, vertical
27	478+35.00	478+45.00	IMG_4985.HEIC _142810	Incomplete shotcrete with 4 inch and 0.5 inch WWM. WWM exposed in many areas. Shotcrete up to 1 inch thickness with few cracks, with possible delamination or non-contact with tunnel walls. No spalling observed. Some efflorescence and thin light colored stalactites, likely from leaching of shotcrete. Mine straps in crown.
28	478+45.00	478+65.00	IMG_4980.HEIC _142617	Car pass - tunnel widened on south wall up to approximately 12 feet. Shotcrete and mine straps installed in the crown. Observed sediment (clay/sand) deposition at the tunnel floor

29	479+50.00	-	IMG_4977.HEIC _142322	Shotcrete and 0.5 inch WWM. Shotcrete up to 1 inch thickness with few cracks, with possible delamination or non-contact with tunnel walls. No spalling observed. Some efflorescence and thin light colored stalactites, likely from leaching of shotcrete. Some iron oxide staining from water inflow and corrosion of WWM.

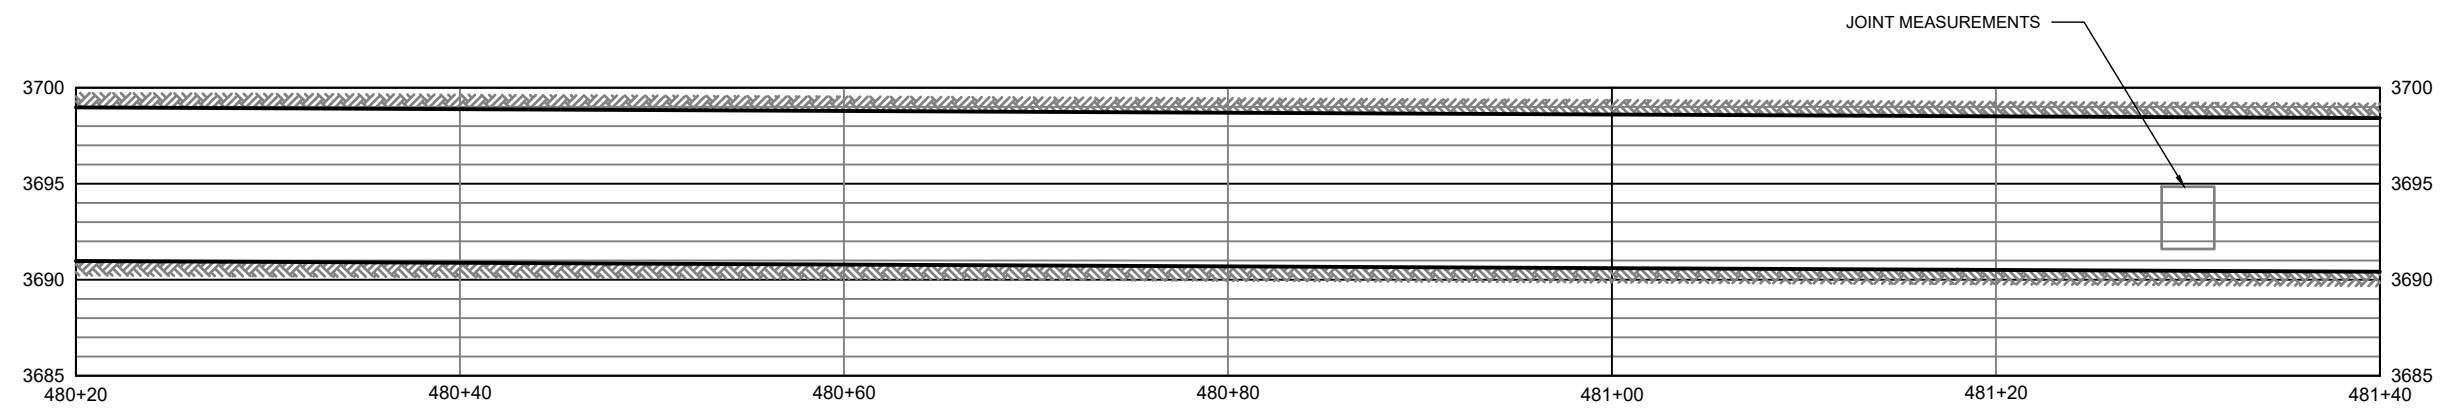
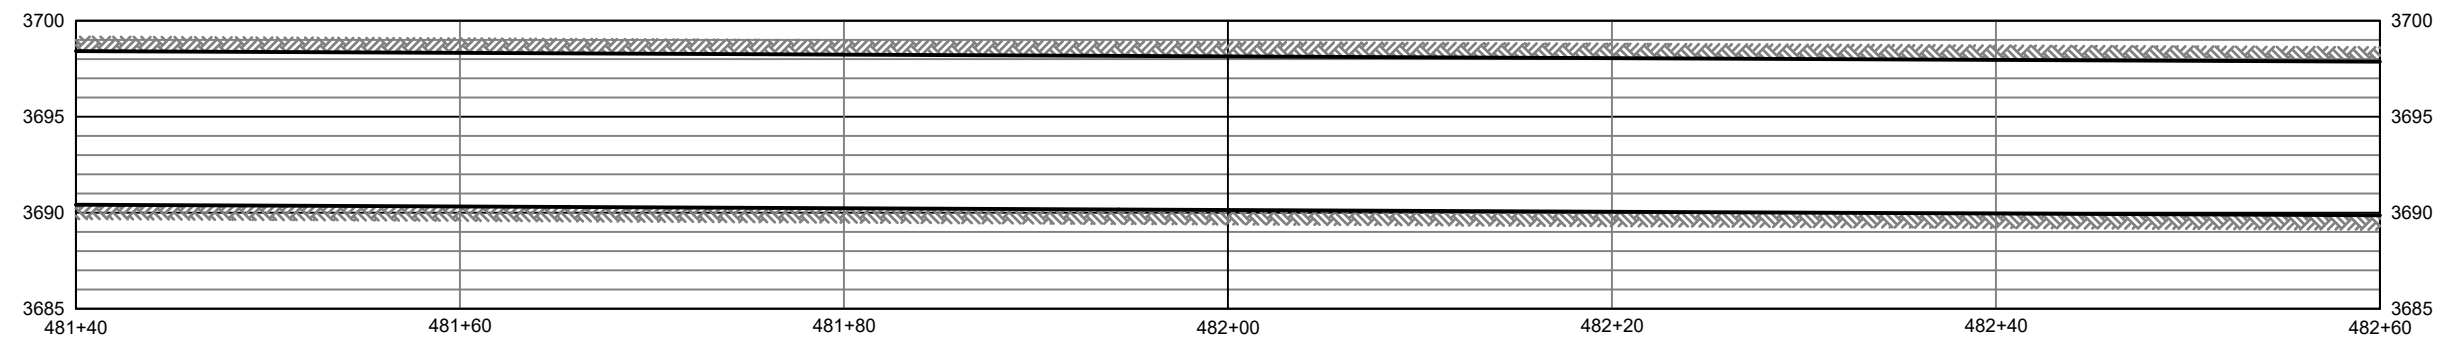
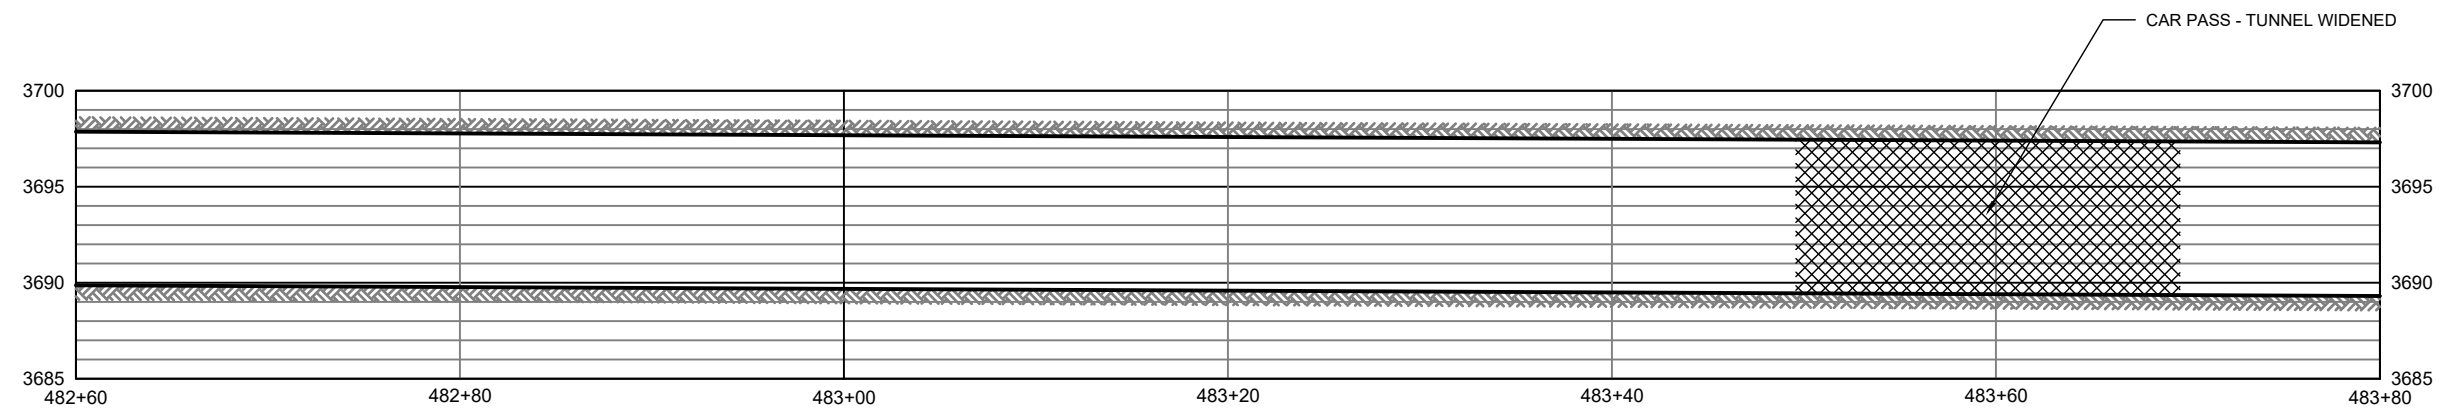
Defect No.	2024 Start Station	2024 End Station	Photo Number	Defect/Observation Description
30	480+20.00	-	_142142	Small breakout on north wall with dimensions of 5 x 5 x 5 feet
31	481+30.00		IMG_4970.HEIC _141534	Geologic measurements - refer to Appendix E
32	483+50.00	483+70.00	IMG_4965.HEIC _141123	Car pass - tunnel widened on south wall up to approximately 12 feet. Observed sediment (clay/sand) deposition at the tunnel floor

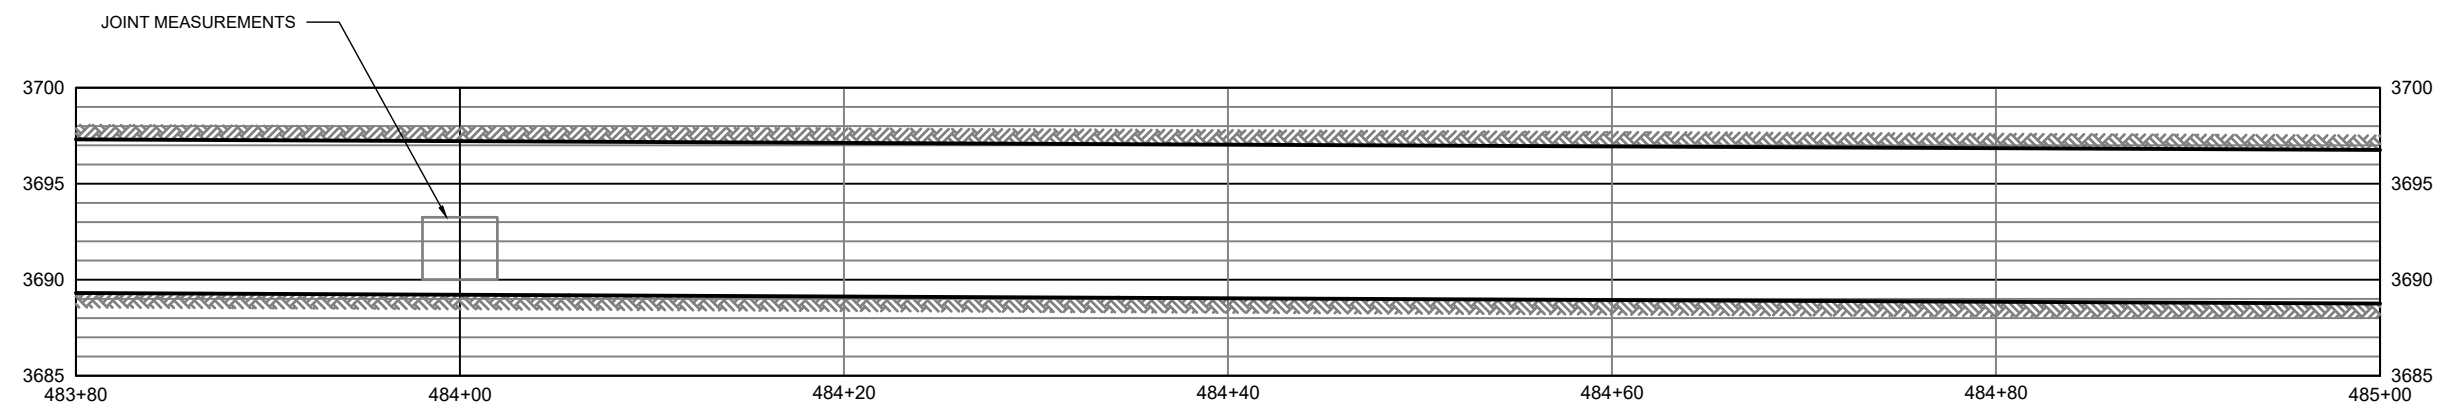
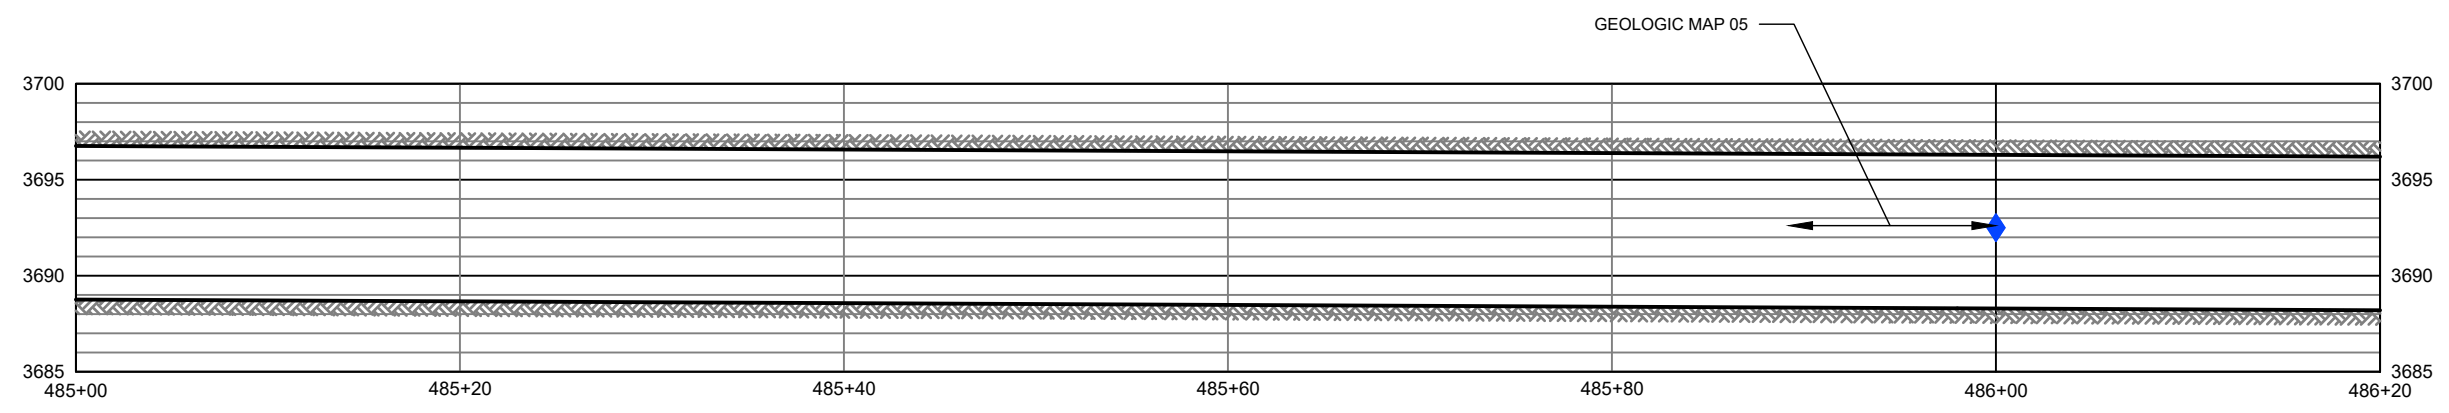
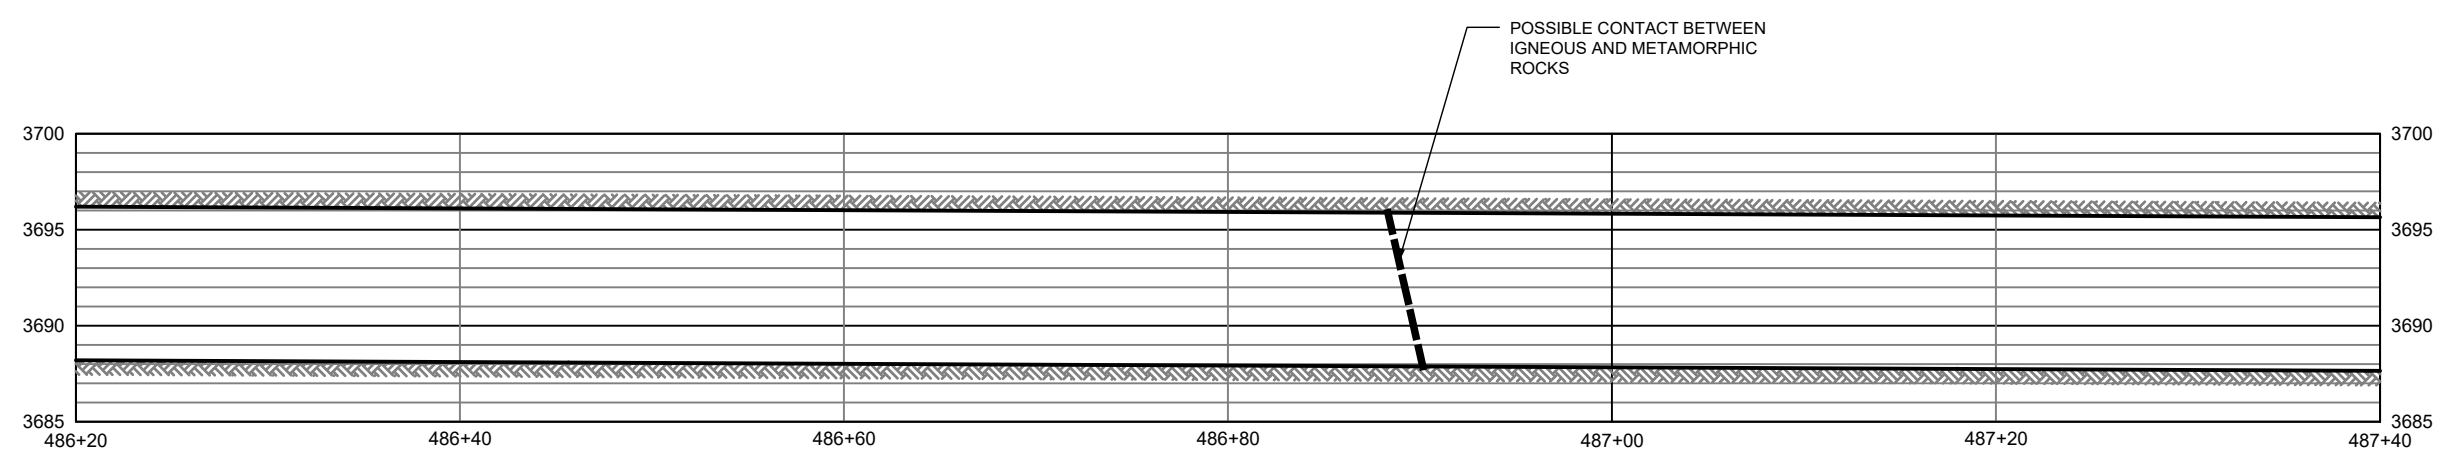
FIG-10
 10 OF 13

Defect No.	2024 Start Station	2024 End Station	Photo Number	Defect/Observation Description
33	484+00.00	-	_140926	Geologic measurements - refer to Appendix E
34	486+00.00	-	IMG_4956.HEIC	Groundwater flow, <1gpm. 2 inch drain installed and clogged.
35	486+00.00	-	_140656	Geologic Map - see tunnel Geologic Map 05 in Appendix E
36	486+70.00	-	_135253	Possible contact between slate/hornfels(?) and granodiorite

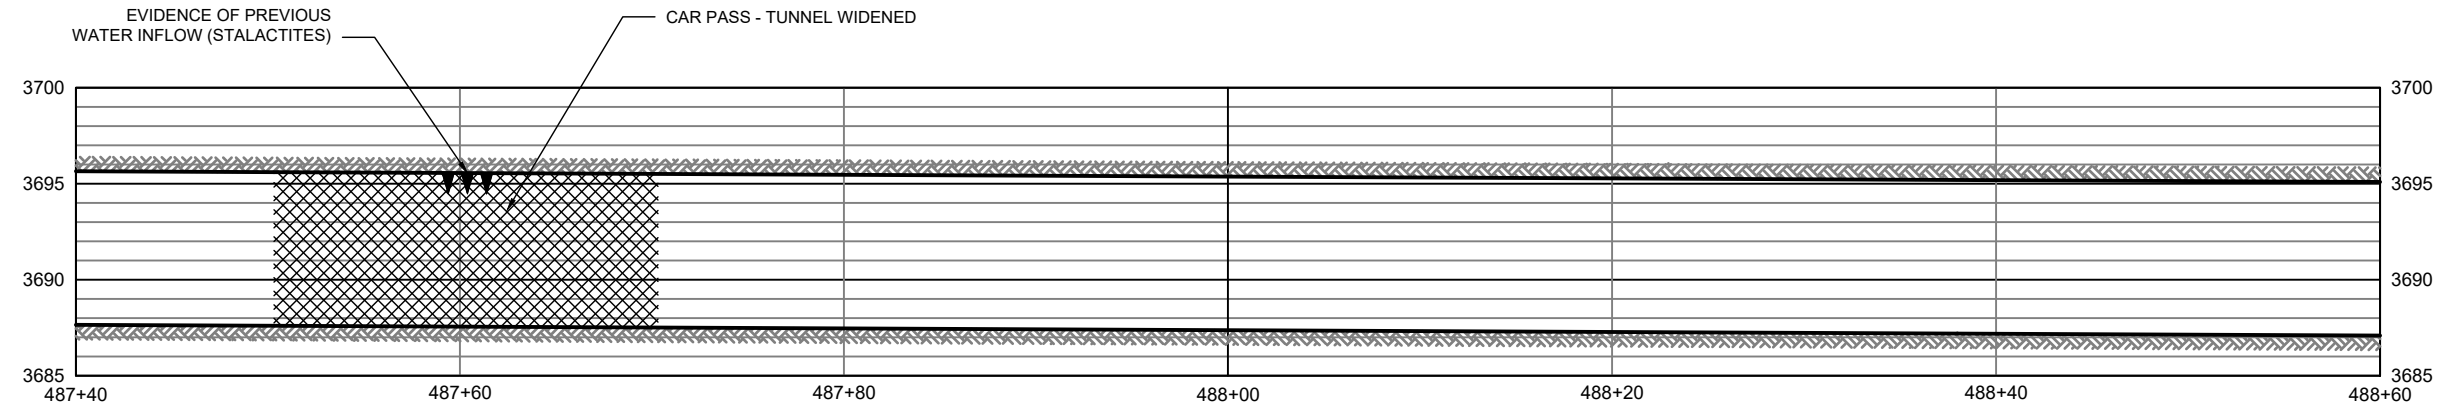
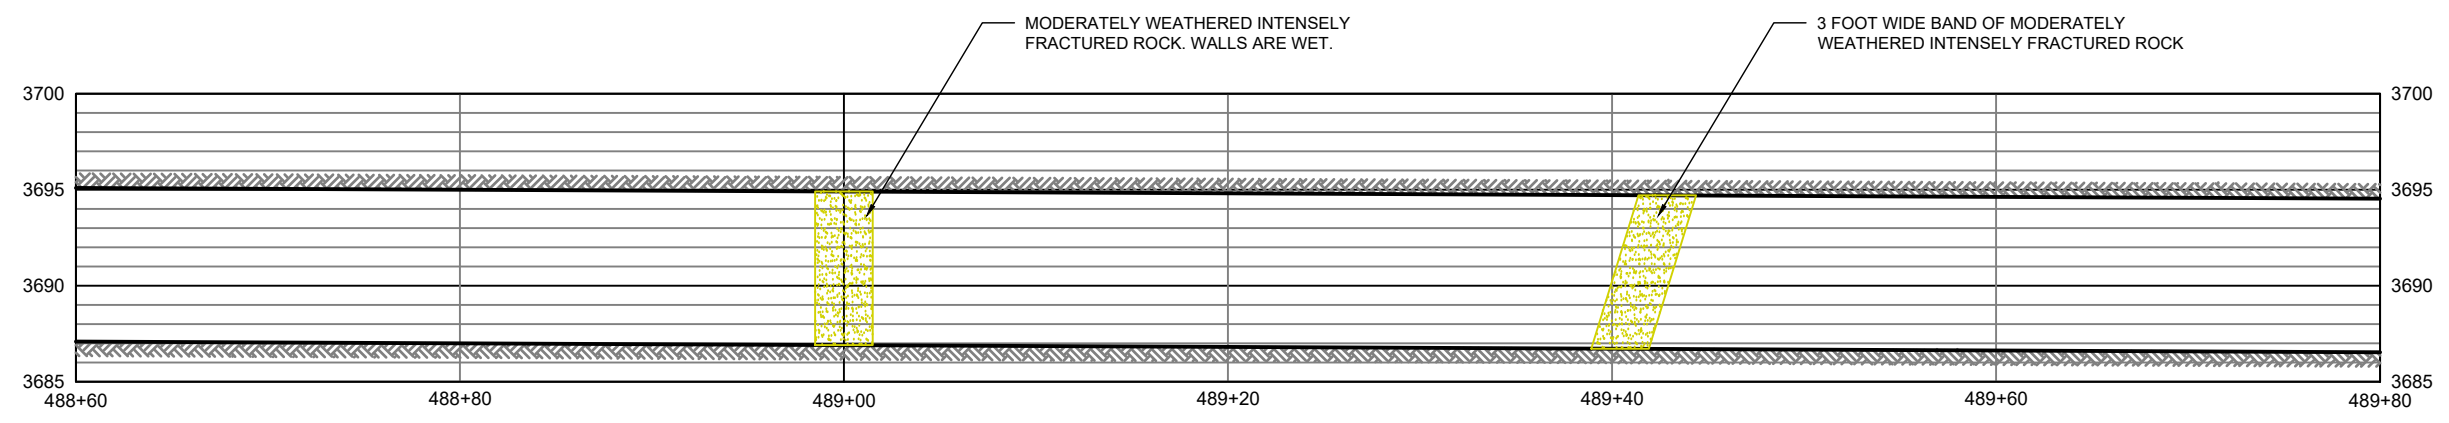
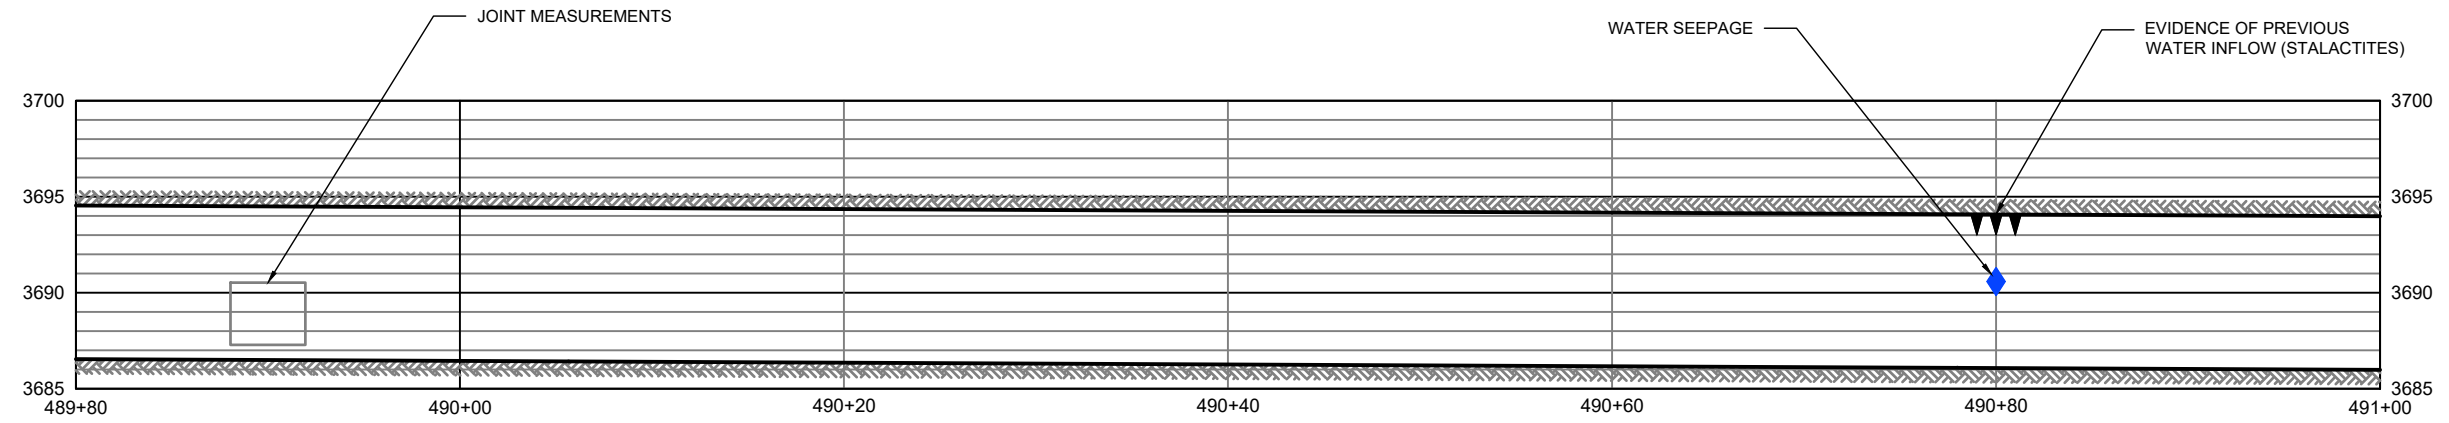
Defect No.	2024 Start Station	2024 End Station	Photo Number	Defect/Observation Description
37	487+55.00	487+75.00	_132647	Car pass - tunnel widened on south wall up to approximately 14 feet. No shotcrete or other apparent support. Some stalactites showing evidence of previous water inflow.
38	489+00.00		IMG_4945.HEIC	Moderately weathered rock, walls are damp to wet
39	489+40.00	-	_132348	3 foot wide band of moderately weathered highly jointed rock. Joints are vertical
40	489+90.00	-	_131953	Geologic measurements - refer to Appendix E
41	490+80.00	-	_131318	Minor water inflow (<1gpm) and evidence of previous water inflow in additional locations due to existing stalactites. Significant iron oxide discoloration. Stalactites in crown

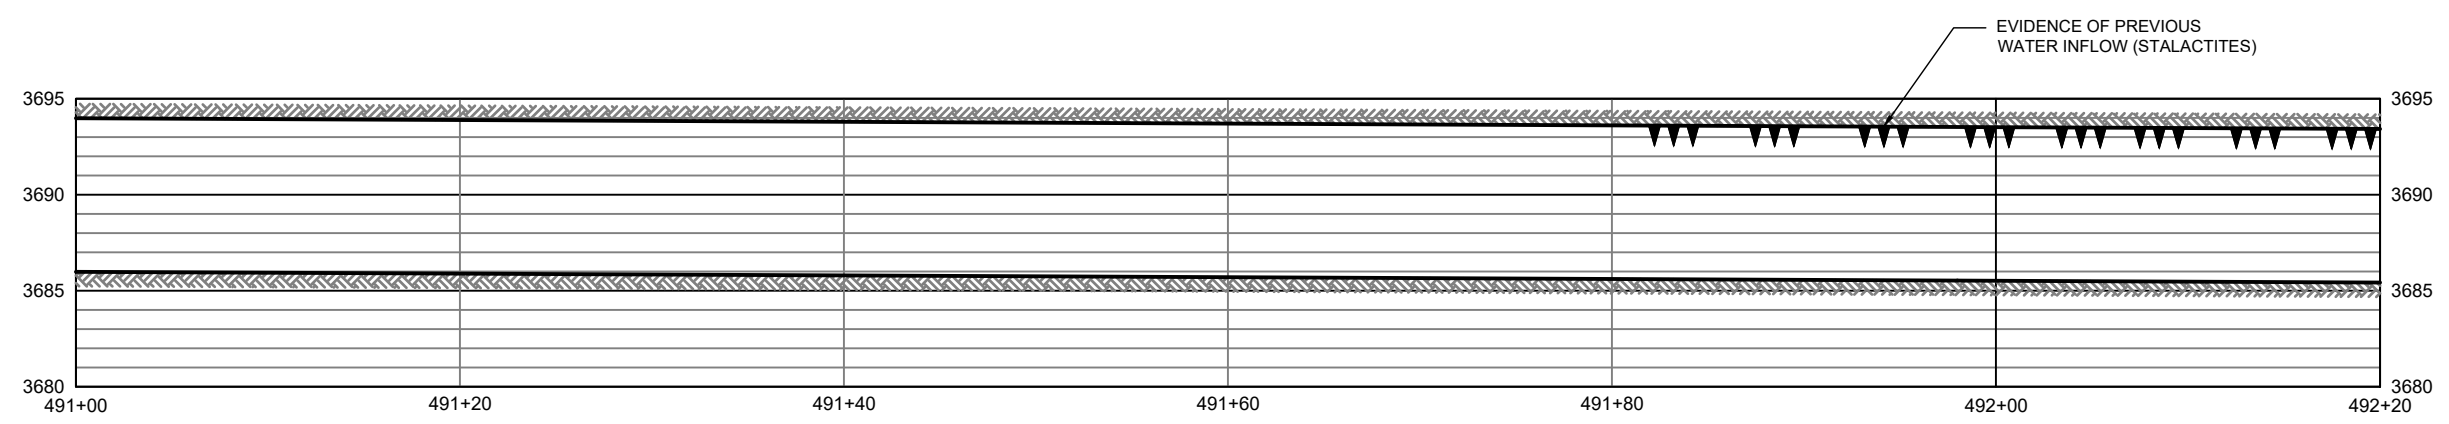
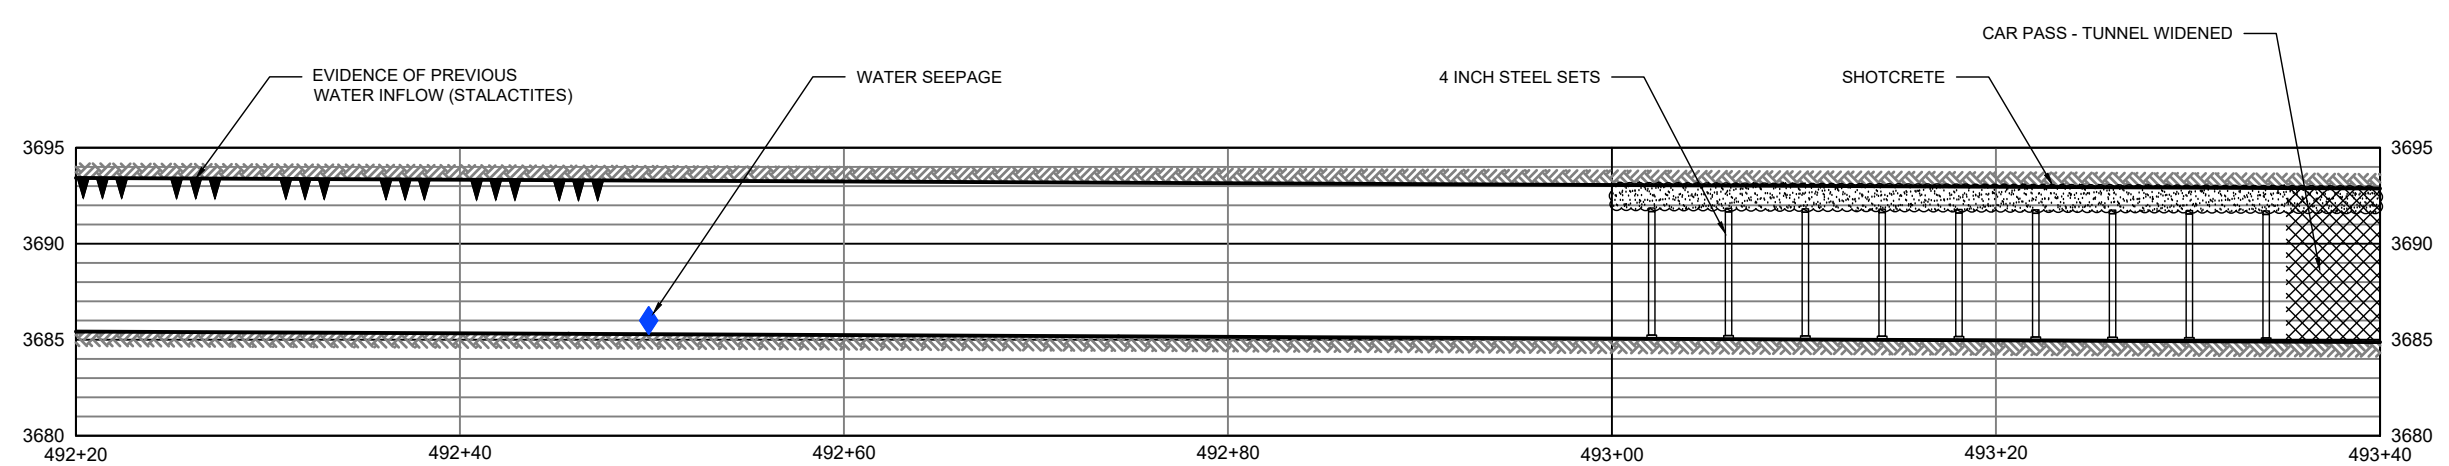
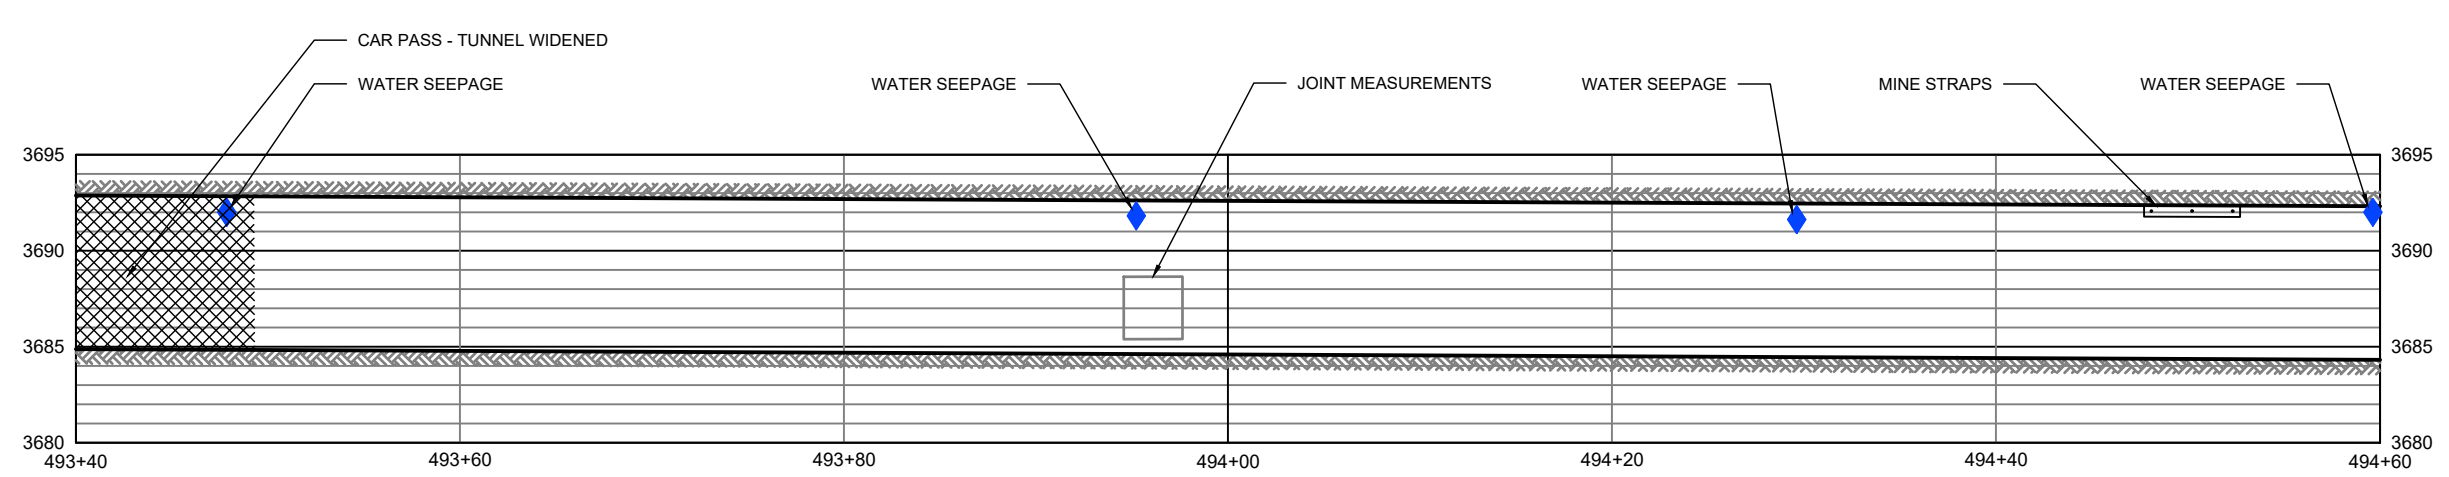
Defect No.	2024 Start Station	2024 End Station	Photo Number	Defect/Observation Description
42	491+85.00	492+50.00	_130751	Water inflow and evidence of previous water inflow in additional locations due to existing stalactites. Single seepage point near invert under slight pressure (artesian) at Sta. 492+50. Significant iron oxide discoloration
43	493+00.00	493+55.00	_105650	Shotcrete and 0.5 inch WWM. Shotcrete up to 1 inch thickness with few cracks, with possible delamination or non-contact with tunnel walls. No spalling observed. Some thin light colored stalactites, likely from leaching of shotcrete.
44	493+10.00	493+34.00	_130107	A total of 8 steel ribs (between #74 and #82) spaced at 4.0-ft were observed. This area is the previous fallout zone. There were about six drainpipes to collect or divert groundwater discharge at several locations within this interval. The wood blocking and timbers between the steel ribs and rock surface were missing at the roof. Steel ribs and tie-bars were covered with shotcrete. Some tie-bars were missing.

45	493+34.00	493+50.00	_130038	Car pass - tunnel widened on south wall up to approximately 14 feet
