**EL DORADO CONDUIT RAW WATER CONVEYANCE
TUNNEL INSPECTION
GEORGETOWN, CALIFORNIA**

BRIERLEY ASSOCIATES CORPORATION

January 2025

Subject: Tunnel Inspection Report
Raw Water Conveyance Tunnel Inspection
Georgetown, California

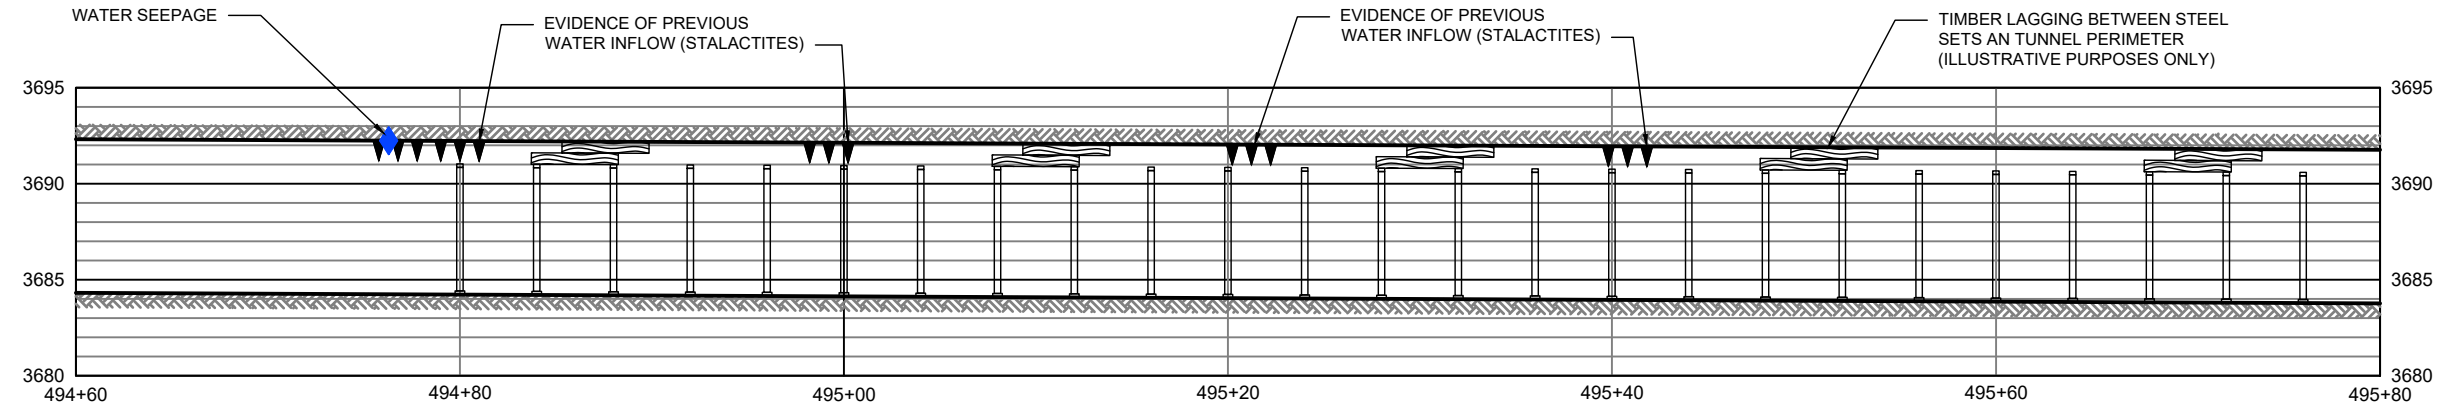
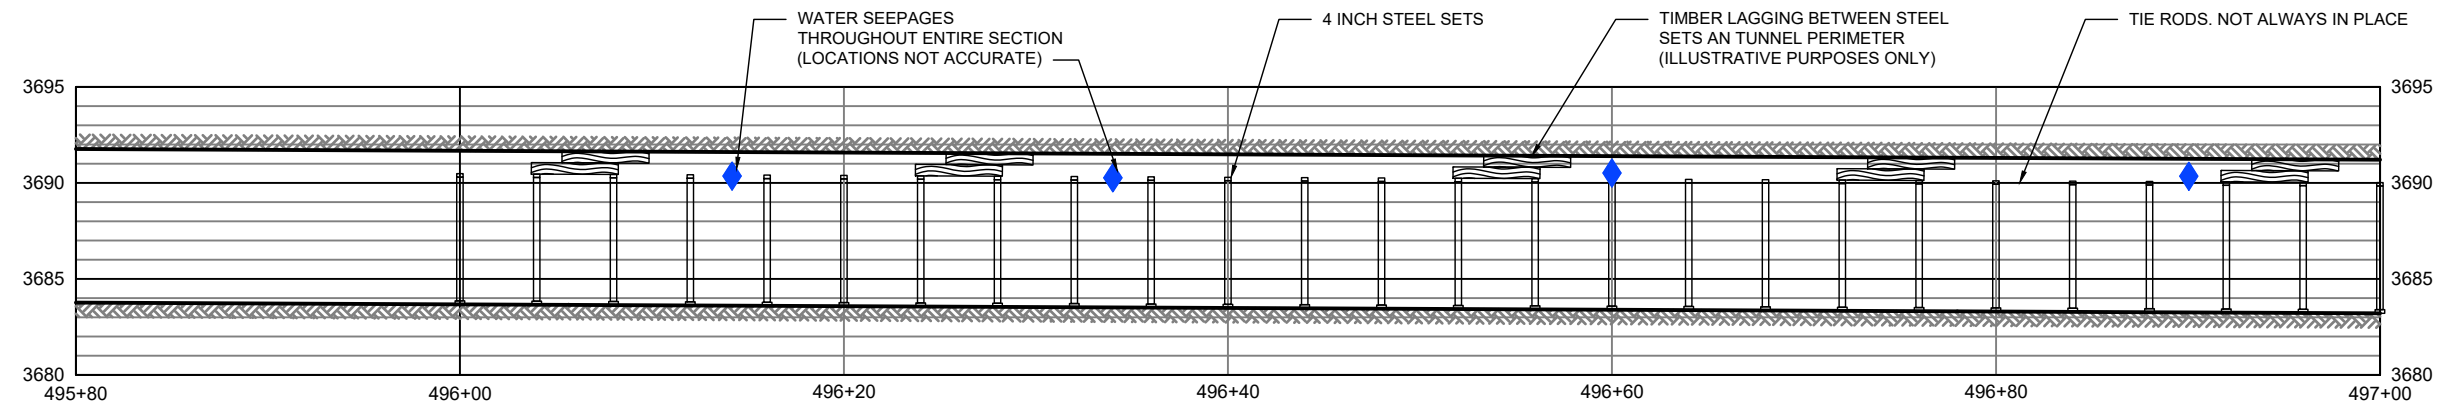
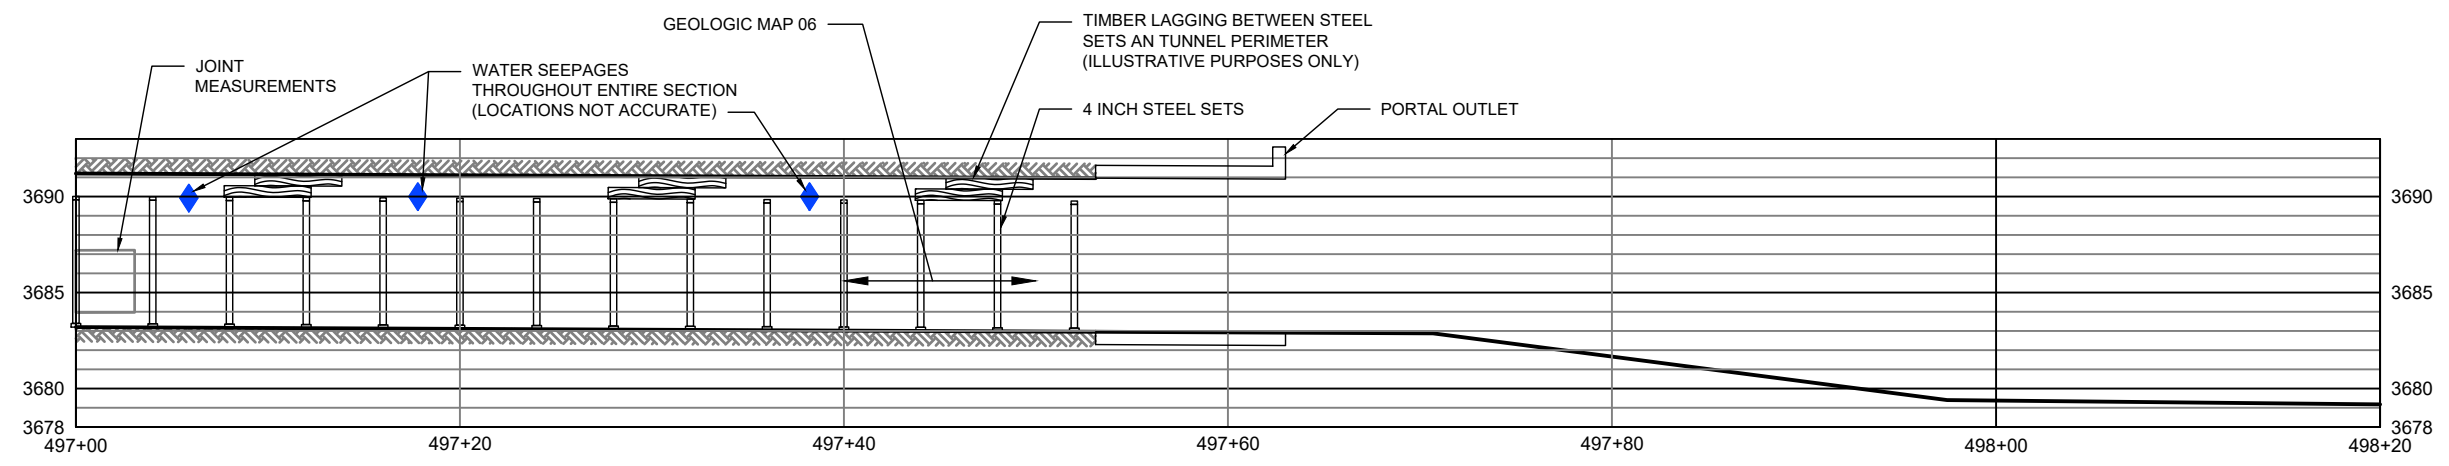
FIG-12
 12 OF 13

Defect No.	2024 Start Station	2024 End Station	Photo Number	Defect/Observation Description
51	494+80.00	495+75.00		A total of 25 steel ribs (between #50 and #74) spaced at 4.0-ft were observed. A tie-bar between the steel rib #53 and #54 were missing on S wall, and some tie-bars were deformed. The wood blocking, shotcrete and timbers were observed to be inadequate at some locations
52	494+80.00	495+75.00	_123028 to _	Iron oxide discoloration and significant stalactites, evidence of previous water inflow throughout section
53	494+30.00	-	_123645	Water inflow of approximately <1gpm and iron oxide discoloration
54	496+00.00	497+50.00	IMG_4926.HEIC	Steel ribs (quantity 49). The first 21 steel ribs (between #49 and #29) were spaced at from 3.0 to 4.0-ft, then, the next 14 steel ribs (between #29 and #14) were spaced at from 2.0 to 3.0-ft, the last 14 steel ribs (between #14 and #1) near the outlet were spaced at approximately 2.0-ft. The steel ribs and tie-bars were not covered with shotcrete, and they appeared to be affected by significant corrosion. Some occasional shotcrete applications were observed on steel ribs closer to the tunnel invert to secure the steel sets. The wood blocking between the steel ribs and rock surface were missing at the shoulders, walls and roof for the first ten steel ribs. Some tie-bars between the steel ribs were missing and deformed.

55	496+00.00	497+53.11	_123124	Significant water inflow throughout entire section. Estimated 10 to 20gpm
