REPORT TO THE BOARD OF DIRECTORS  
BOARD MEETING OF DECEMBER 8th, 2020  
AGENDA ITEM NO. 7.B.

**SUBJECT:** General Managers Monthly report, November 6<sup>th</sup> – December 2<sup>nd</sup>, 2020

Auburn Lake Trails Community Disposal System  
**FEASIBILITY STUDY REPORT**

November 16, 2020

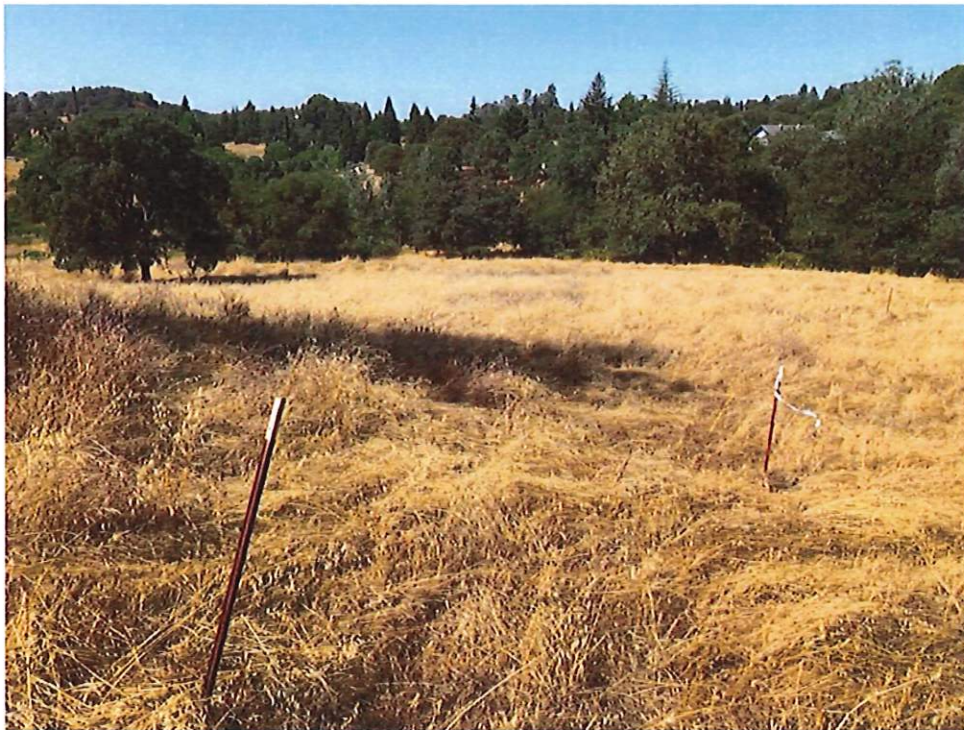
Photo No. 1 Northern portion/margin of Field O. View is looking downslope to the southwest. Excavation LF1 was located at the post with white flagging (photo date 8/3/2020).

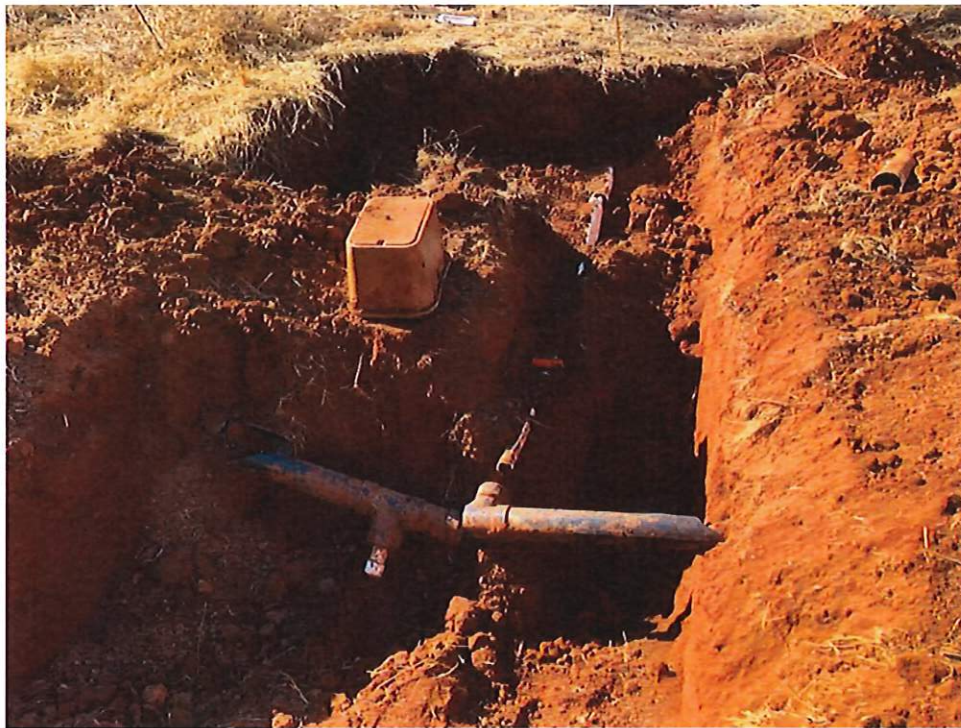
District staff excavated and exposed the northern end of one leach field lateral at location LF1 (see Figure 1). Geocon observed and recorded findings. The lateral was exposed along with its distribution line and a ball valve. The exposed lines were dry and valves at both ends of the lateral were in the off position. Based on the number and location of valves in the central part of Field O, LF1 appeared to be the fourth lateral down from the top of the field. It is assumed that the other laterals in Field O connect to the junction with a ball valve.

Photo No. 2 Distribution piping exposed in LF1 at the northern margin of Field O. View is looking approximately along contour to the southwest (photo date 8/6/20).

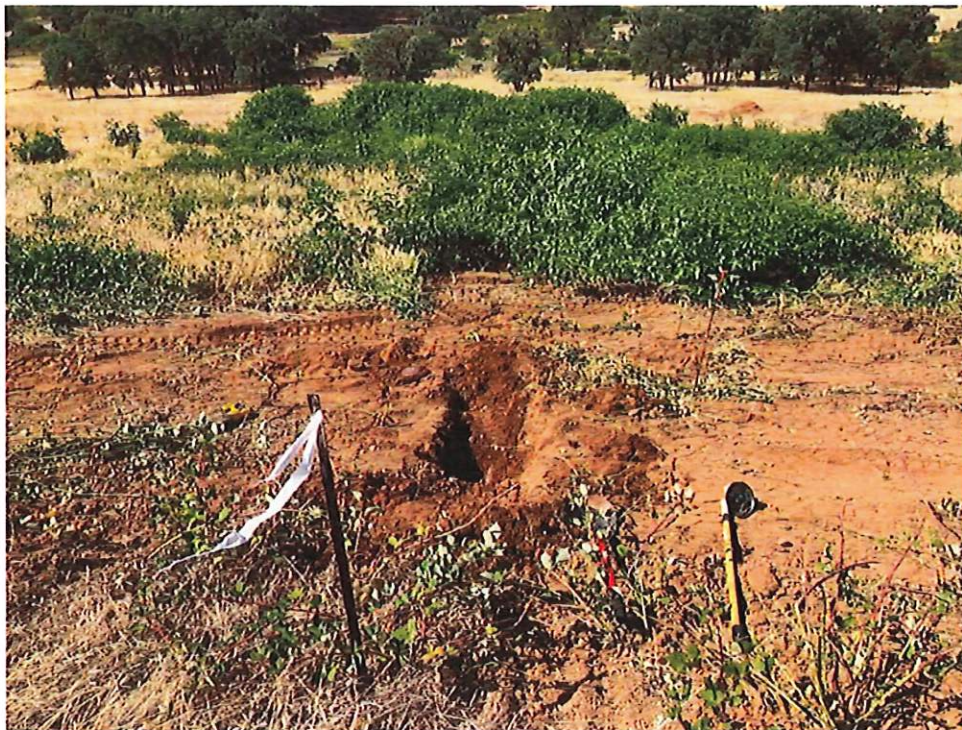
Photo No. 3 View looking directly downslope (southwest) from the top of Field A. Excavation LF4 is in the foreground (photo date 8/7/2020).

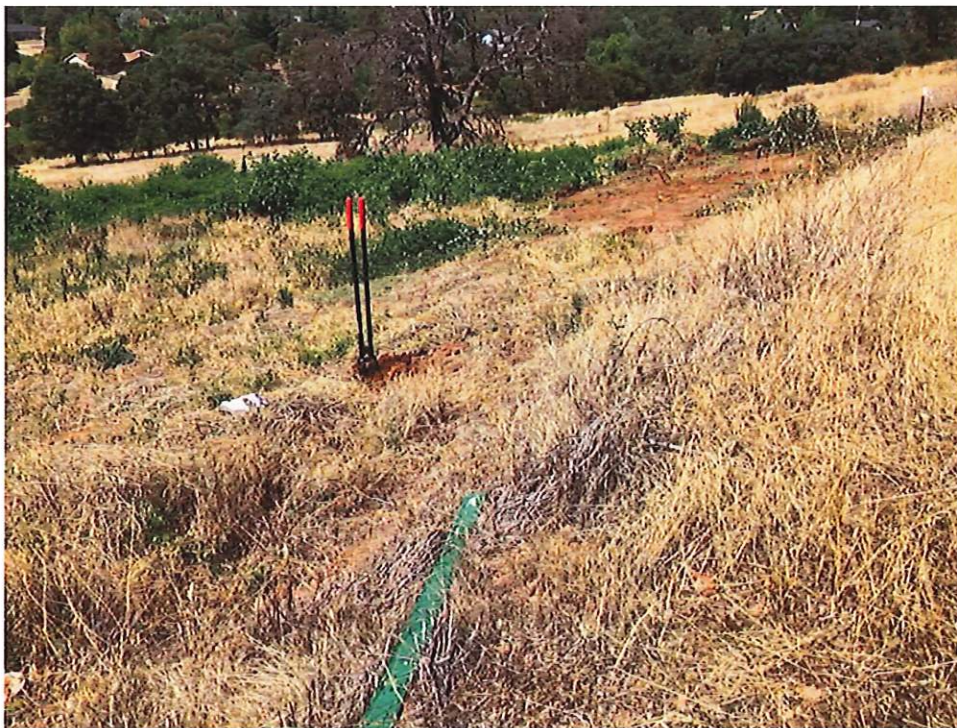
Photo No. 4 View looking to the west from near the top, eastern corner of Field A. (photo date 8/7/2020).

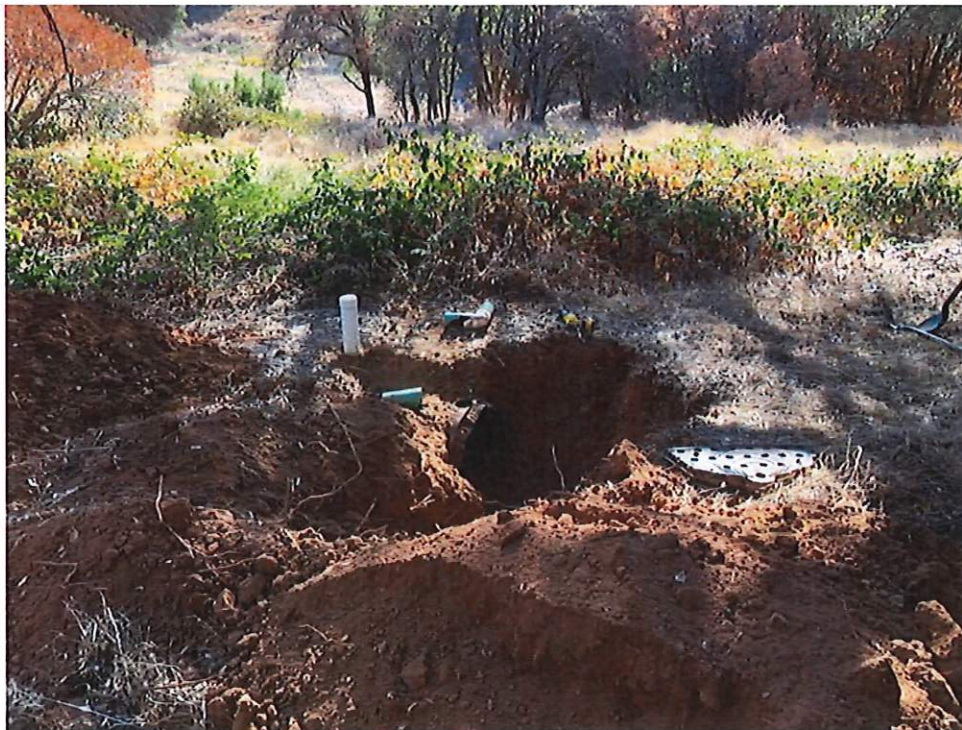
Photo No. 5 View looking east (downslope) at the southwestern portion of Field B and excavation LF2, exposing the end of an infiltrator (photo date 8/7/2020).

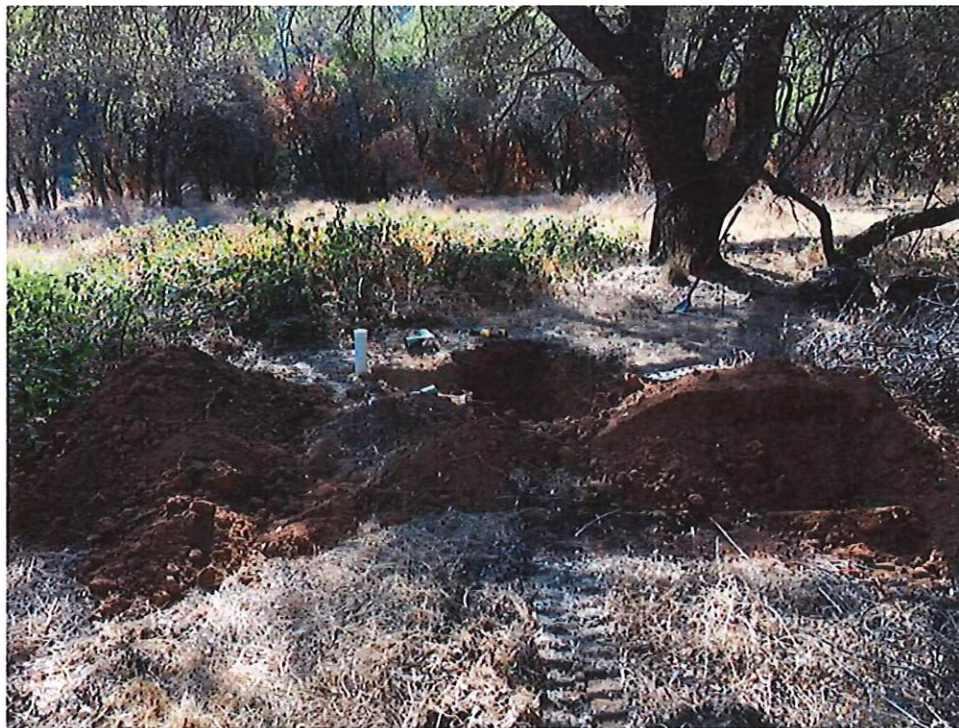
Photo No. 6 View looking southeast at the southwestern end of Field B and excavation LF2 (photo date 8/7/2020).

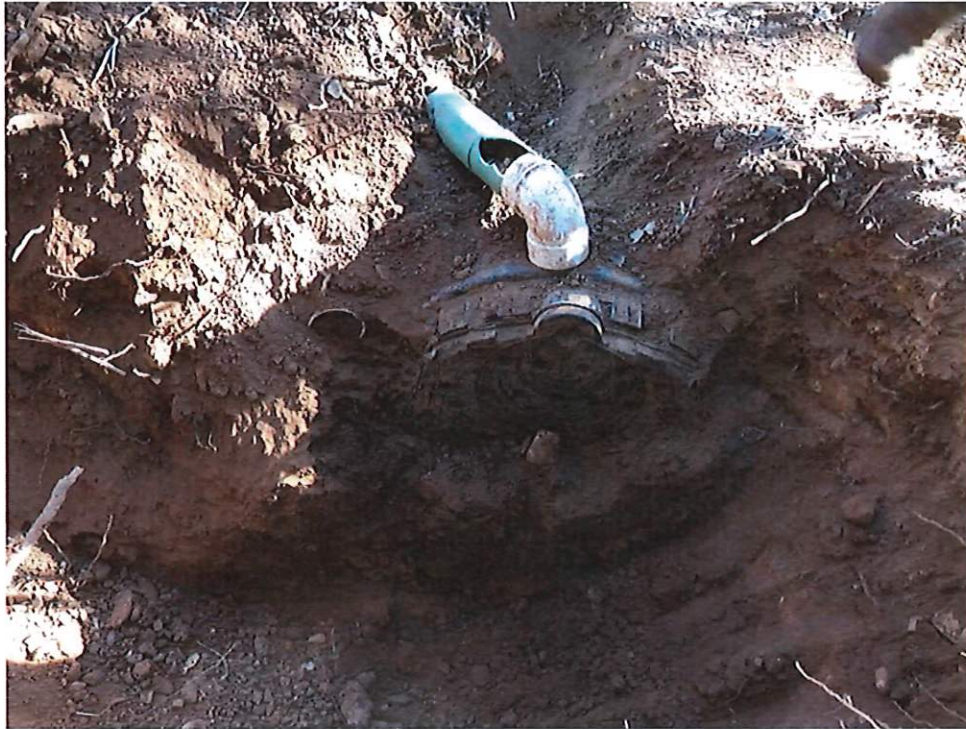
As expected, fluid was present throughout the entire infiltrator in Field A because effluent flow was sent there approximately three days prior to the investigation. The other locations in the second infiltrator were dry because Field B had not been in use recently. No apparent obstructions, damage, or roots were observed, nor were areas of wet or saturated surface soil observed. The infiltrators were in generally good condition. However, the distribution piping inside the infiltrators was no longer hanging from the top in several locations and instead lying on top of the biosolids due to deteriorated and broken zip-ties. The piping itself had no apparent damage. It is likely that the fields are in good condition due to District staff cycling through using each field during normal operations.

Photo No. 7 Southwest end of Field B, Row 4 infiltrator exposed in excavation LF2. (photo date 8/7/2020).

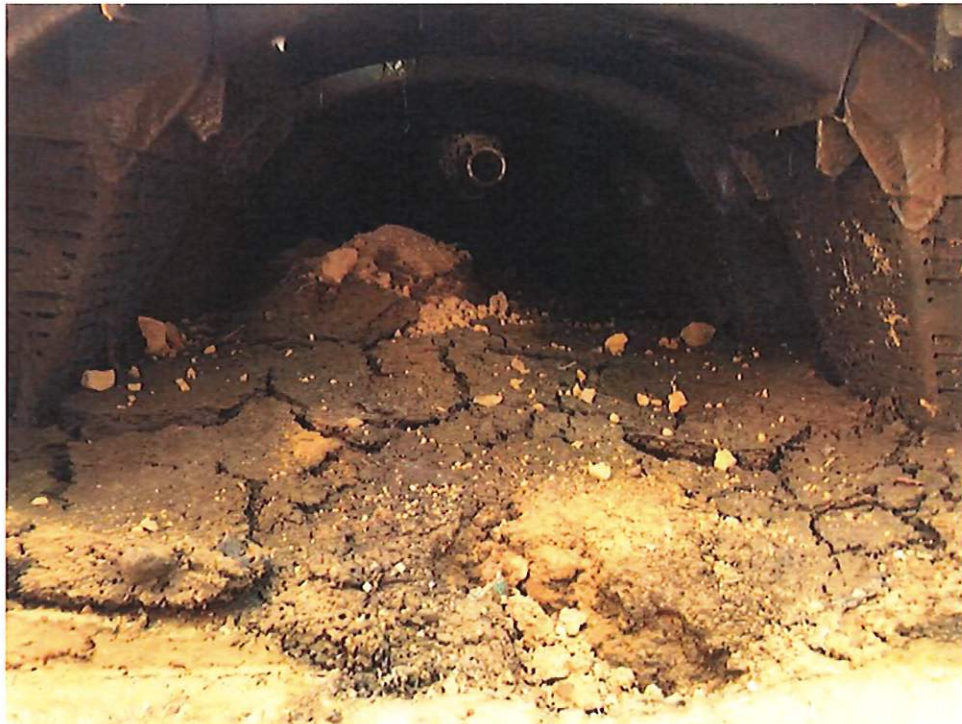
Photo No. 8 Looking into the southwest end of Field B, Row 4 infiltrator (looking to the northeast) (photo date 8/7/2020).

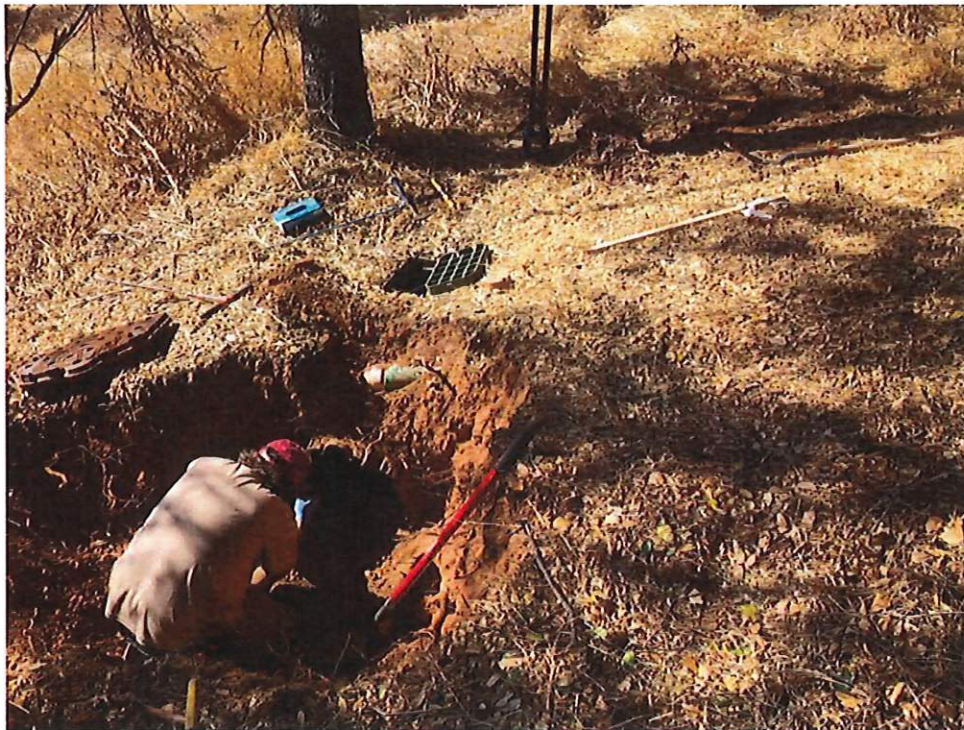
Photo No. 9 Northeast end of Field B, Row 2 infiltrator exposed in excavation LF3. View is looking to the southwest (photo date 8/7/2020).

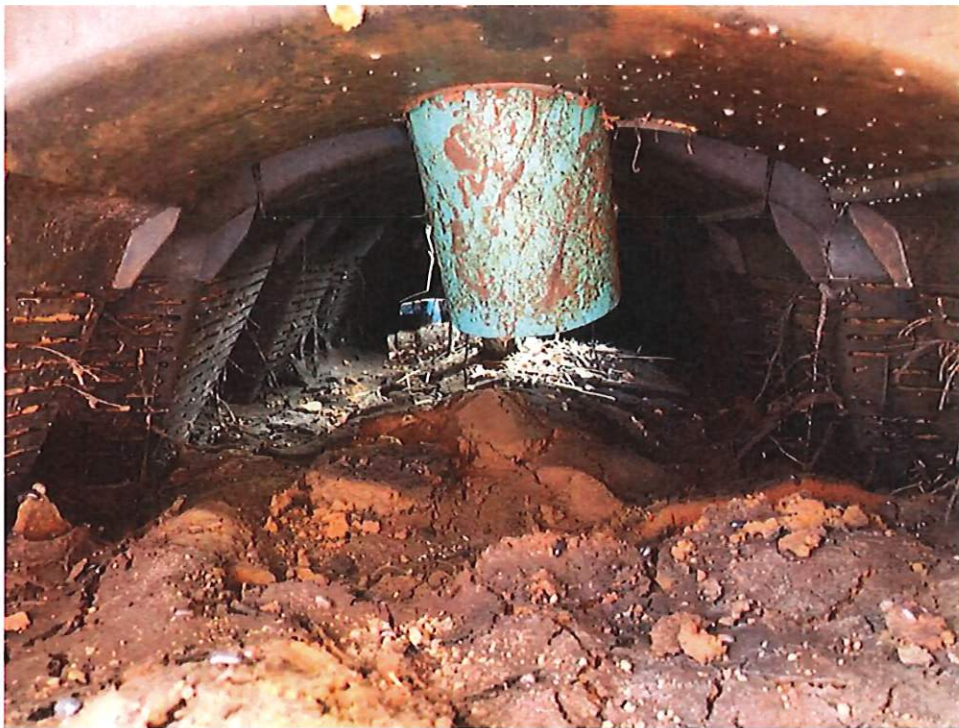
Photo No. 10 Looking into the northeast end of Field B, Row 2 infiltrator (looking to the southwest) (photo date 8/7/2020).

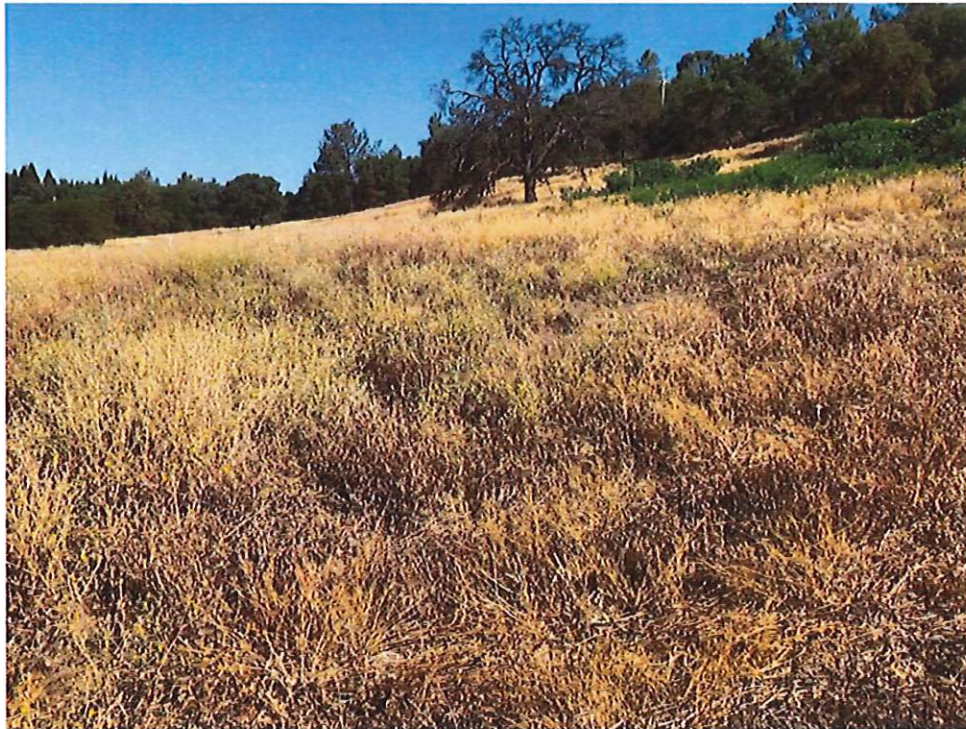
Photo No. 11 View looking to the north-northwest at possible expansion area downslope of Fields A and O. Downslope limit of lush vegetation in Field A is in upper right (photo date 8/3/2020).

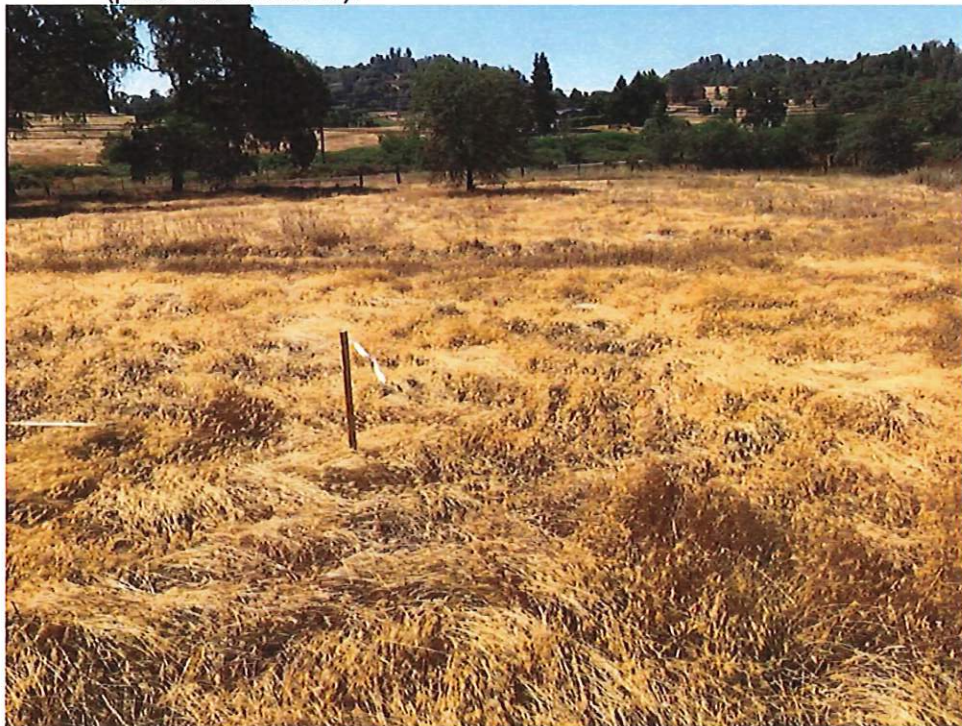
Photo No. 12 View looking to the south at possible expansion area downslope of Field A. Foreground stake marks the location of Soil Profile Test Pit TP8 (photo date 8/3/2020).

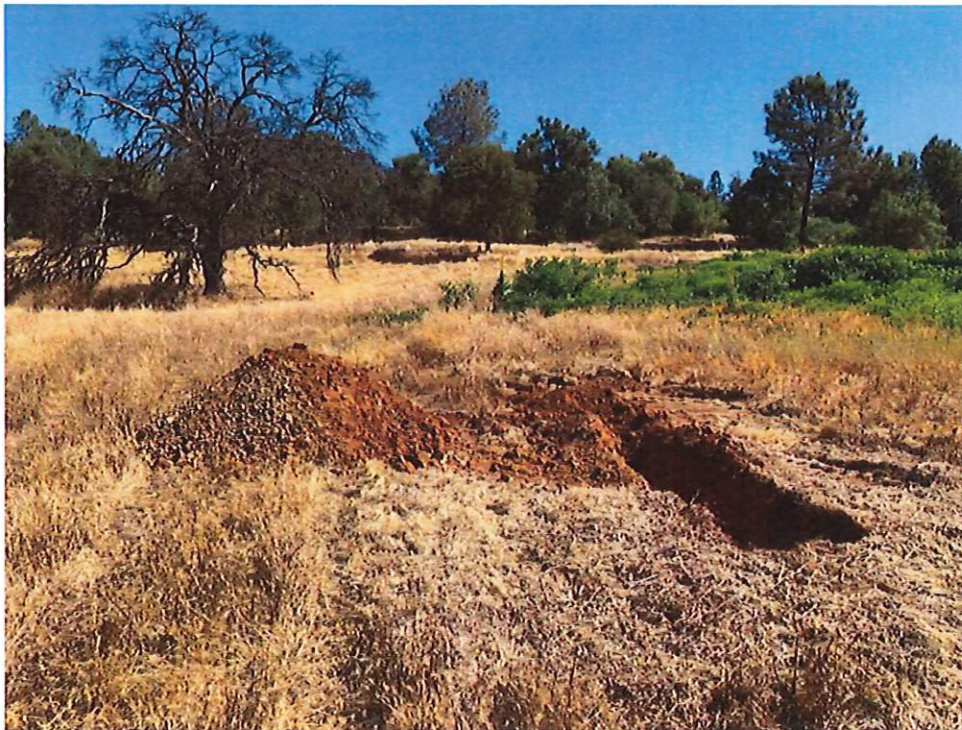
Photo No. 13 View looking northeast at Soil Profile Test Pit TP6. Downslope limit of lush vegetation in Field A is in upper right (photo date 8/6/2020).

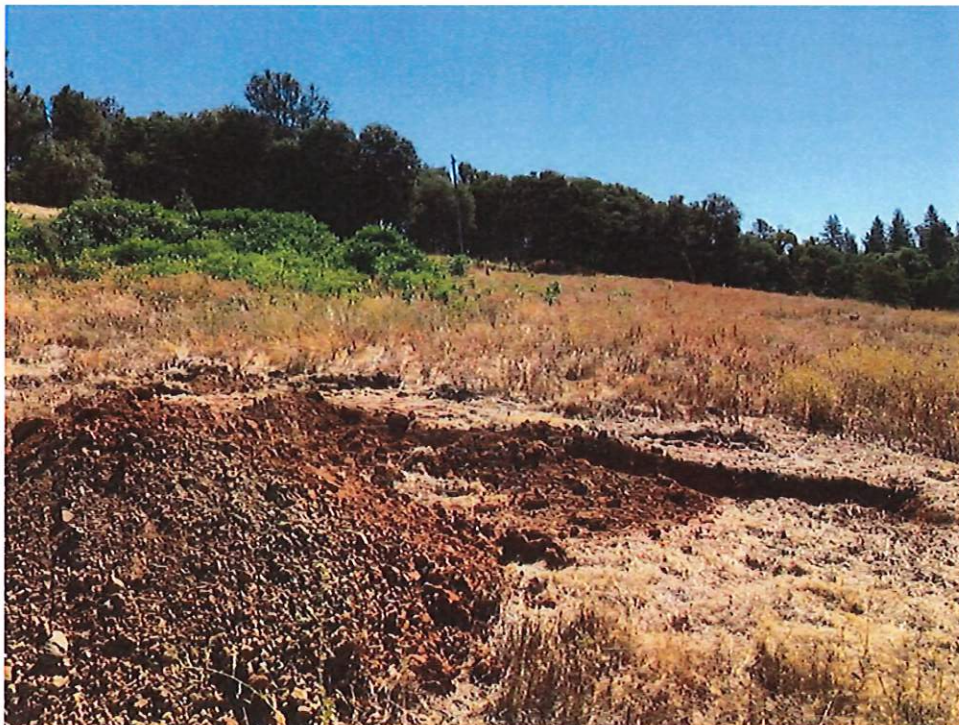
Photo No. 14 View looking southeast at Soil Profile Test Pit TP6. Downslope limit of lush vegetation in Field A is in upper left (photo date 8/6/2020).

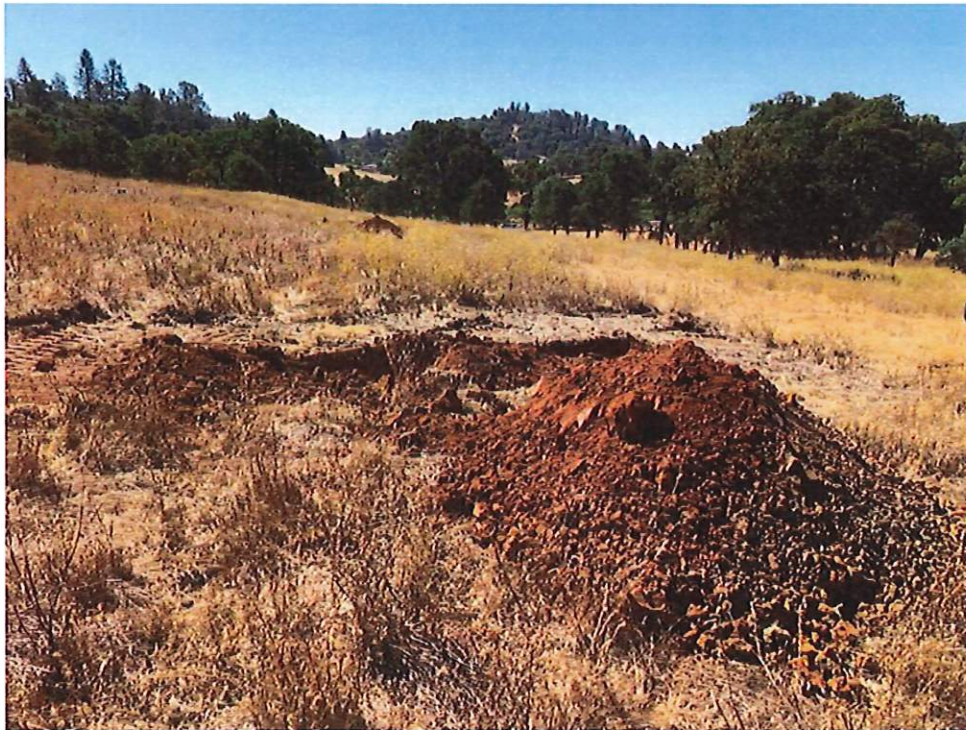
Photo No. 15 View looking to the southeast at Soil Profile Test Pit TP6, with TP7 excavation visible beyond (photo date 8/6/2020).

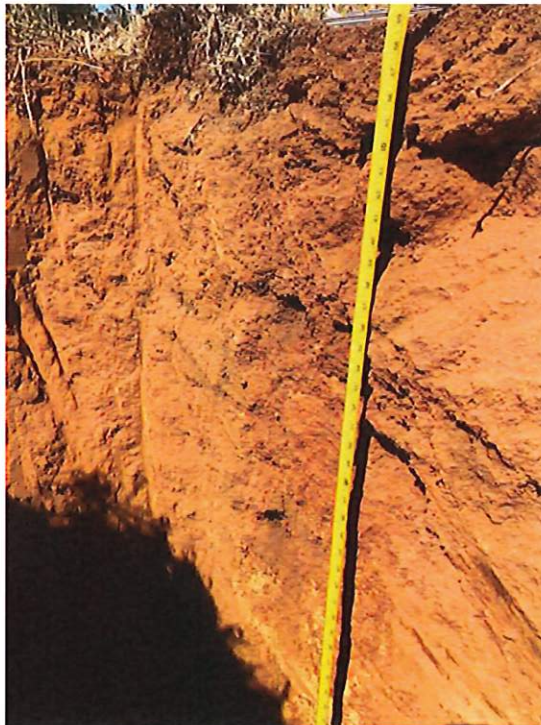
Photo No. 16 Soil profile in Test Pit 6 (photo date 8/6/2020).

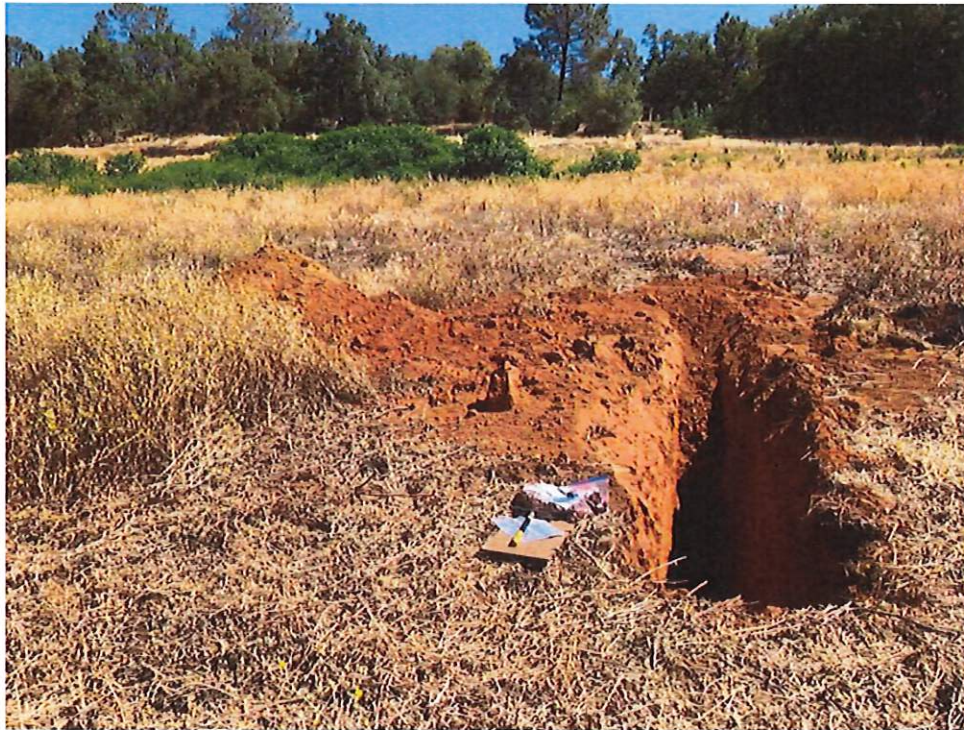
Photo No. 17 View looking to the north (upslope) at Soil Profile Test Pit TP7, with Field A in the background. White riser beyond the test pit is bottom (south corner) of Field A (photo date 8/6/2020).

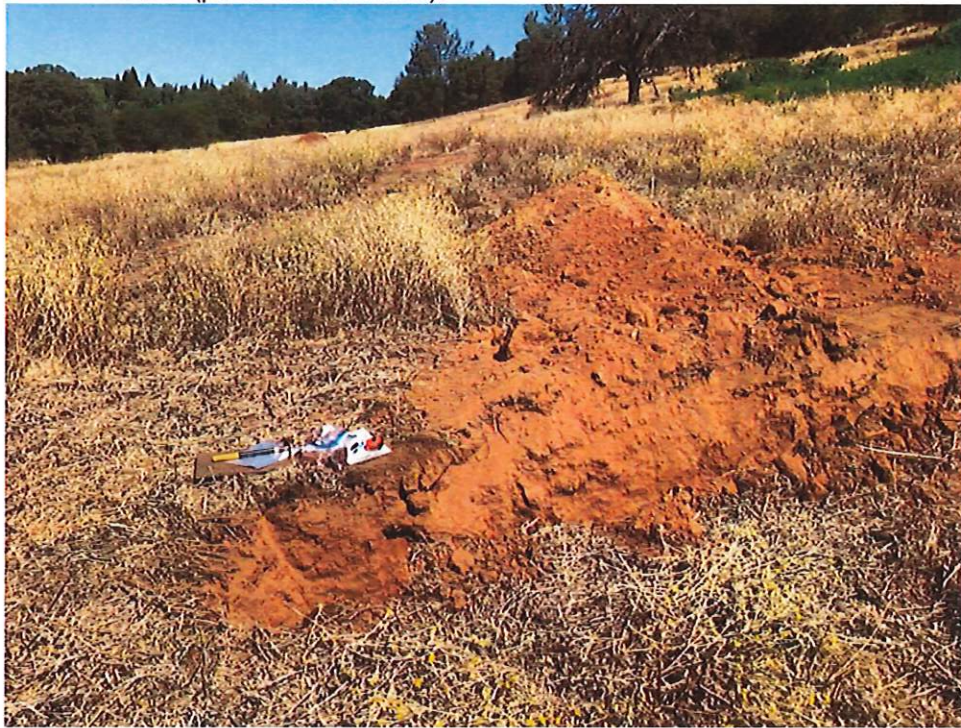
Photo No. 18 View looking to the northwest at Soil Profile Test Pit TP7, with lush vegetation of Field A in the upper right and TP6 excavation near upper left (photo date 8/6/2020).

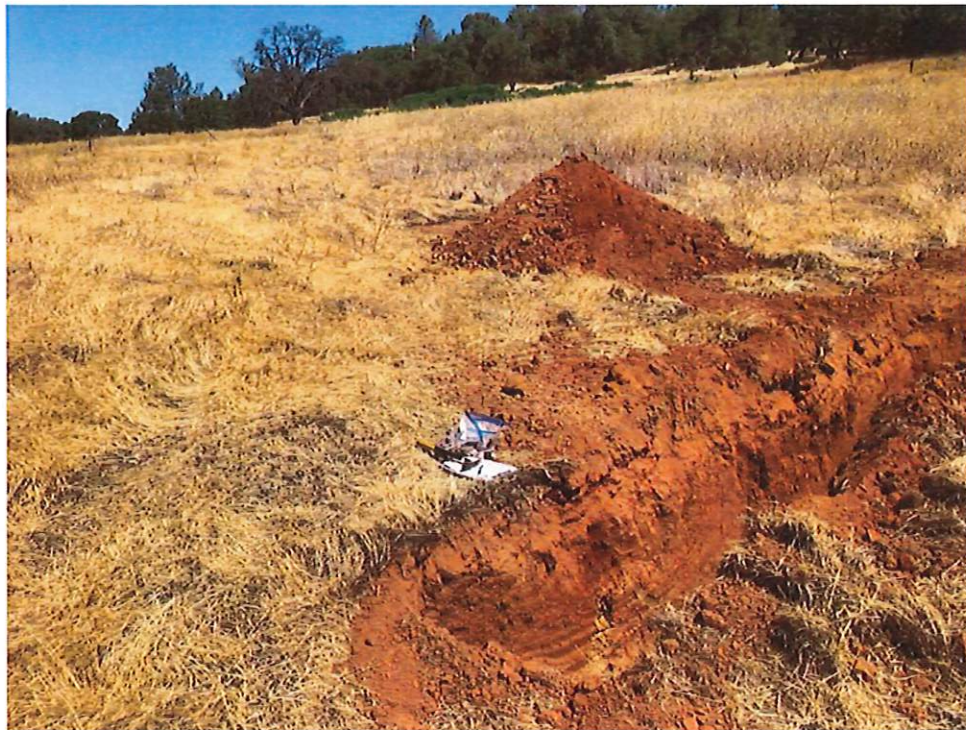
Photo No. 19 View looking to the north at Soil Profile Test Pit TP8 (photo date 8/6/2020).

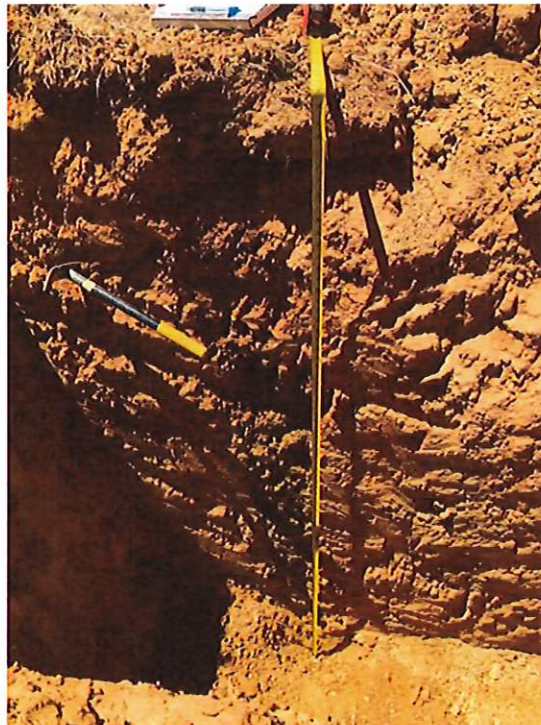
Photo No. 20 Soil profile in Test Pit TP9 (photo date 8/6/2020).
