Auburn Lake Trails Community Disposal System

FEASIBILITY STUDY REPORT

November 16, 2020

Bennett Engineering Services
1082 Sunrise Ave, Suite 100
Roseville, CA 95661

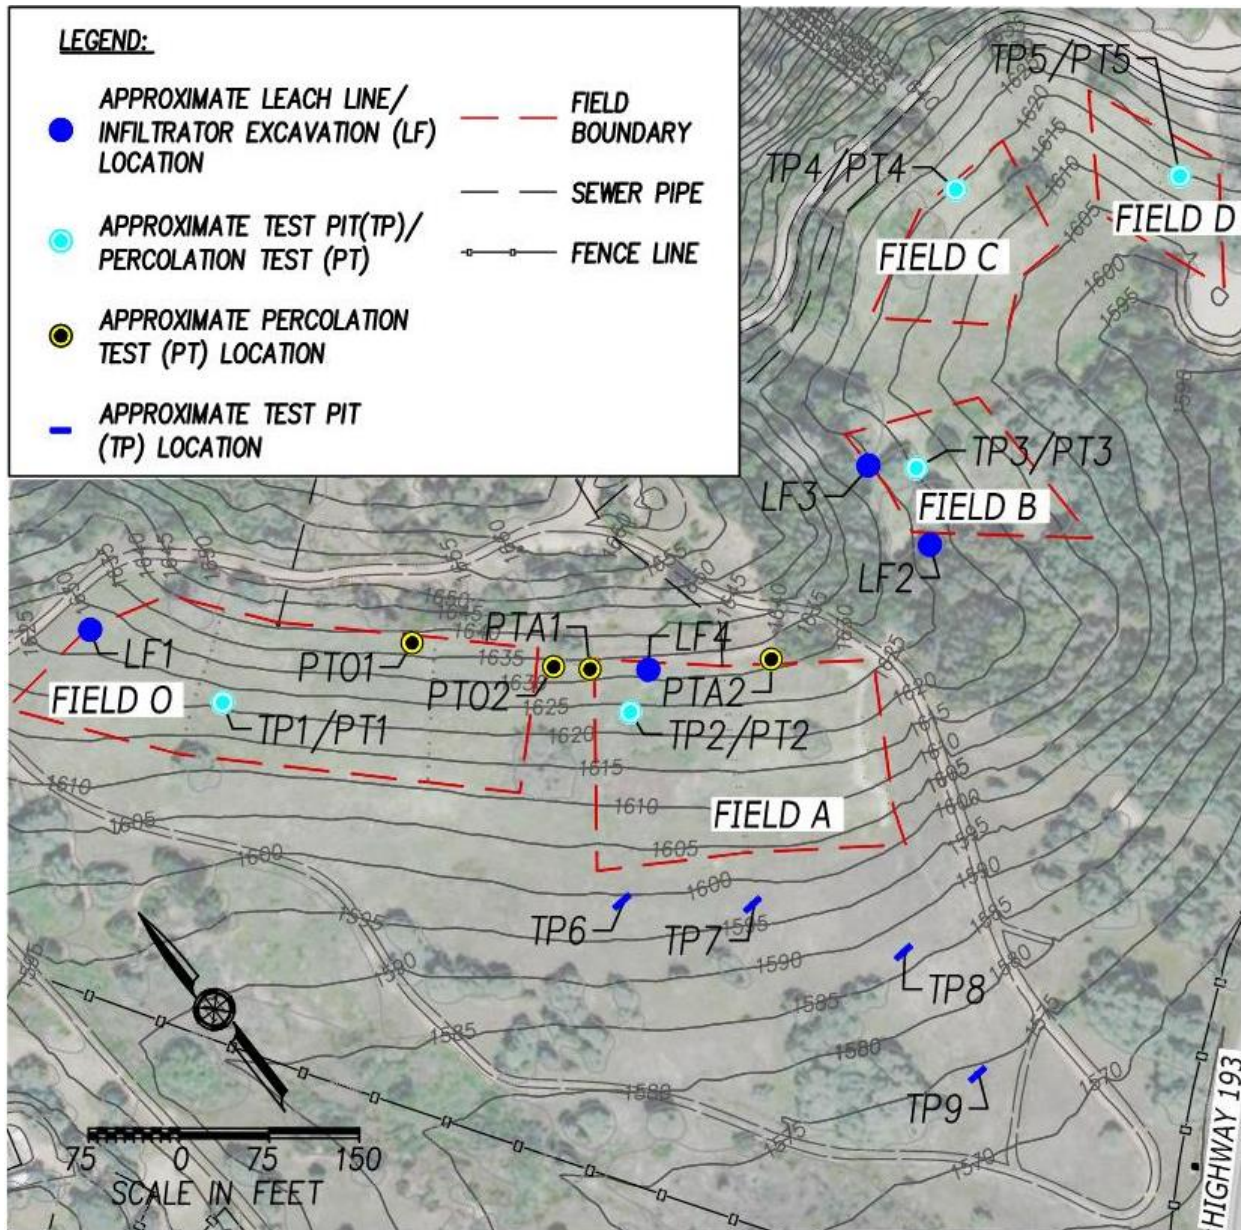
Figure 1. Disposal Area Site Plan

Figure 1 shows a site plan of the District disposal field area.

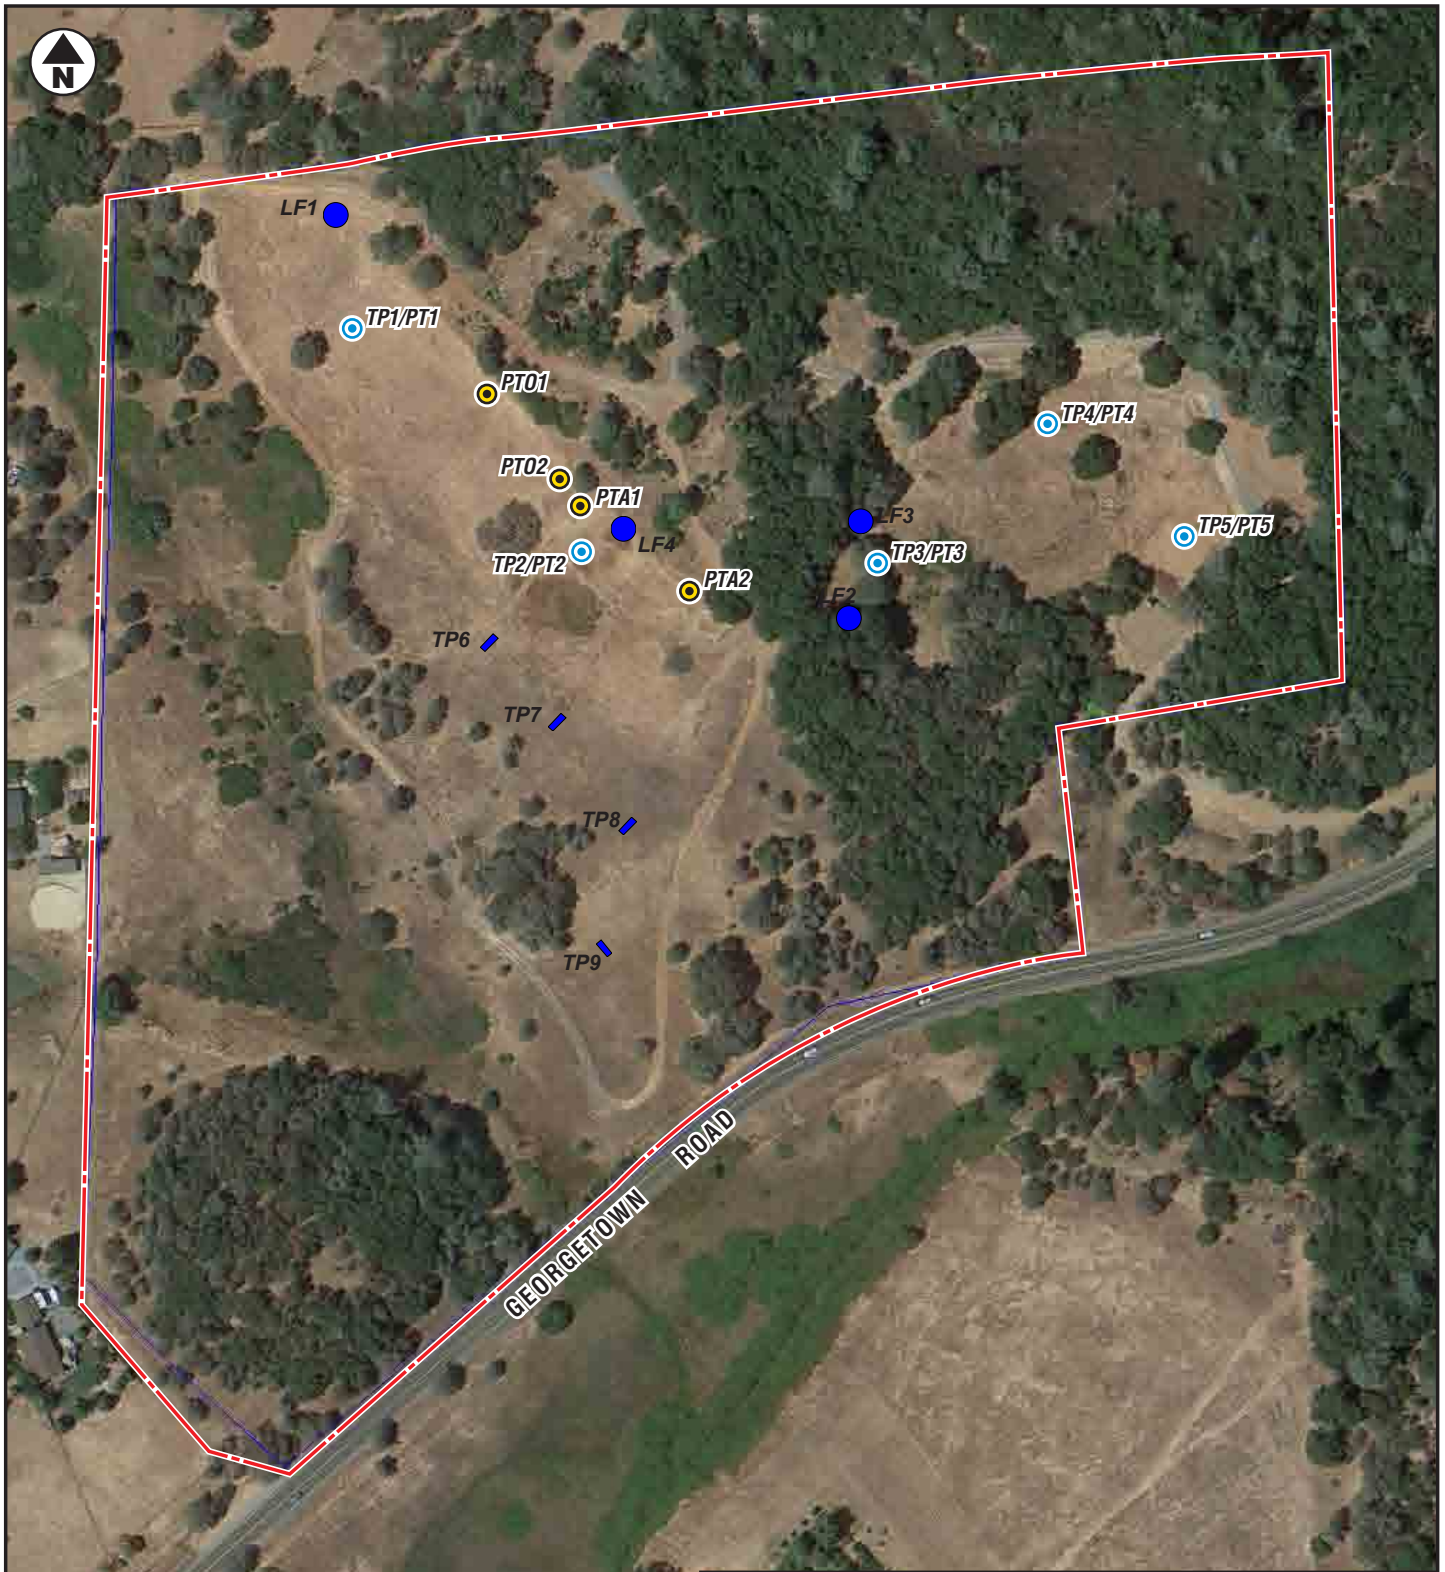
Figure 2

The facility is an existing community wastewater disposal system consisting of five subsurface disposal fields on an approximately 30-acre site in gently rolling oak woodland terrain. The site is generally bounded by State Route 193 to the south, rural residential properties to the north and west, and undeveloped oak woodlands to the north and east. The current site configuration is shown on the Site Plan, Figure 2.
