**EL DORADO CONDUIT RAW WATER CONVEYANCE
TUNNEL INSPECTION
GEORGETOWN, CALIFORNIA**

BRIERLEY ASSOCIATES CORPORATION

January 2025

Subject: Tunnel Inspection Report
Raw Water Conveyance Tunnel Inspection
Georgetown, California

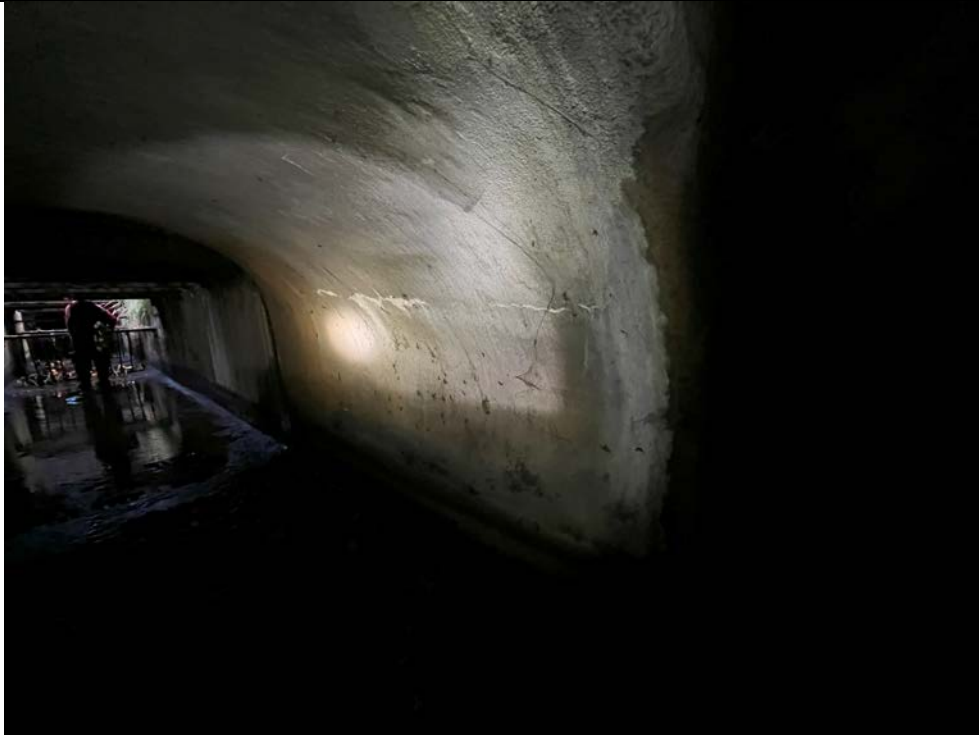
STATION: 451+47 – 451+57

Defect No.	2024 Start Station	2024 End Station	Photo Number	Defect/Observation Description
1	451+47.00	451+57.00	_164249 _164300	The concrete surface of transition structure has some rust and efflorescence especially along a crack. There was no delamination, scaling, spalling, exposed bar, honeycombing or active leakage. While brown staining was mainly present where the concrete is close to the trash rack and first steel ribs in the tunnel, light-colored and greenish staining was in the middle section. Condition State: CS2
2	451+57.00	452+15.00		A total of 16 steel ribs (between #83 and #98) were observed at spacing of approximately 4-ft. The steel ribs and tie-bars were usually covered with shotcrete and it was not possible to inspect the steel rib surfaces under shotcrete. Shotcrete appears in reasonable condition and no spalling noted. Where tie-bars were not covered with shotcrete, they appeared to be affected by significant corrosion. The wood blocking between the steel ribs and rock surface appeared to be inadequate. Some minor water inflow through shotcrete at certain locations, mainly on south wall, totalling 5-10gpm

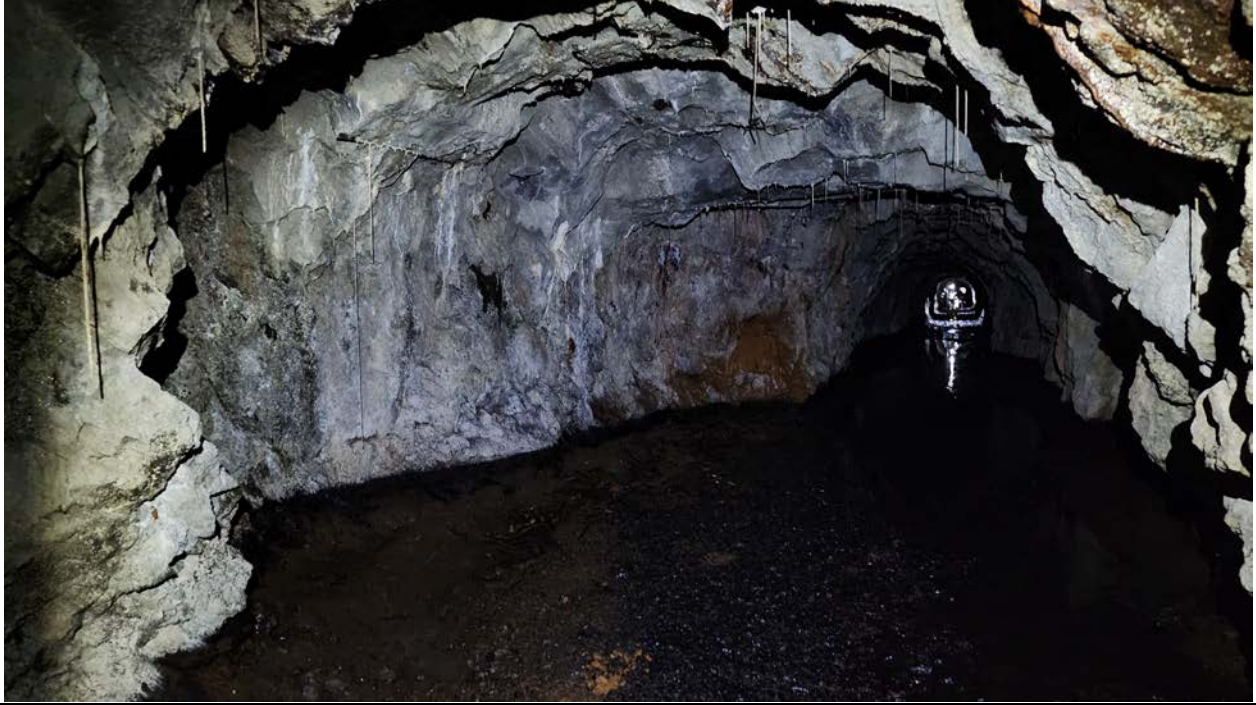
STATION: 460+70 – 460+90

11	459+90.00	460+00.00	_160405	Geologic Map - see tunnel Geologic Map 02 in Appendix E
12	460+70.00	460+90.00	IMG_5036.HEIC _155006	Car pass - tunnel widened on north wall up to approximately 12 feet. Observed sediment (clay/sand) deposition at the tunnel floor at N
13	460+50.00	461+20.00	IMG_5035.HEIC _154821	Shotcrete and mine straps with some delamination in places. Shotcrete up to 1 inch thickness with few cracks. Thin light colored stalacties, likely from leaching of shotcrete
14	461+50.00	-	IMG_5033.HEIC _154235	Geologic measurements - refer to Appendix E
15	462+30.00	463+00.00	IMG_5030.HEIC _153249	Shotcrete in crown and tunnel walls, including invert. Shotcrete up to 1 inch thickness with few cracks. No spalling observed. Thin light colored stalacties, like from leaching of shotcrete.
16	462+50.00	463+00.00	_152936	Evidence of previous water inflow with 6 to 12 inch long stalactites
17	464+20.00	464+30.00		Geologic Map - see tunnel Geologic Map 03 in Appendix E

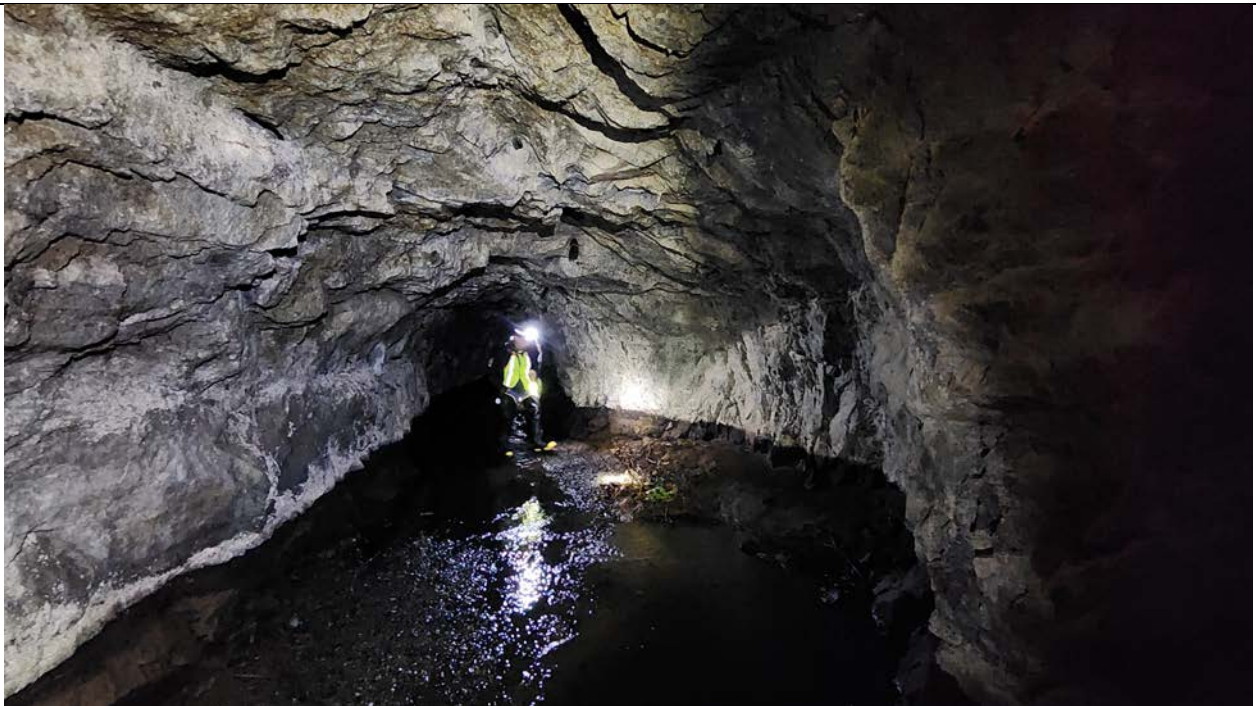
STATION: 473+30 – 473+50

23	473+30.00	473+50.00	IMG_5005.HEIC _145236	Car pass - tunnel widened on south wall up to approximately 12 feet. Observed sediment (clay/sand) deposition at the tunnel floor
24	476+45.00	476+60.00	IMG_4997.HEIC _143713	Incomplete shotcrete with 4 inch WWM. WWM exposed in many areas. Shotcrete up to 1 inch thickness with few cracks, with possible demalination or non-contact with tunnel walls. No spalling observed. Some efflorescence and thin light colored stalactites, likely from leaching of shotcrete. Mine straps in crown.
25	477+35.00	477+50.00	_143433	Single mine strap installed in crown
26	477+70.00	-	IMG_4988.HEIC _143353	0.5 inch WWM and mine straps in crown. Water seep with iron oxide discoloration; tunnel walls wet; 2 to 3 foot wide quartz vein, vertical
27	478+35.00	478+45.00	IMG_4985.HEIC _142810	Incomplete shotcrete with 4 inch and 0.5 inch WWM. WWM exposed in many areas. Shotcrete up to 1 inch thickness with few cracks, with possible demalination or non-contact with tunnel walls. No spalling observed. Some efflorescence and thin light colored stalactites, likely from leaching of shotcrete. Mine straps in crown.

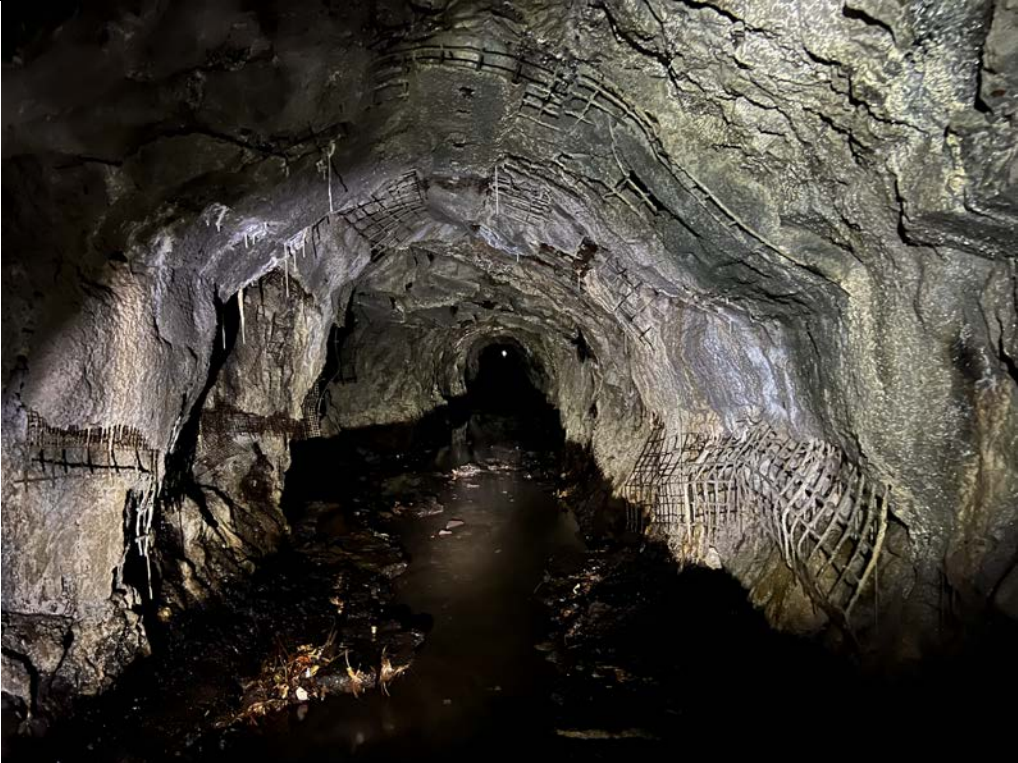
STATION: 478+45 – 478+65

28	478+45.00	478+65.00	IMG_4980.HEIC _142617	Car pass - tunnel widened on south wall up to approximately 12 feet. Shotcrete and mine straps installed in the crown. Observed sediment (clay/sand) deposition at the tunnel floor
29	479+50.00	-	IMG_4977.HEIC _142322	Shotcrete and 0.5 inch WWM. Shotcrete up to 1 inch thickness with few cracks, with possible demalination or non-contact with tunnel walls. No spalling observed. Some efflorescence and thin light colored stalactites, likely from leaching of shotcrete. Some iron oxide staining from water inflow and corrosion of WWM.
30	480+20.00	-	_142142	Small breakout on north wall with dimensions of 5 x 5 x 5 feet
31	481+30.00		IMG_4970.HEIC _141534	Geologic measurements - refer to Appendix E
32	483+50.00	483+70.00	IMG_4965.HEIC _141123	Car pass - tunnel widened on south wall up to approximately 12 feet. Observed sediment (clay/sand) deposition at the tunnel floor

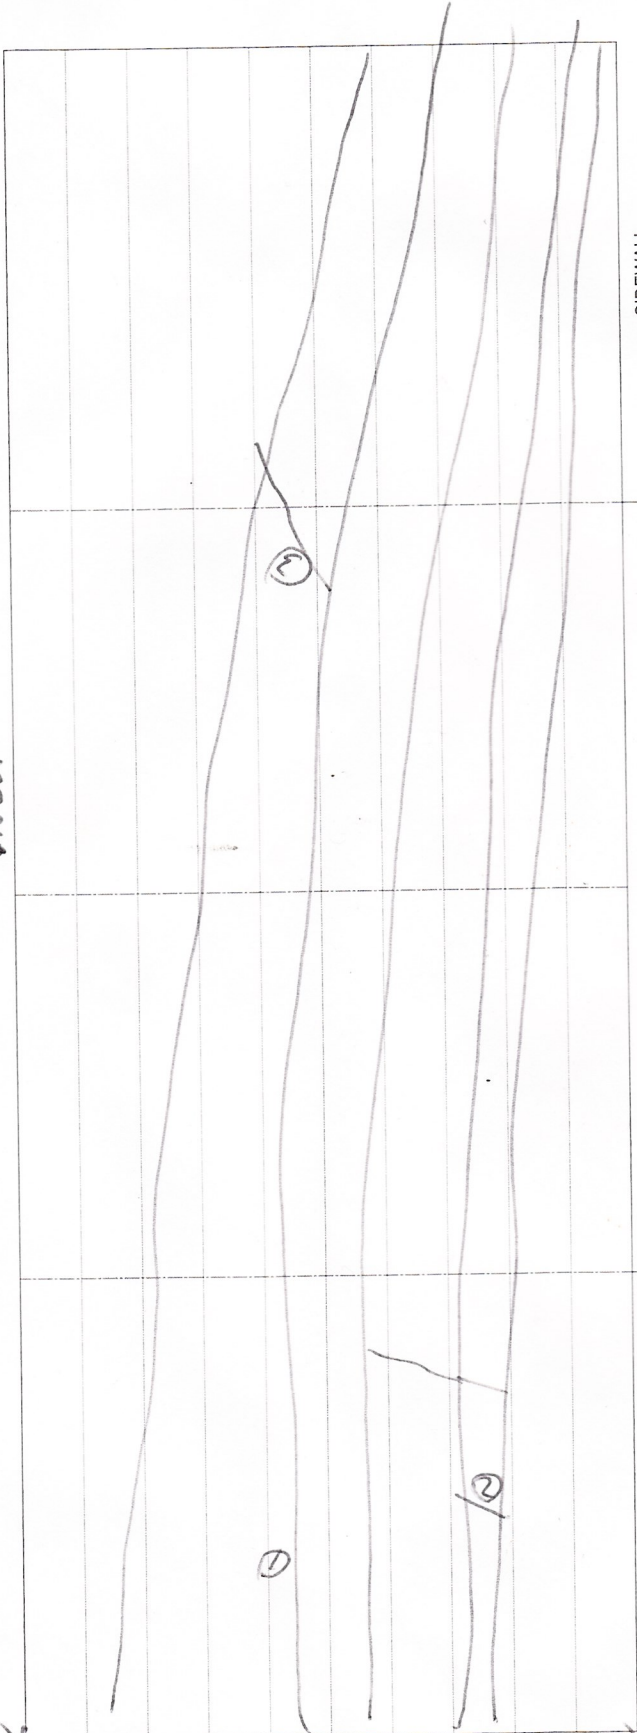
STA. 454
+ 05

ID	Type	Dip	Dir.	DISCONTINUITIES				Weathering	Seepage	COMMENTS	GROUNDWATER	
				Roughness	Persistence	Aperture	Infill				Spacing	ID
1	S1	70	215	R	>10'	Tight	clean	6"-10' SW	None			
2	J	20	335	R	<1'	Tight	None	<1' SW	None			
3	S	55	035	R	<10'	Tight	clean	>10' SW	None

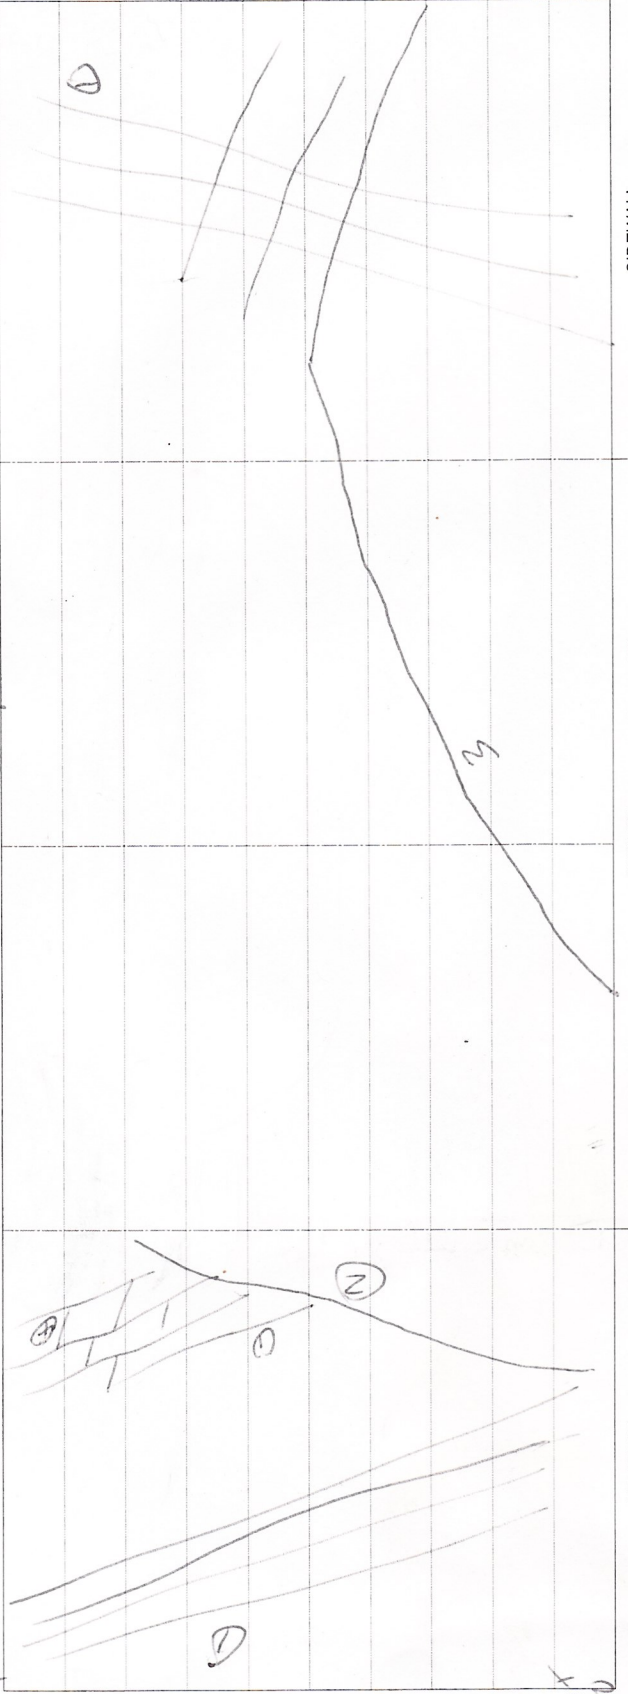
STA. 407.90

ID	Type	Dip	Dir.	Roughness	DISCONTINUITIES			Infill	Spacing	Weathering	Seepage	GROUNDWATER	
					Persistence	Aperture	Weathering					ID	Flow
1	JK	50	325	rough	710	step	0	20ft	sl. wx	—			
2		35-5	110	irregular						—			
3		20	130	irregular	>10	step	0.2	710ft	mod. wx	—			
4		87	050	rough	71	tight	0	21 ft	sl. wx	—

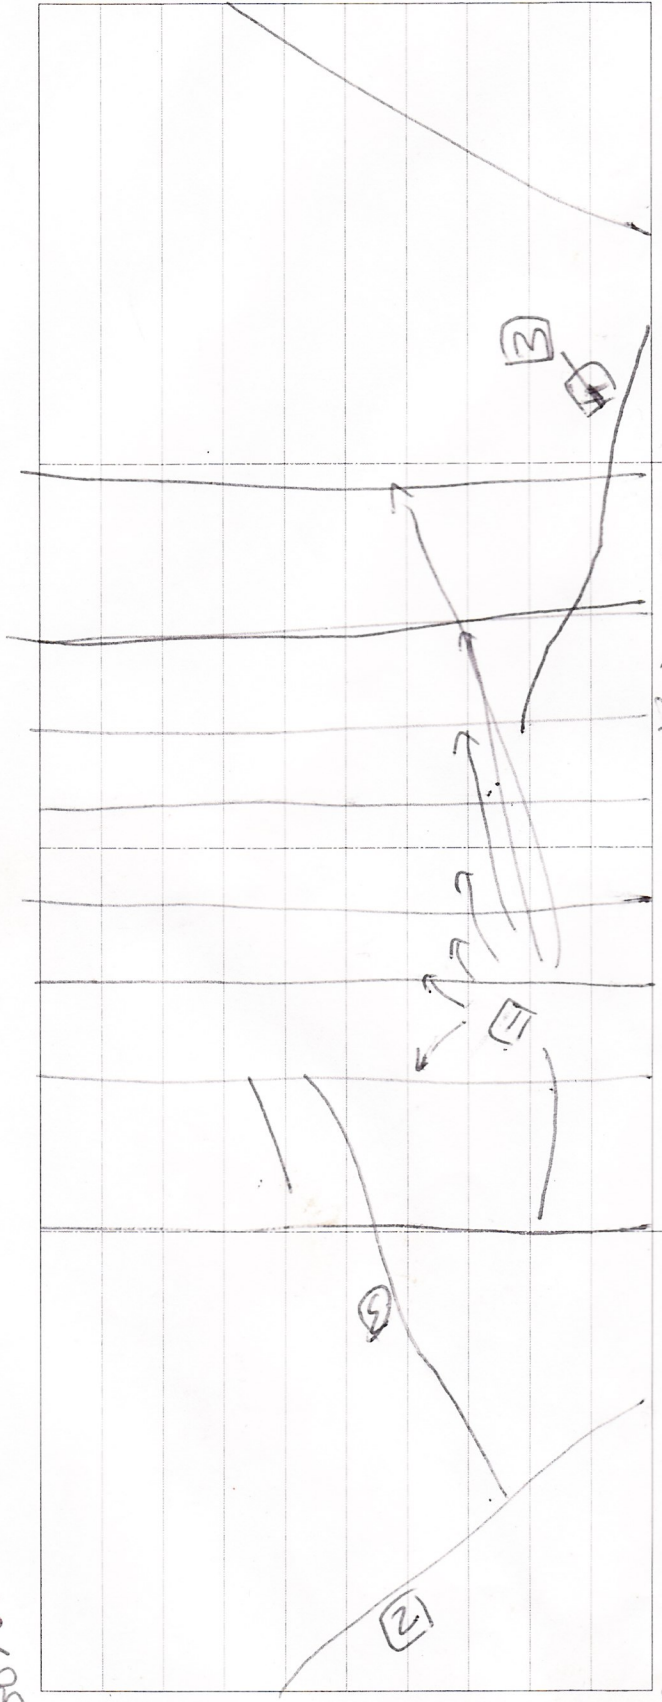
STA. 6185+00

ID	Type	Dip	Dir.	Roughness	Persistence	Aperture	Infill	Spacing	Weathering	Seepage	COMMENTS	GROUNDWATER	
												ID	Flow
1	S	5N 780	S. strike	R	69-30'	light	None	1-5'	Slight w.	None			
2	S	45E 020		R	< 30'	light	None	5-10'	S.W.	None			
3	S	65W 220		R	< 5'	light	None	7-10'	S.W.	None
